DRAFT ADA SELF-EVALUATION AND TRANSITION PLAN

CALIFORNIA TAHOE CONSERVANCY

DECEMBER 2018

*Accessibility Compliance Evaluation completed by:
California Department of General Services
Real Estate Services Division
Professional Services Branch, Arch Unit B
Eric Driever, Senior Architect, CASp*

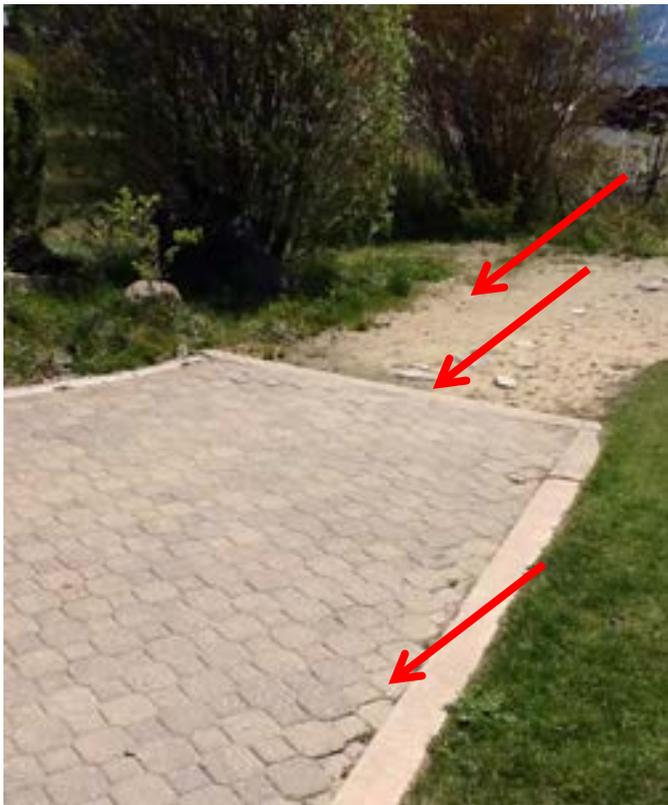
There is no accessible path to beach access. This transition has a vertical transition greater than 1/2" and the trail is uneven. Vertical changes greater than 1/4" exist due to settling pavers.

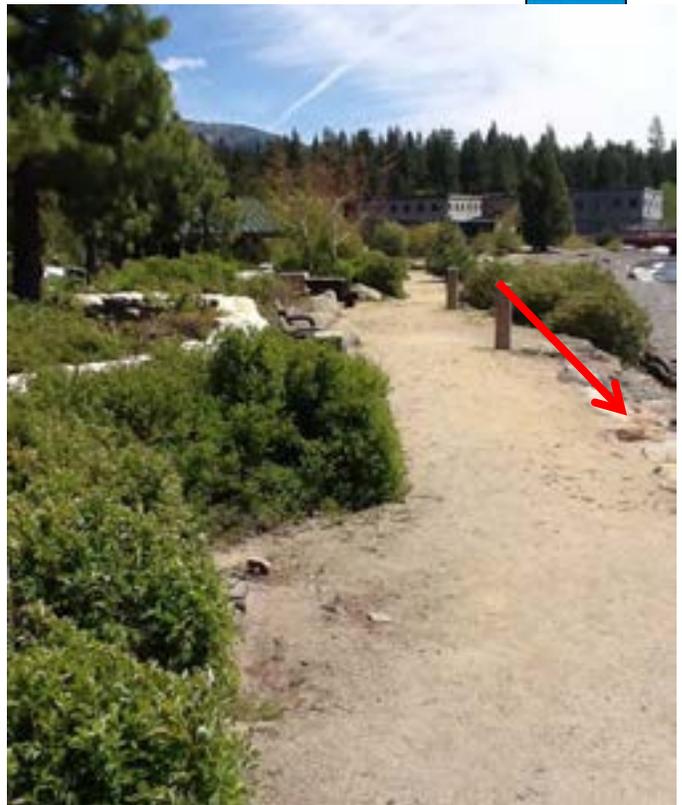
The ledge and vertical change next to the path exceeds 30". The decomposed granite path exceeds slope requirements.

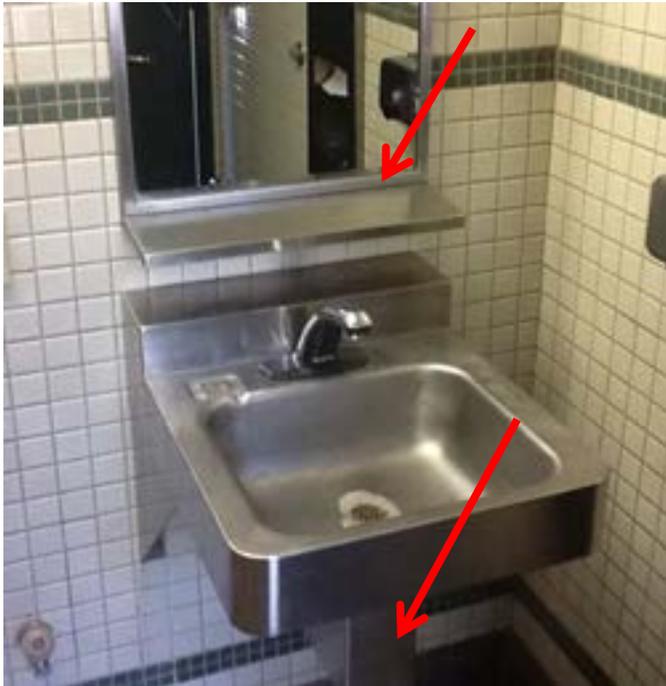
6.I: Lavatory Knee Clearance	Knee clearance extends only 6" from the front edge of the lavatory instead of the minimum 8".	Replace lavatory or adjust stainless steel shroud over piping so that it allows for the required knee clearance.	Short-term

The bottom of the mirror's reflective surface is higher than 40" above finish floor. The metal shroud limits clear knee space to 6" instead of the required 8".

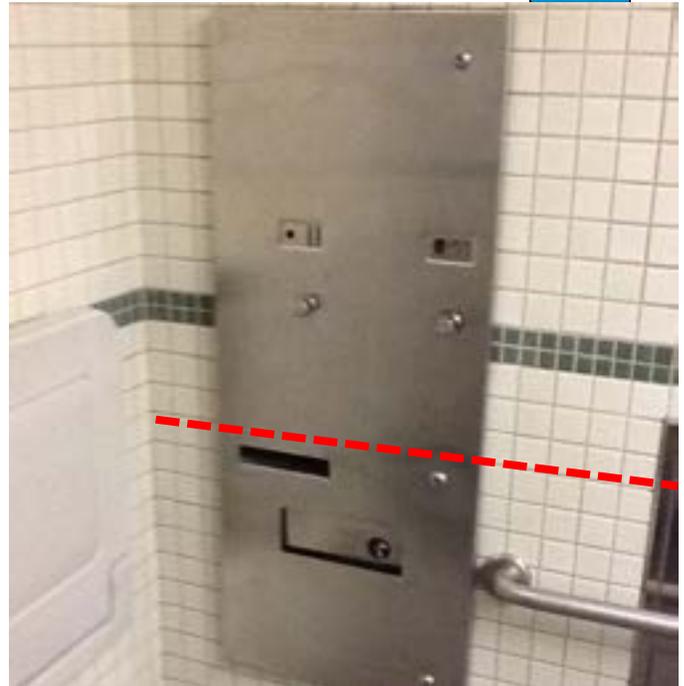
ITEM	EXISTING BARRIER	POTENTIAL OPTIONS	CORRECTIVE TIMELINE
CARNELIAN WEST			
6: Restrooms			
6.K: Dispensers Operating Height	Sanitary napkin dispenser's coin slot is located 53" above finish floor instead of the maximum 40".	Remount or replace dispenser so that the highest operable part is no higher than 40" above finish floor.	Short-term

The coin slot and operator is more than 40" above finish floor.

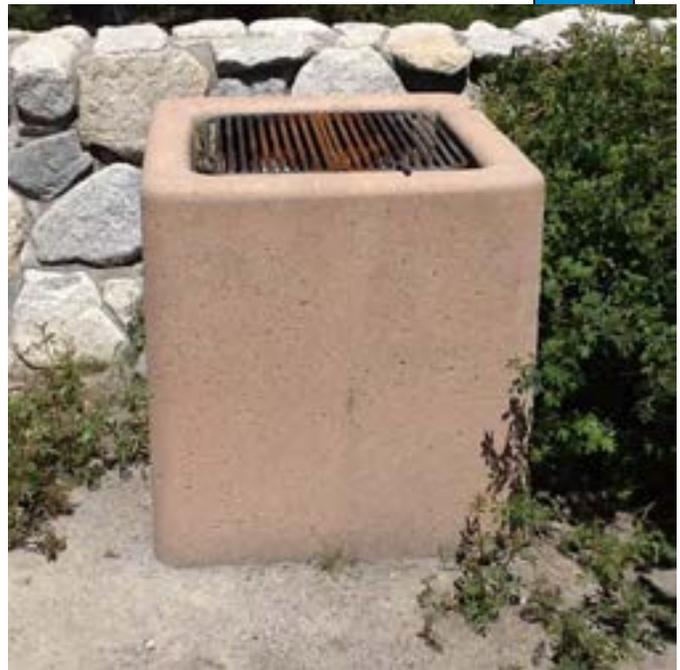
Barbecue should be provided along an accessible route.

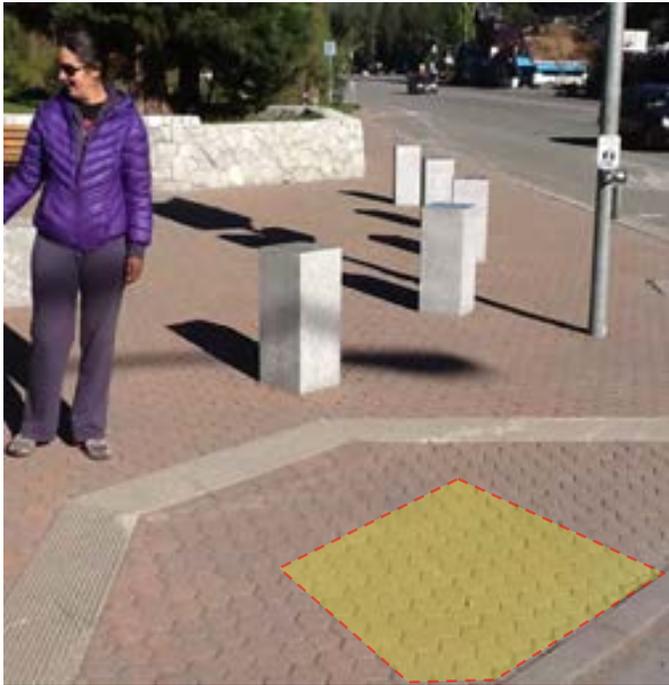
Curb ramp lacks truncated domes.

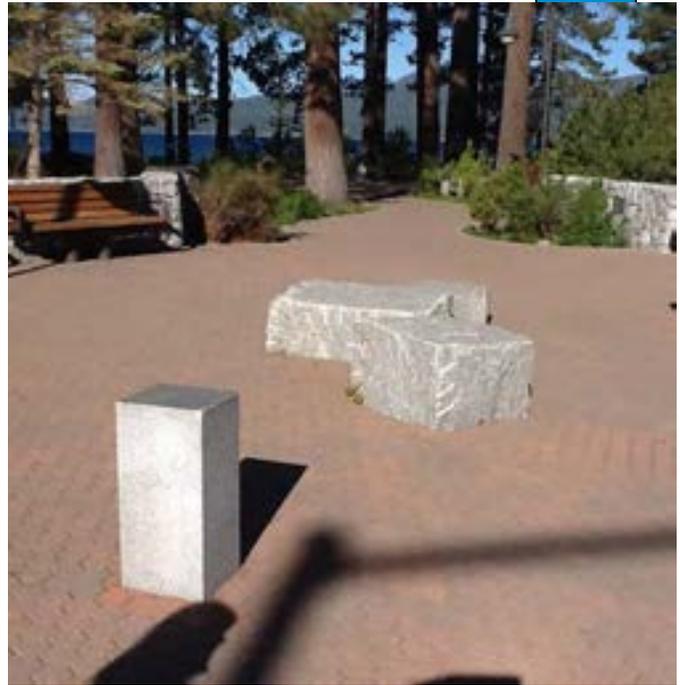
No clear direction of travel exists in the plaza so cross slopes in all directions must not exceed 1:48 (2%).

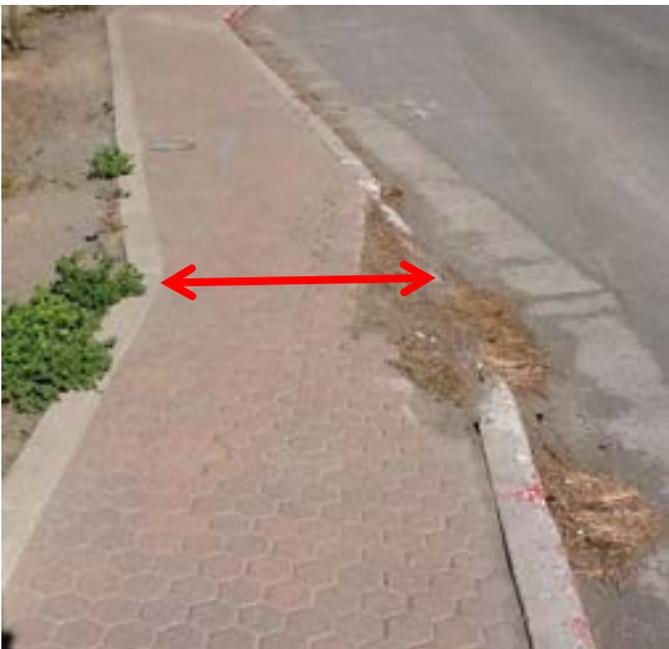
1.C: Path of Travel Width	Damage to the walkway reduces the path of travel to less than 48".	Repair walkway to meet accessibility guidelines. *Note: Evaluate if issue was corrected with new streetscape improvements in 2014-2015.	Done

Damaged walk is reduced to less than 48" in width.

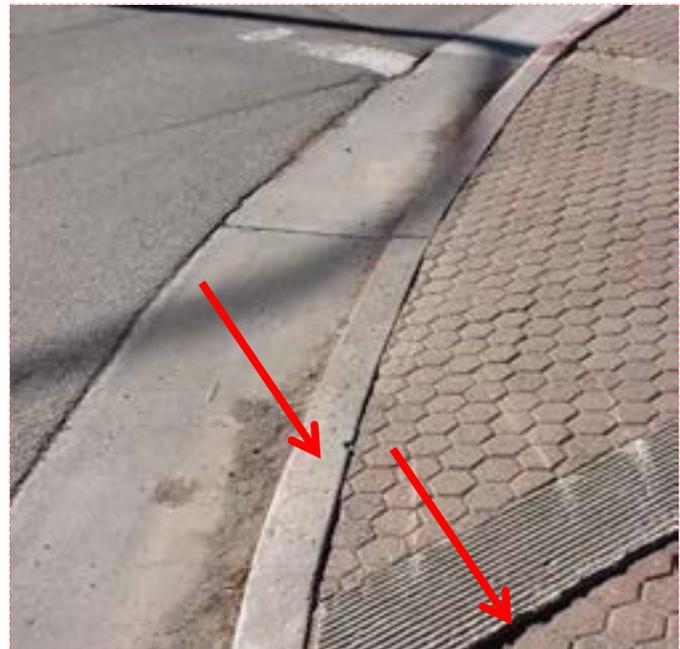
The curb ramp lacks truncated domes and lacks a 24" straight section at the flared edges. Excessive vertical change exists between pavers and concrete elements.

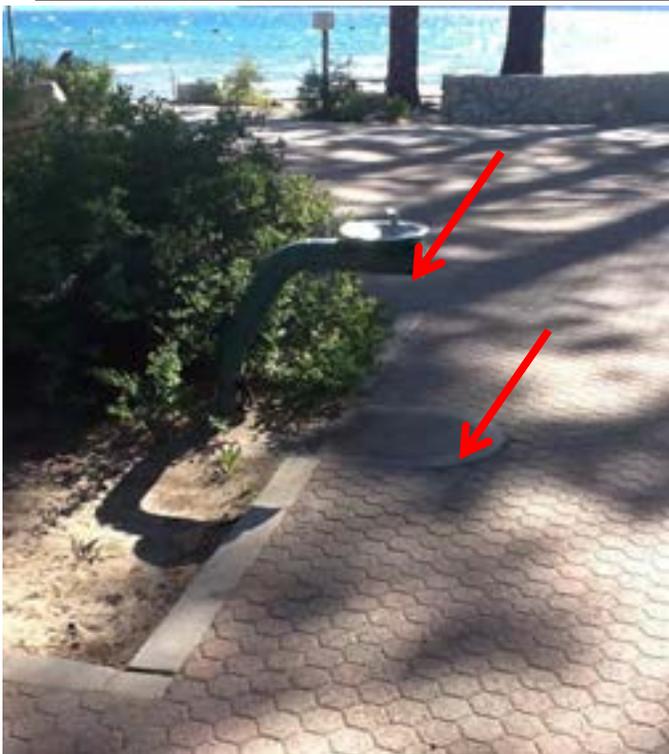
4.C: Protruding Objects	The free-standing drinking fountain projects into the path of travel more than 4" and is not protected by side rails for cane detection.	Install rails to allow for cane detection or replace drinking fountain and set outside of the path of travel so that it is not considered a protruding object.	Mid-term

Drinking fountain creates a protruding object. Only a "low" drinking fountain is provided instead of both a "high" and "low" fountain. The clear space is not level and contains a transition greater than ¼" at the concrete utility box.

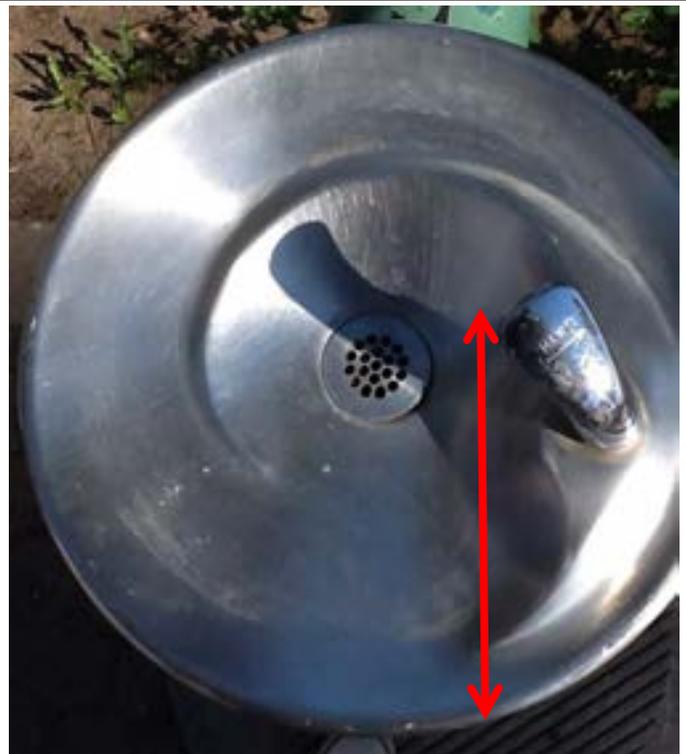
4.D: Operation	The drinking fountain controls require more than 5 lbs. of force to operate.	Replace drinking fountain with a model that meets accessibility standards.	Mid-term

4.E: Spigot	The spigot and water flow is more than 5" from the front of the drinking fountain.	Replace drinking fountain with a model that meets accessibility standards.	Mid-term

The spigot and water flow is more than 5" from the front of the drinking fountain and requires more than 5 lbs. of force to operate.

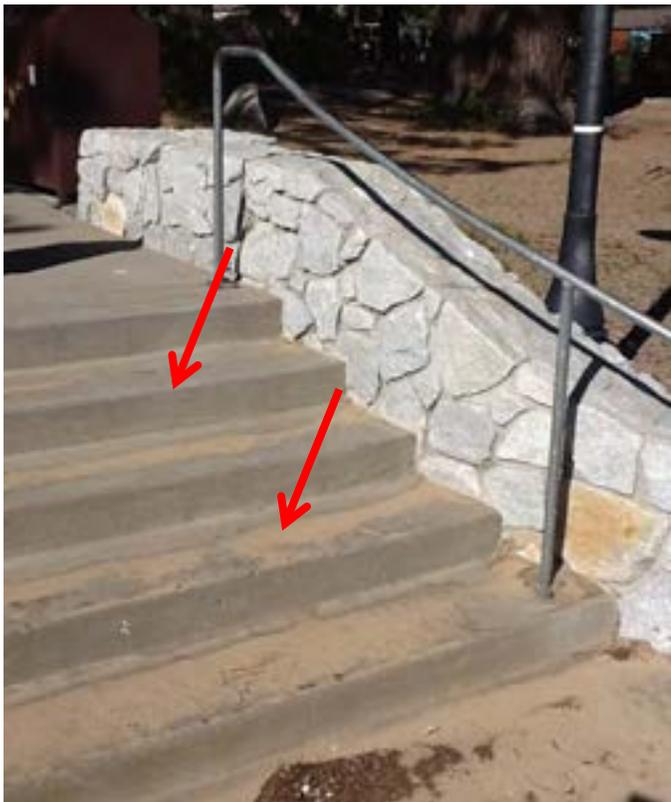
Stairs lack a 2" contrasting band 1" back from nosing and sand causes the surface to not be slip resistant.

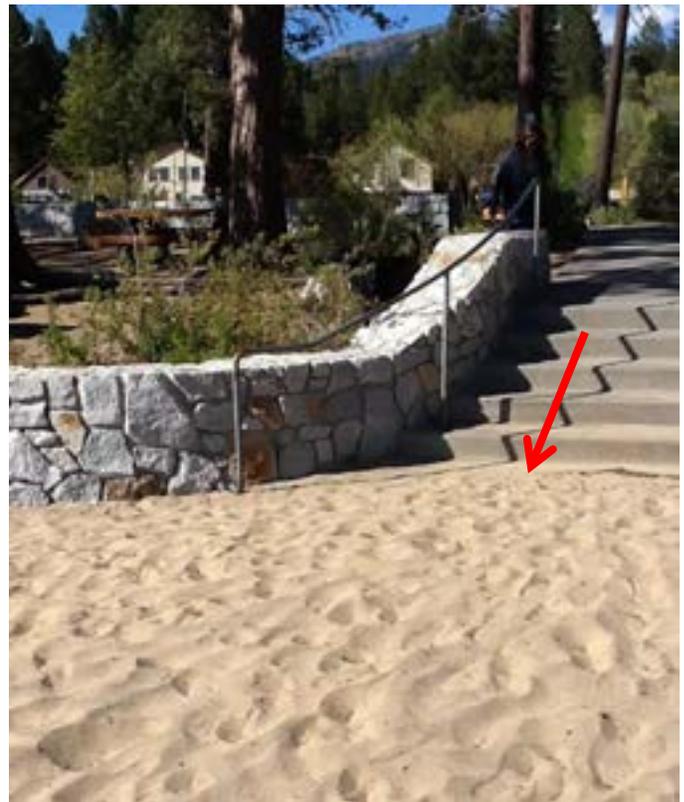
The bottom of the stairs requires a firm and stable landing.

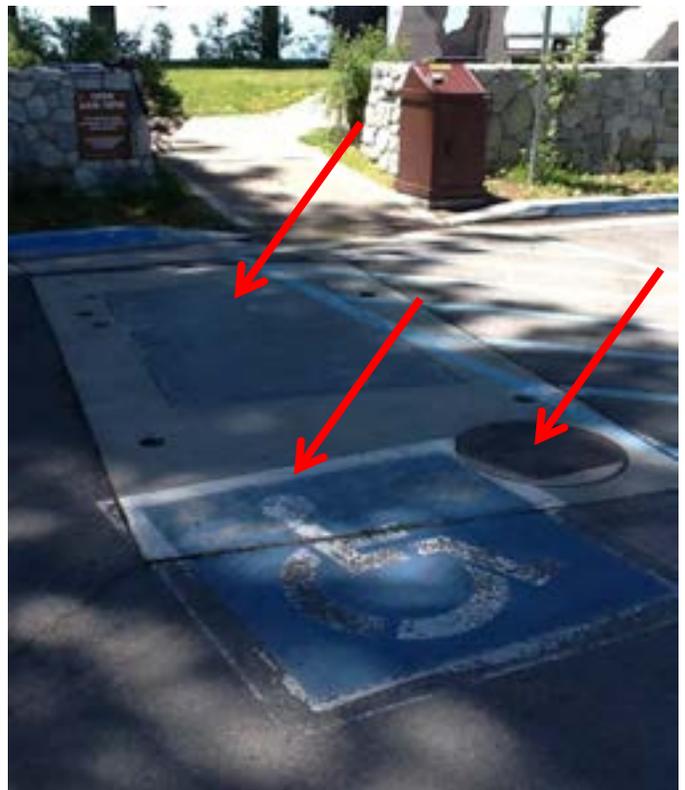
1.B: Cross Slope and Surface	Cross slope in accessible aisle is greater than 2% (2.2%). Uneven surface and inconsistent striping of accessible spaces due, respectively, to parking space location over concrete storm filter vault and the inconsistent replacement of the manhole cover.	With the relocation of parking spaces to the restroom area, re-grade parking area if needed so that cross slope does not exceed 2% and provide appropriate striping.	Long-term

Cross slopes exceed 2%. Surface paint is difficult to maintain over storm drain facilities

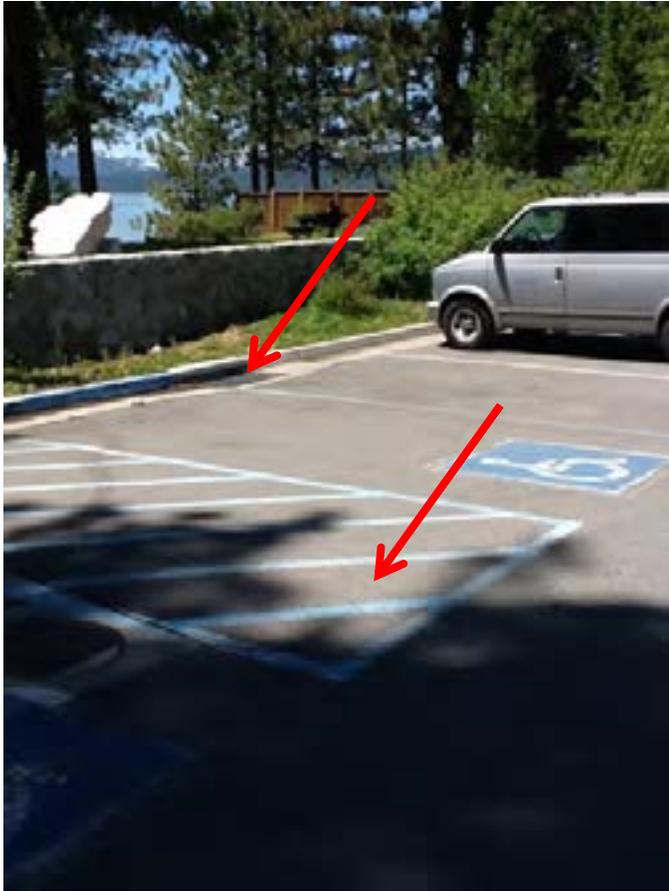
1.C: Lettering	The words "NO PARKING" are not provided in the access aisle.	Revise access aisle striping to include required lettering at appropriate dimensions.	Done

*Excessive cross slopes in parking area due to drain.
Striped area lacks the words "NO PARKING".*

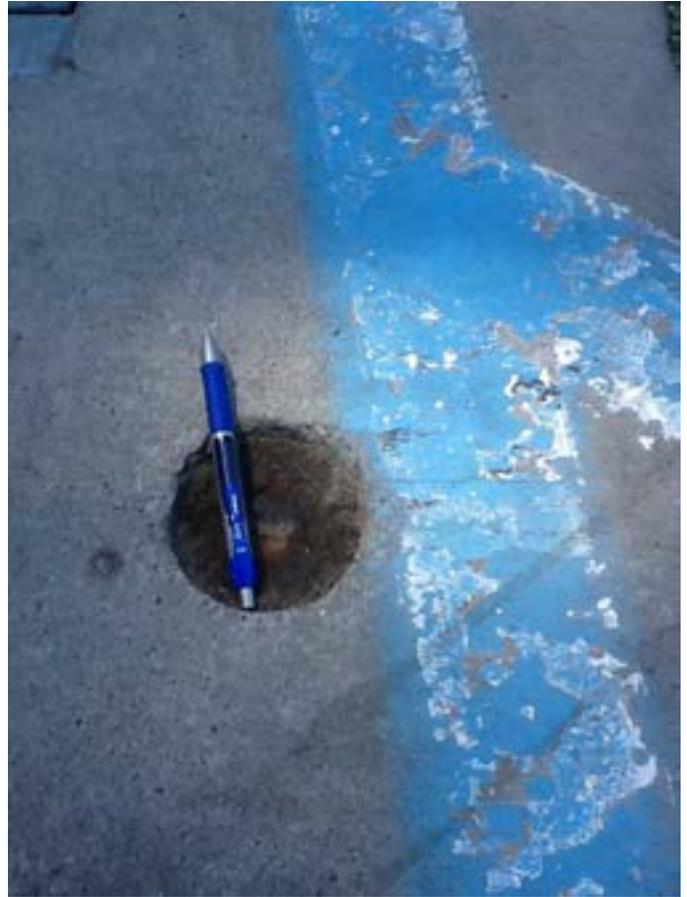
*Border should be blue. Diagonal lines can be blue or white,
whichever has better contrast.*

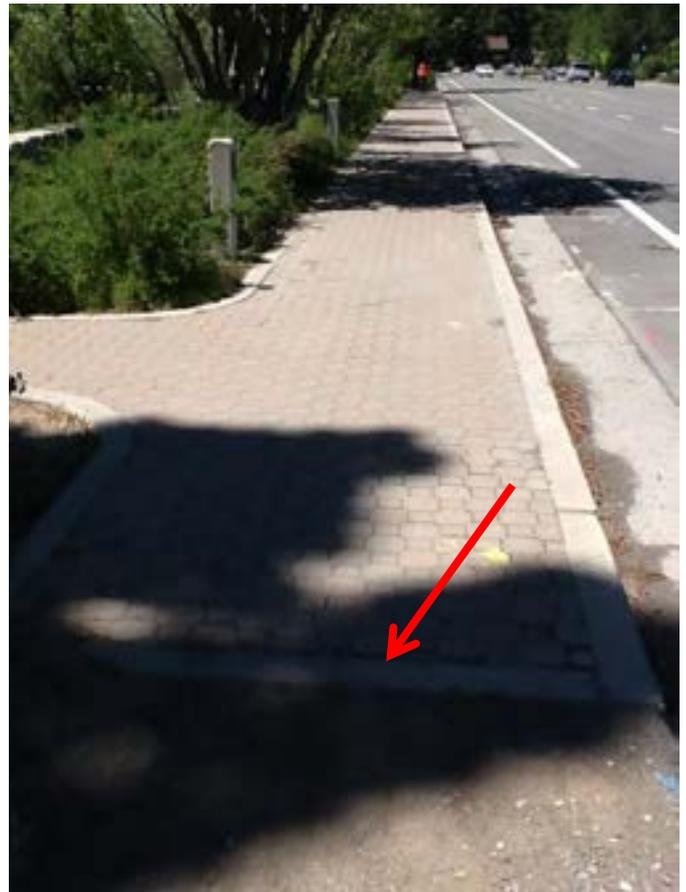
Excessive vertical change exists at the walk's terminus.

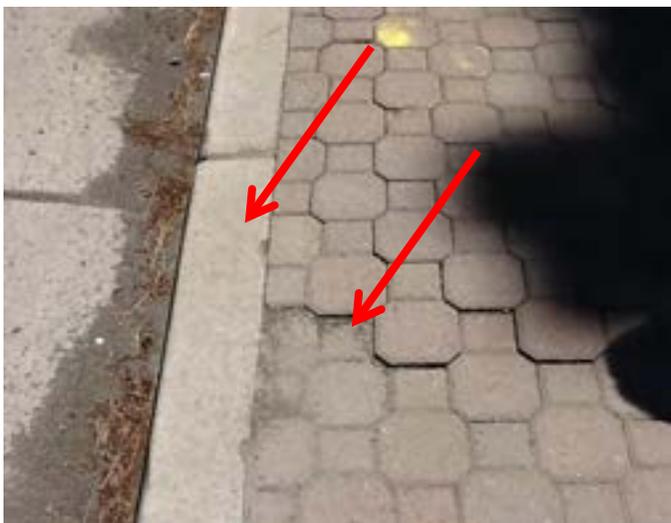
Differential settling causes both non-conforming cross slopes as well as excessive vertical change.

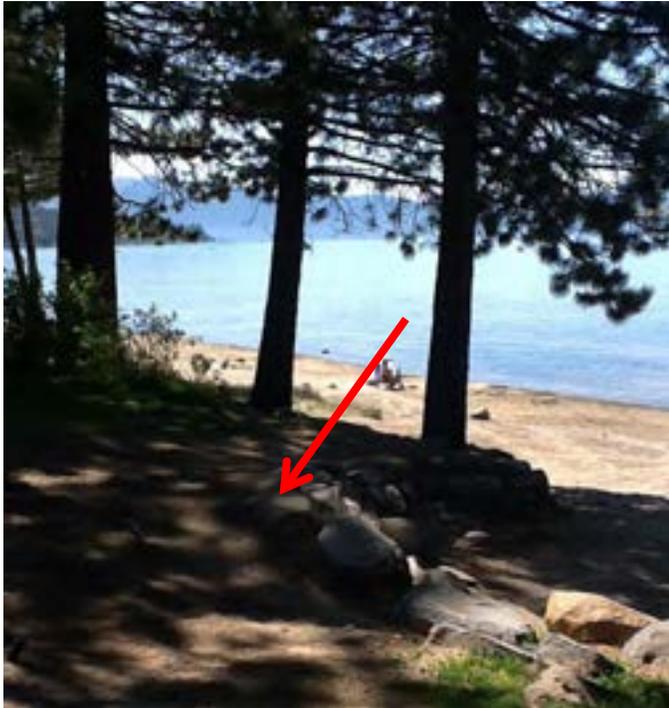
An accessible path is not provided to the beach.

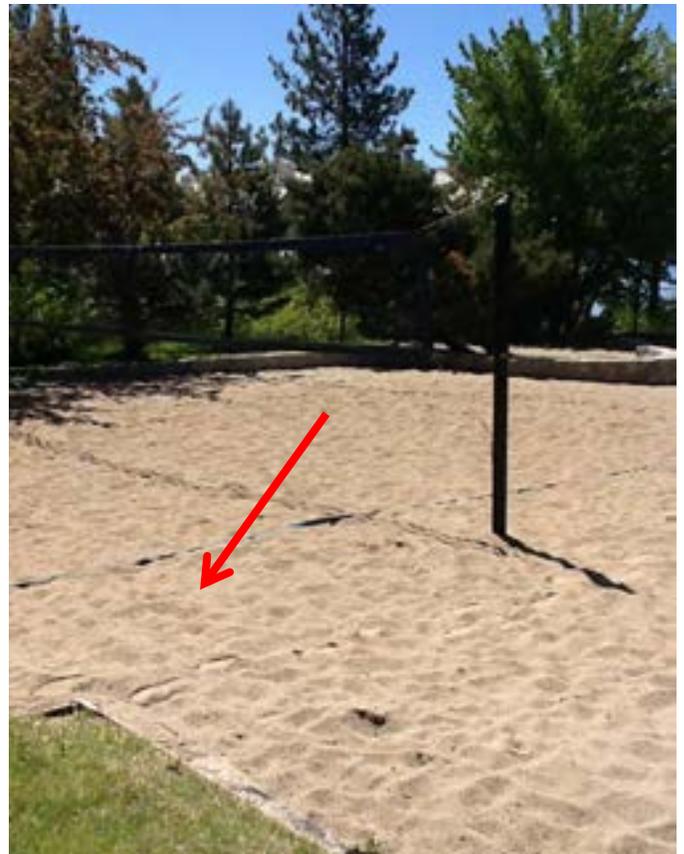
The path of travel that leads to the volleyball courts does not coincide with the path available to the general public.

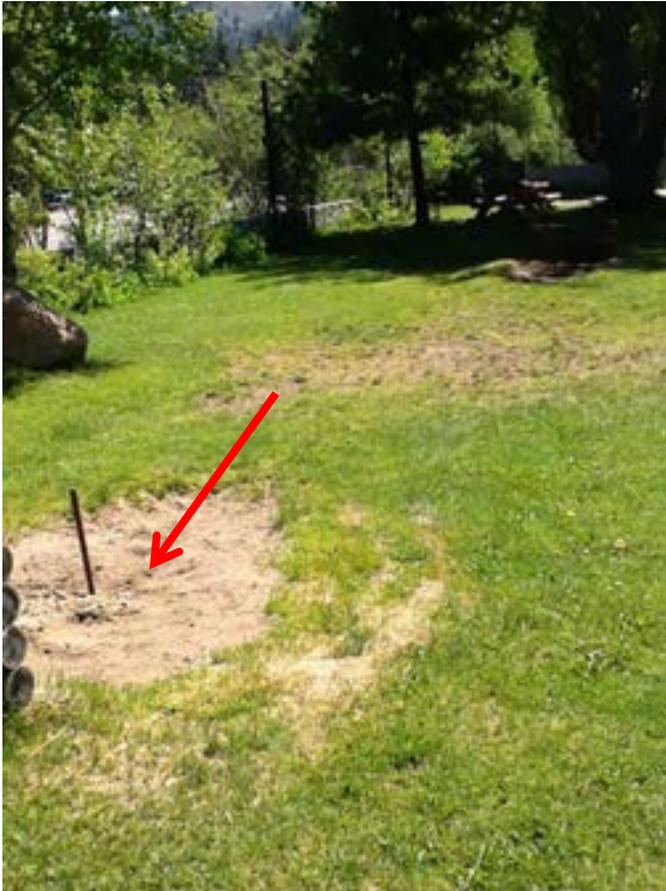
Horseshoe pits are not on an accessible route.

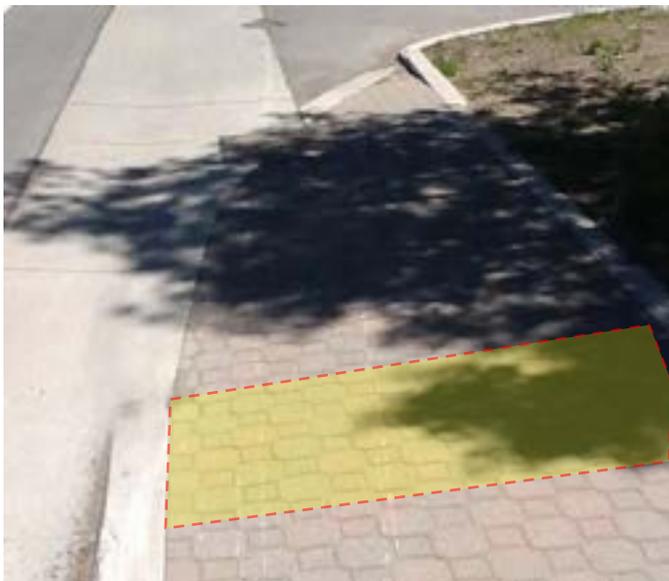
4.F: Cross Slope	The path of travel crossing the drive entrance includes a V-gutter. The cross slopes created by the V-gutter exceed 2%.	Regrade and replace v-gutter if possible to create a path of travel with a cross slope that does not exceed 2%. Coordination with Placer County public works may be required. Consider creating a new curb cut and pedestrian crossing that does not coincide with the v-gutter.	Mid-term

Ramp/flush transition lacks truncated domes. The V-gutter cross slope exceeds 2%.

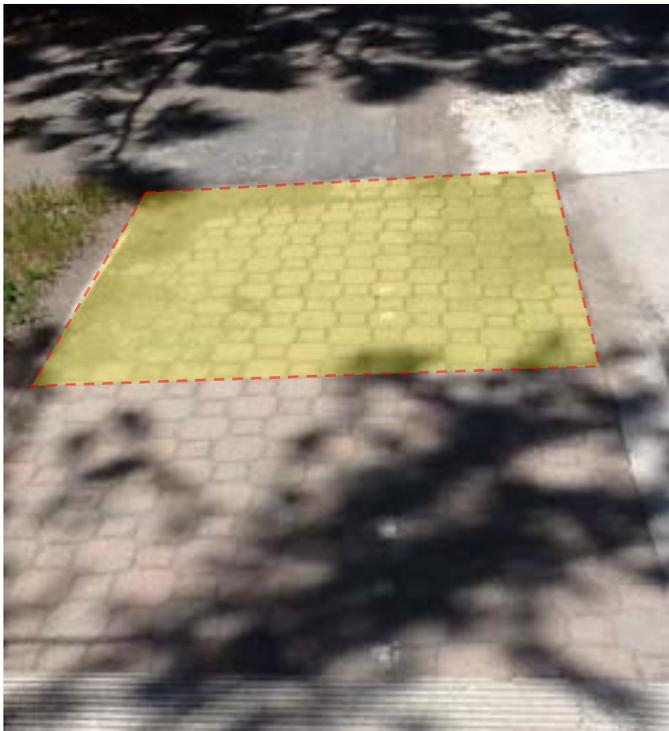
Ramp lacks truncated domes at flush transition to vehicular way. Slope of gutter exceeds 5%.

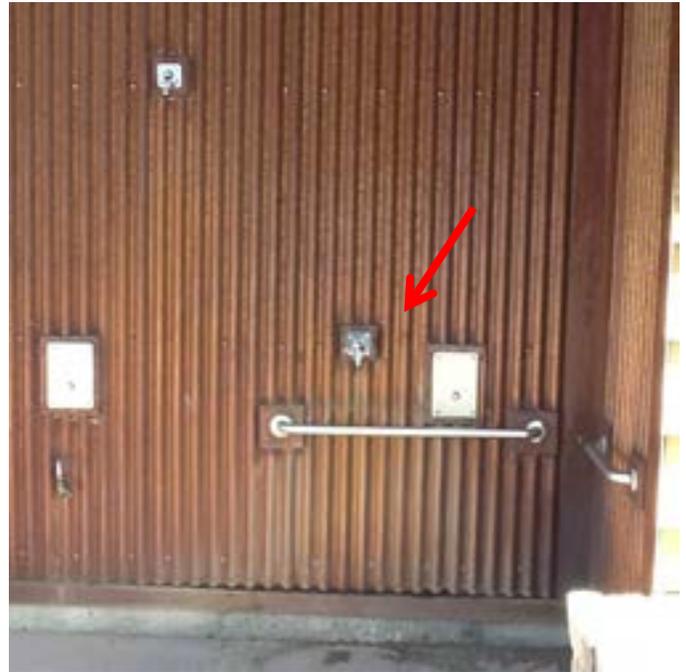
It appears that at the time of construction this low shower may have been intended for a wheelchair user but this does not comply with either the CBC or ADA.

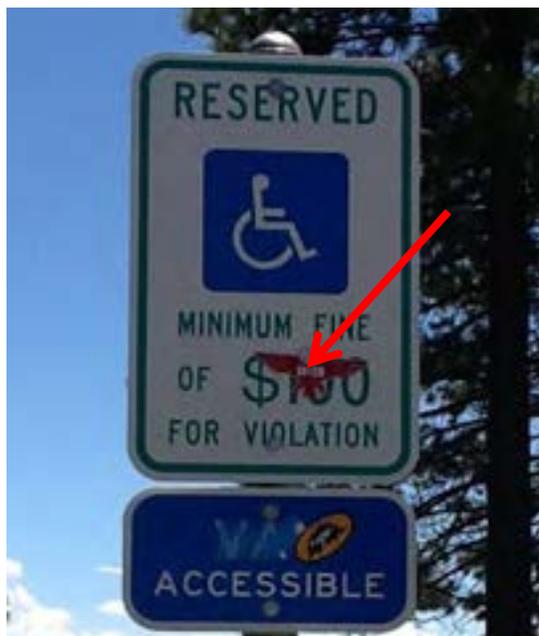
6.D: Accessible Parking Signage	The sign indicating the minimum fine is outdated and reads \$100 instead of \$250.	Replace with corrected fee amount.	Done

Fine should read \$250, not \$100. Vandalized sign is not legible.

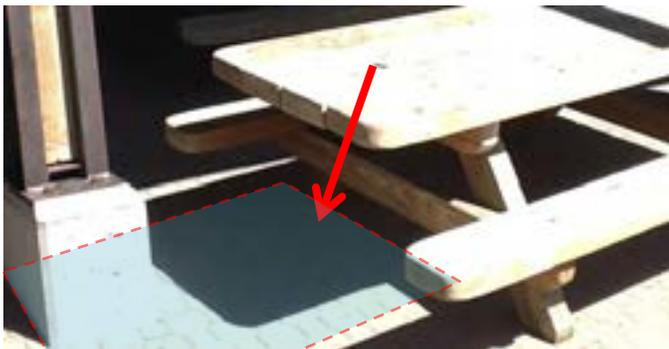
7.B: Picnic Tables	Accessible picnic table does not provide 30"x48" wheelchair space nor the allowed knee space within those limits.	Replace picnic table with a table that meets accessibility requirements.	Short-term

Inadequate clear space is provided on the approach to the accessible table. An accessible picnic table must provide a 30"x48" wheelchair space and provide for the allowed knee space within those limits.

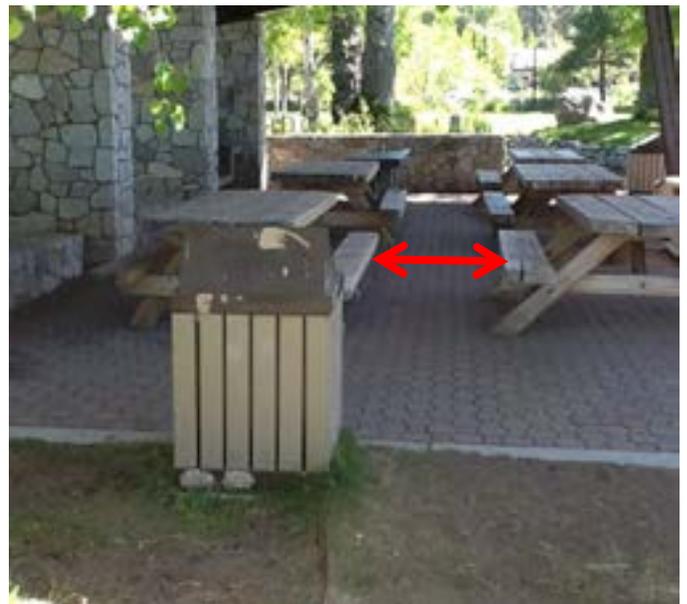
The current layout does not provide the required 36" clear space between and around the tables.

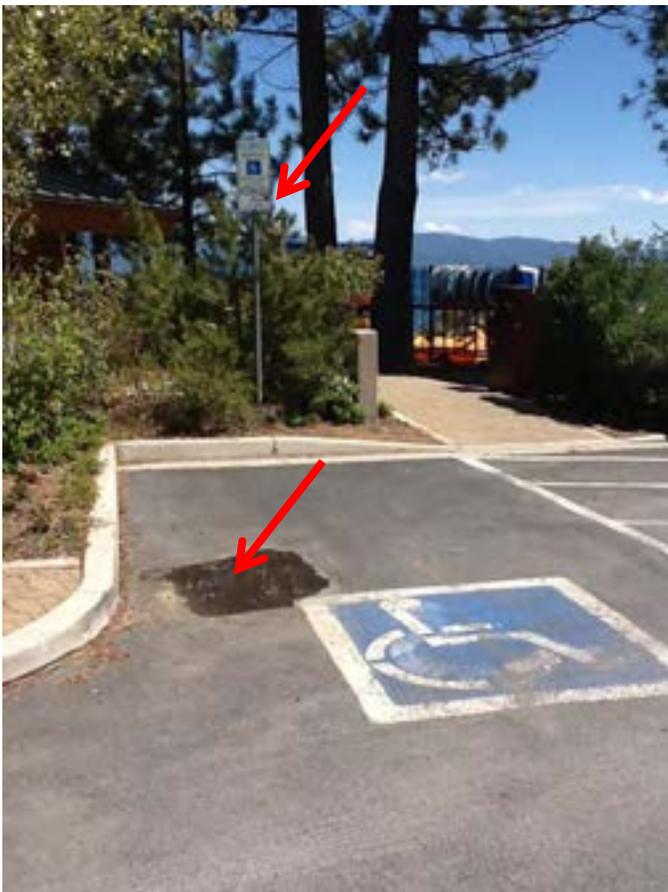
An excessive cross slope creates a bird bath area in the accessible parking space. The sign lacks the "Minimum Fine \$250" text.

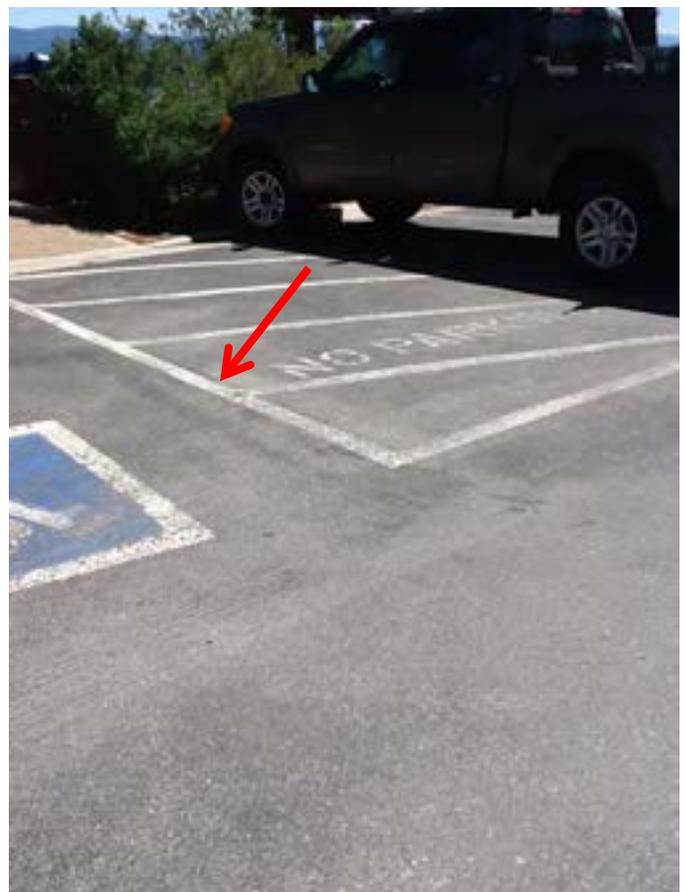
The border of the accessible aisle should be blue.

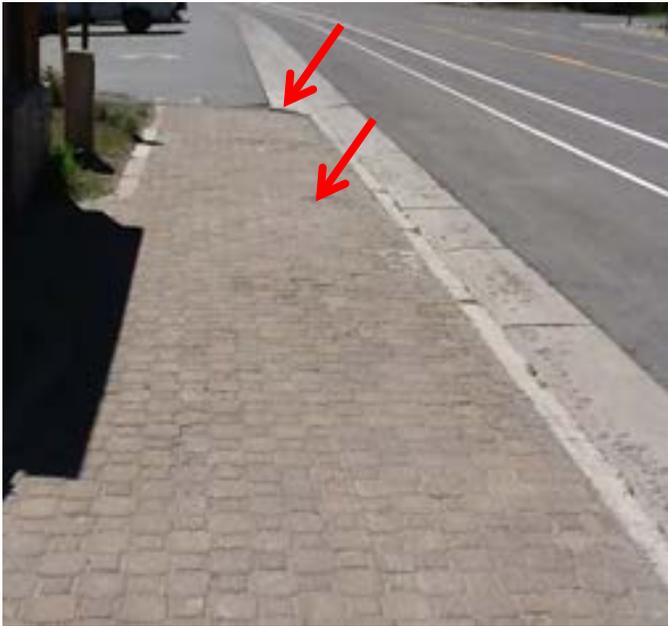
Excessive vertical change where pavers abut concrete curbs. Pavers are degraded in areas due to effects of snow and ice.

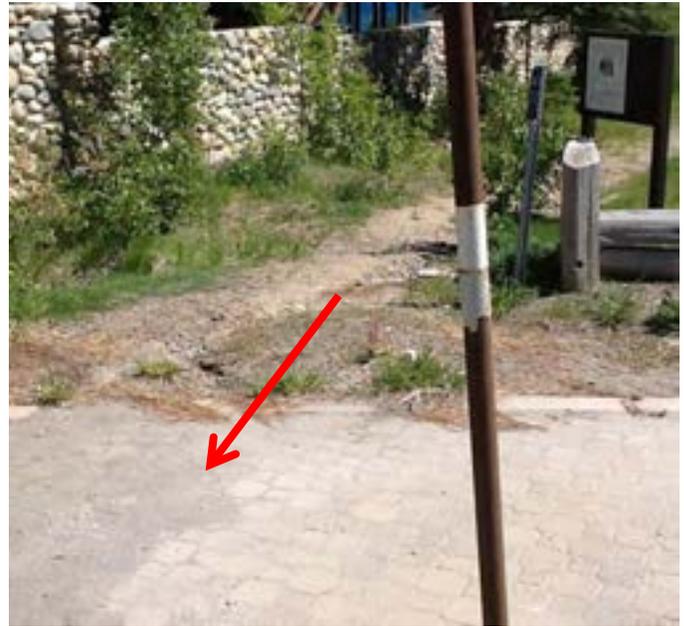
Walkway transitions to a dirt/decomposed granite material that is not stable or slip resistant.

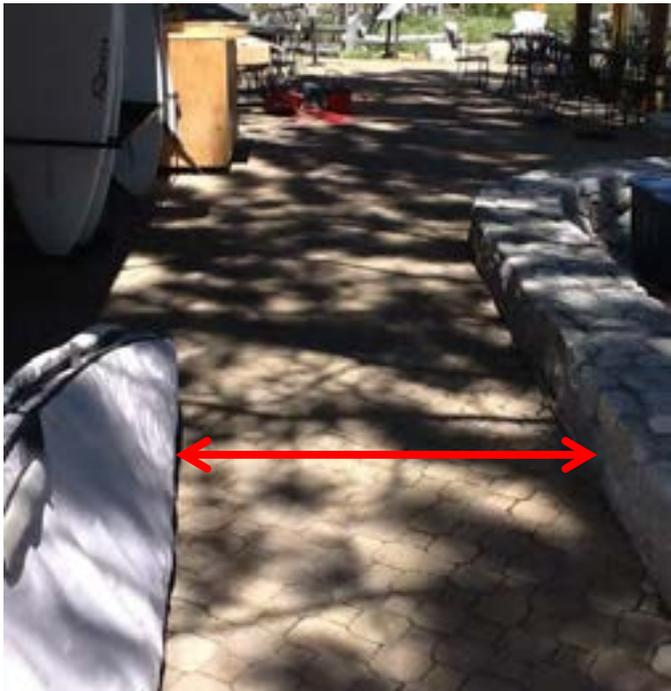
Storage reduces the path of travel to less than 48" minimum clear.

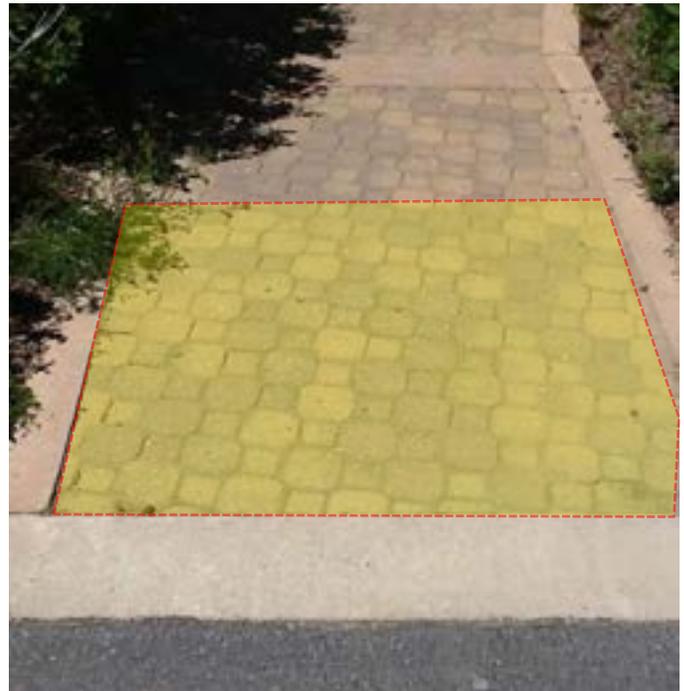
Flush transition to vehicular way lacks truncated domes.

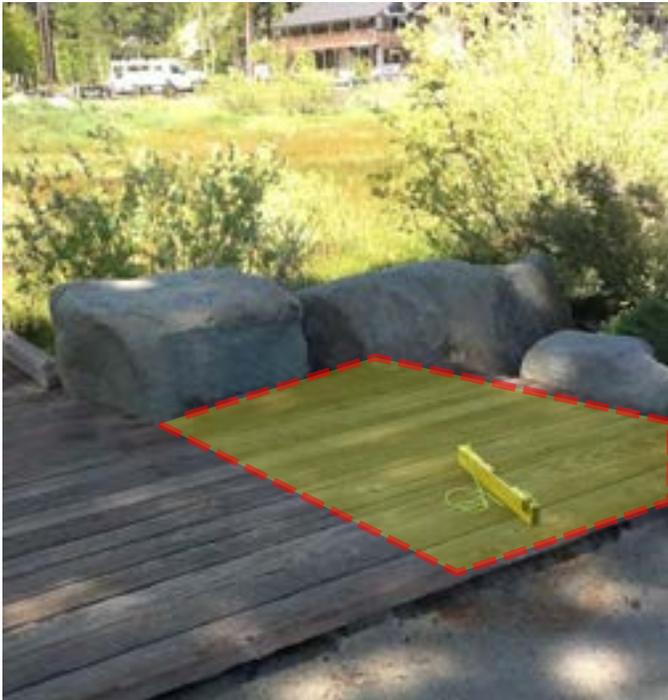
The wheelchair observation space is appropriately sized at 30"x48". However, this would not be considered an accessible beach entrance when judged against other standards since it lacks the appropriate transition from boardwalk to beach.

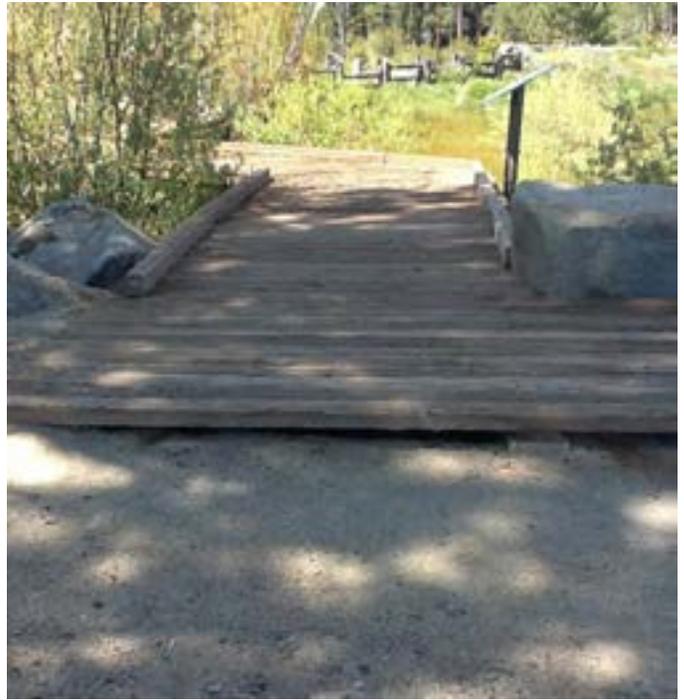
The terminus of the boardwalk and the accessible path to the beach is in excess of 1/2" vertical rise making the beach inaccessible.

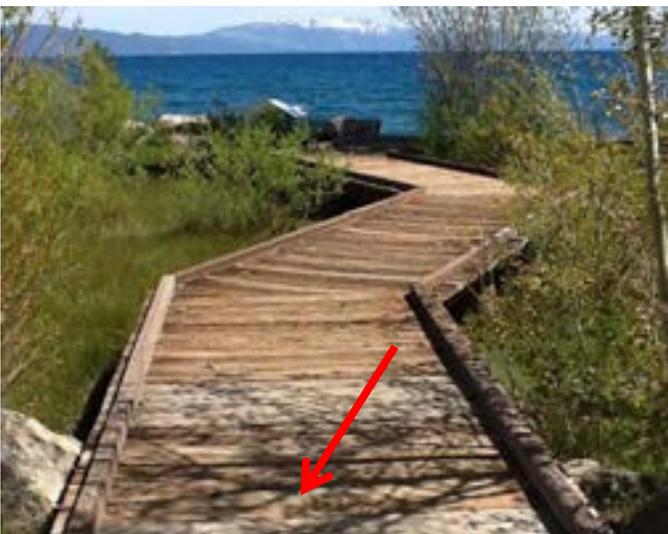
Boardwalk wood members have decayed creating excessive vertical change leading to the lake access.

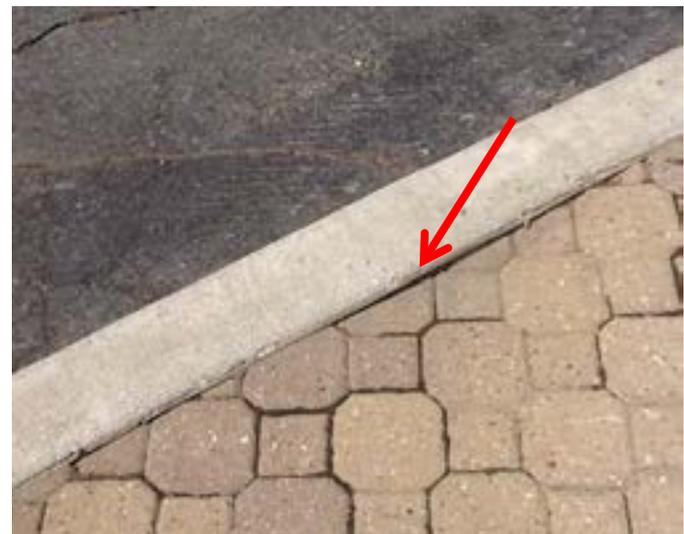
Excessive vertical change exists between the pavers and concrete curb.

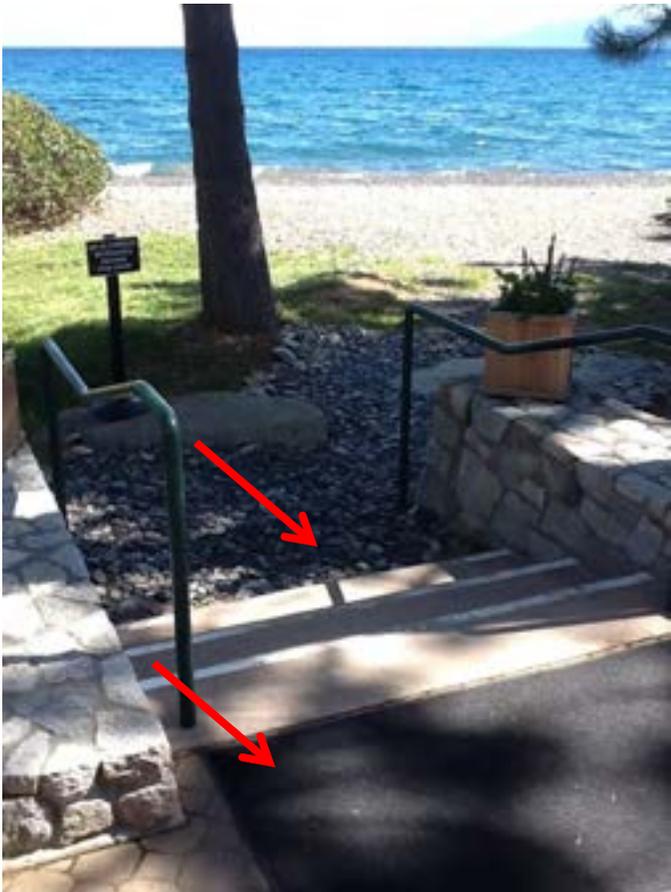
The stair's bottom landing is not level, firm or stable and the top landing is not level and the rug is not attached.

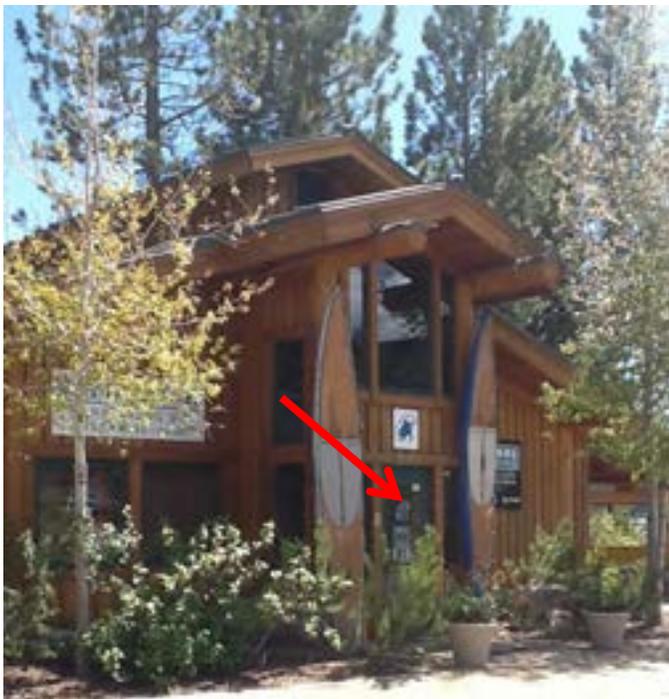
Primary entrance lacks the International Symbol of Accessibility (ISA) sign.

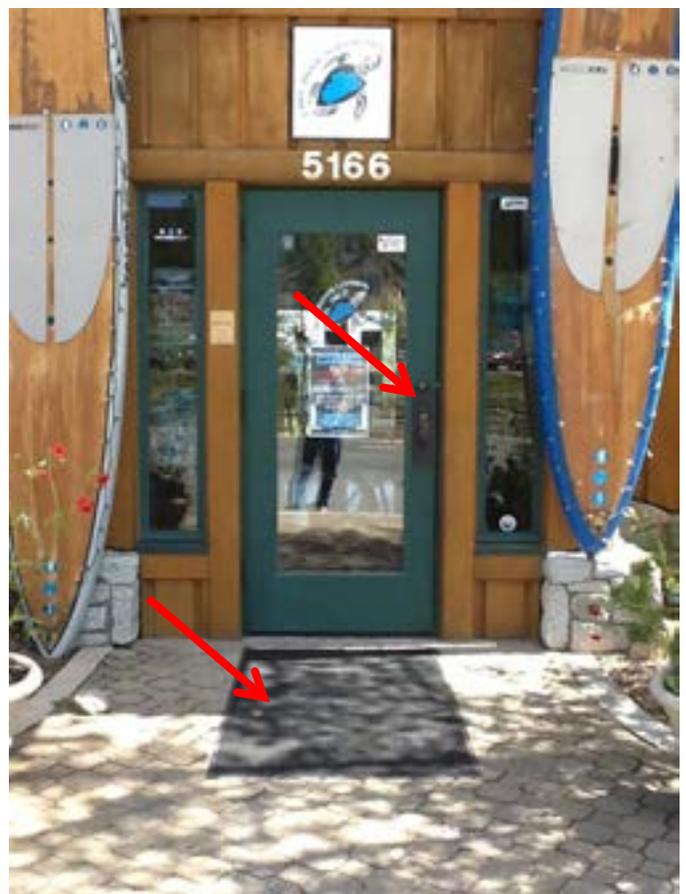
The rug is not firmly attached and the door operating effort requires more than 5 lbs of force.

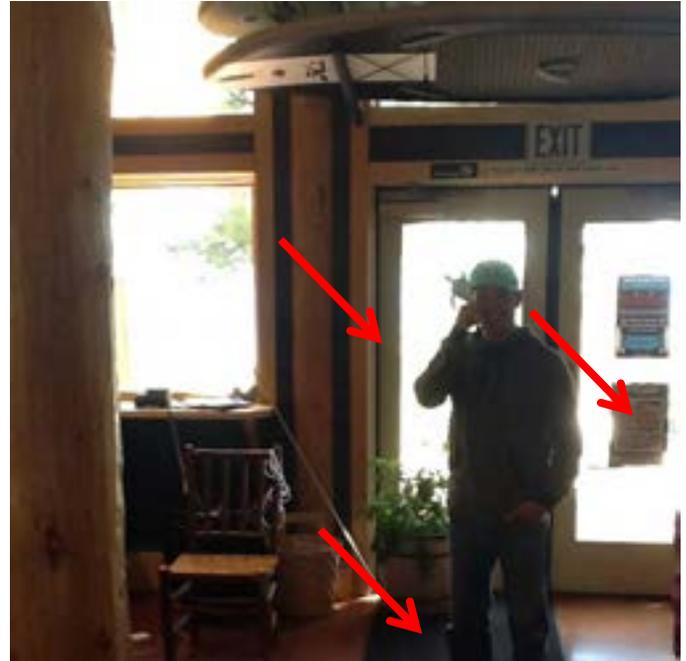
Rug is not firmly attached and no ISA is provided at the entry. A tactile and braille "EXIT" sign should be provided.

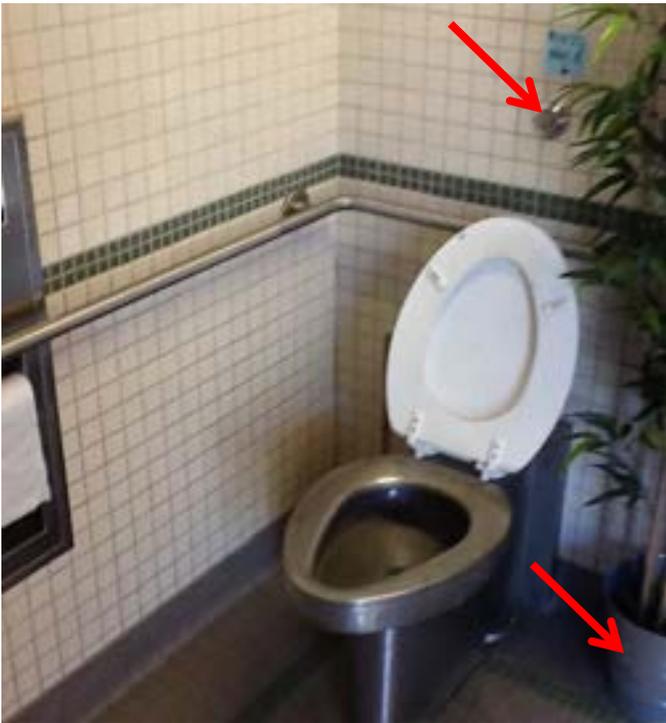
The flush controls are centered on the toilet instead of being located on the fixture's wide side. The potted plant should not be located in the fixture's clear space.

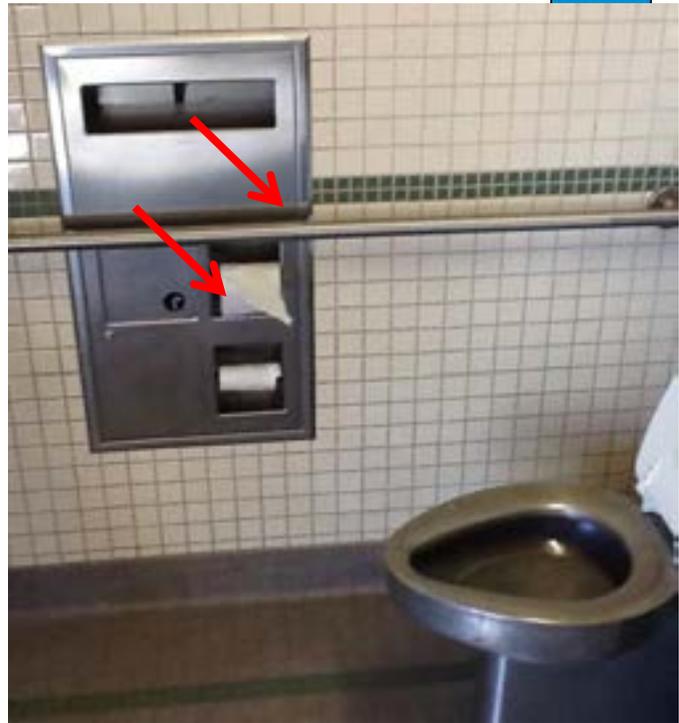
The toilet paper/seat cover dispenser reduces the clear space behind the grab bar to less than 1-1/2". The top roll of toilet paper is not compliant. Should the lower roll be empty, the upper roll would not comply.
