DRAFT ADA SELF-EVALUATION AND TRANSITION PLAN

CALIFORNIA TAHOE CONSERVANCY

DECEMBER 2018

*Accessibility Compliance Evaluation completed by:
California Department of General Services
Real Estate Services Division
Professional Services Branch, Arch Unit B
Eric Driever, Senior Architect, CASp*

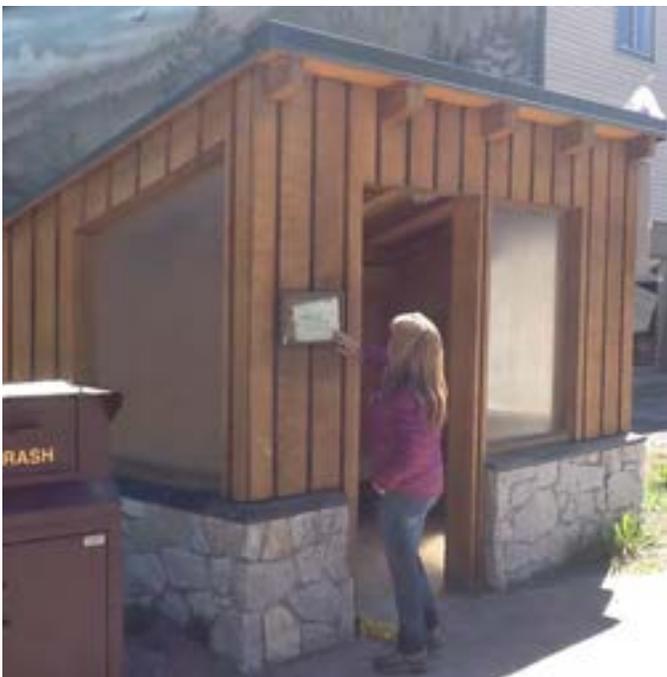
The bus shelter's bench reduces the turning area inside the shelter to less than 60" and does not have an accessible space to the side.

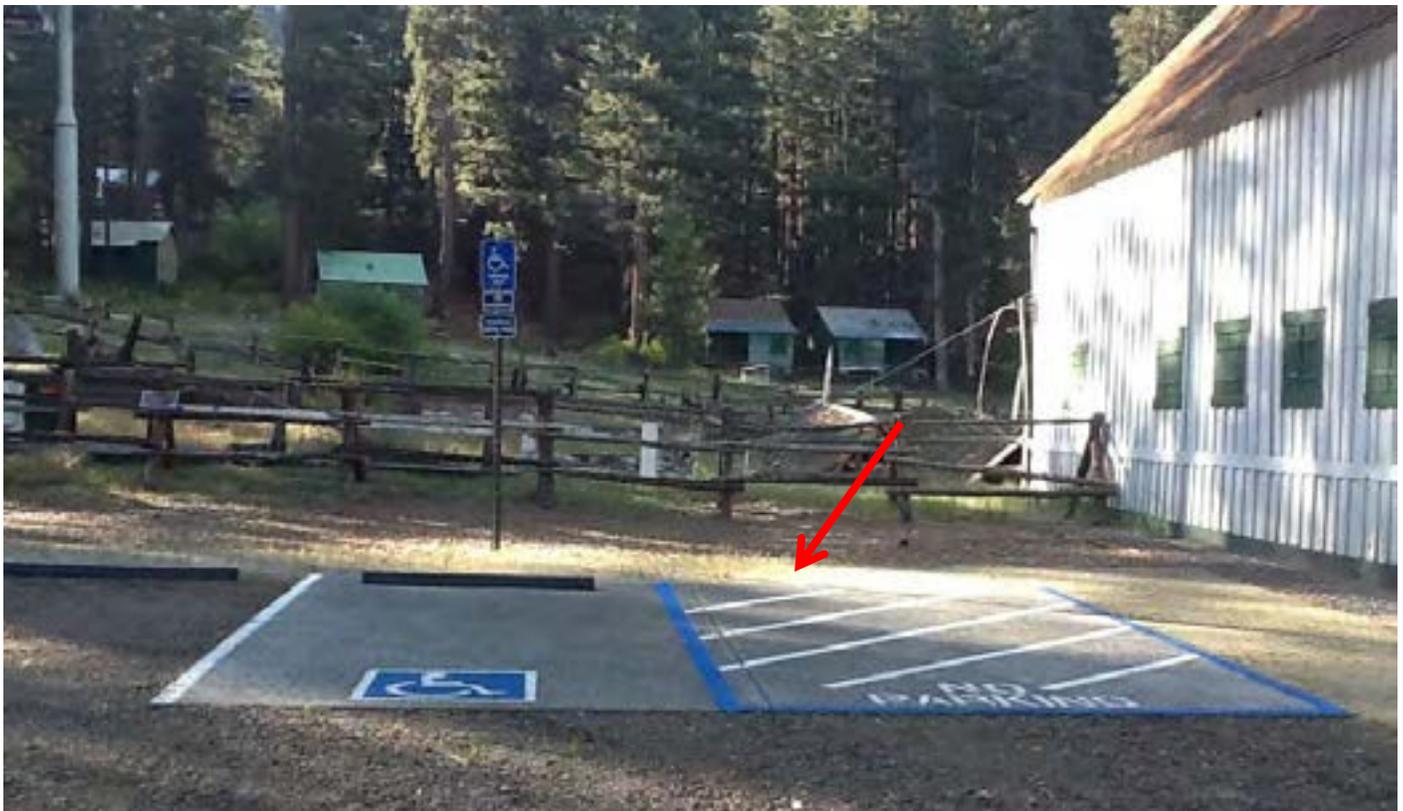
Access path from parking is decomposed granite which has no overall standards to confirm its ability to be firm and slip resistant.

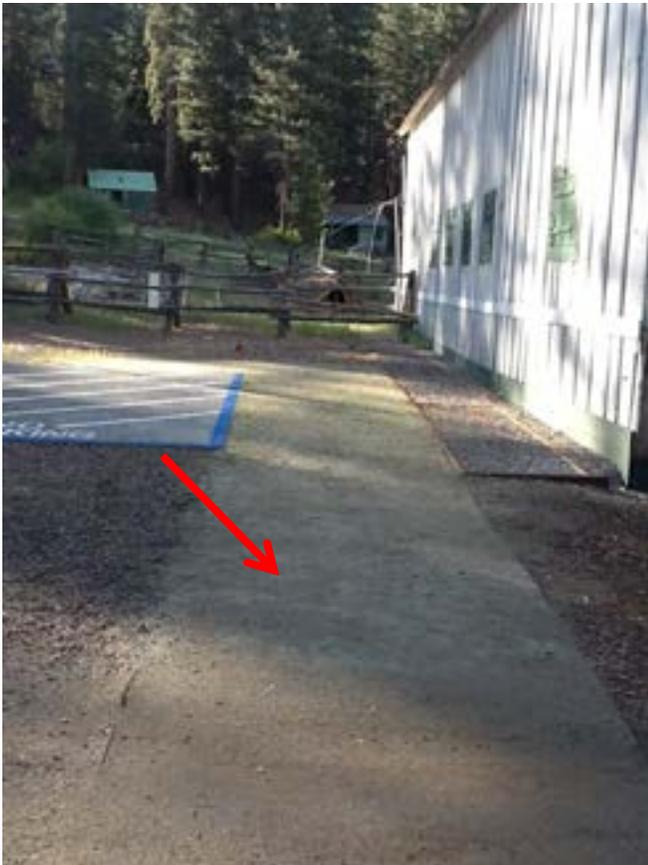
No overall standards exist for decomposed granite to confirm its ability to be firm and slip resistant.

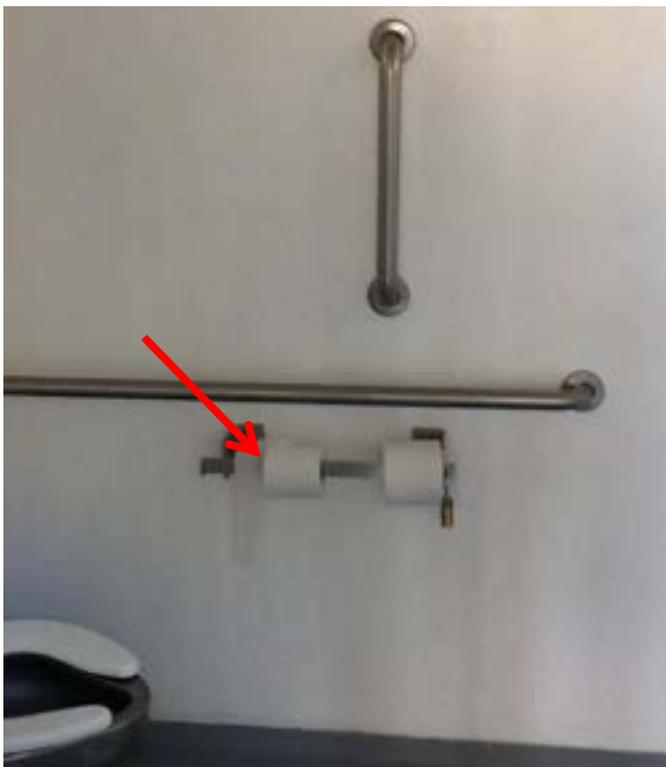
The dispenser allows for multiple rolls and is mounted at 27 1/2" above finish floor. The end of the roll is beyond the allowable horizontal reach for a toilet paper dispenser.

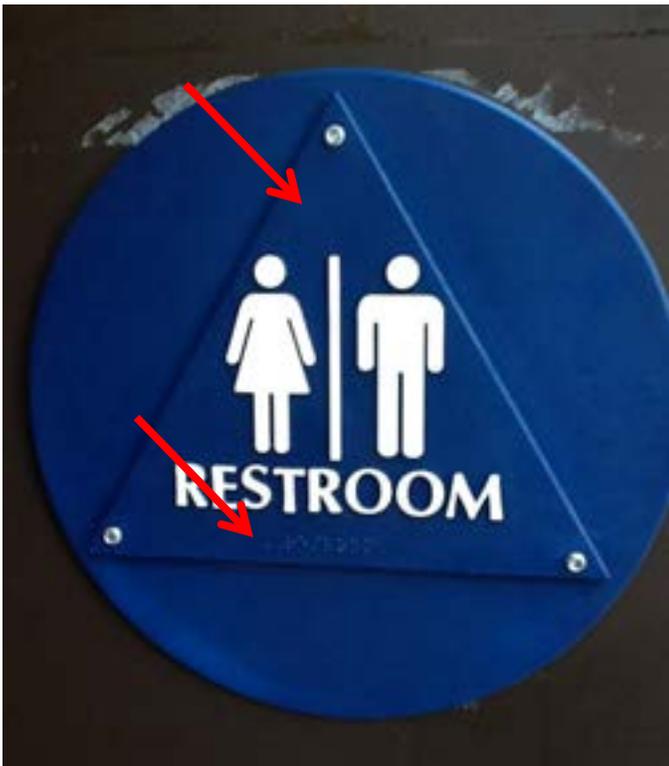
Braille should not be included on door sign and the triangle does not contrast with the circle.

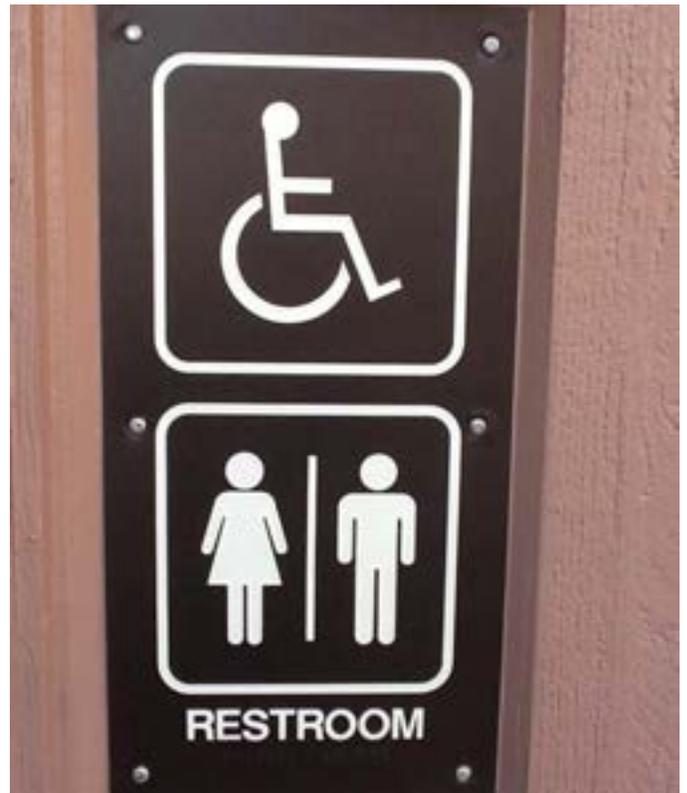
Raised characters must match the pictogram (e.g. "MEN'S OR WOMEN'S" or "UNISEX" and the braille must match the raised characters.

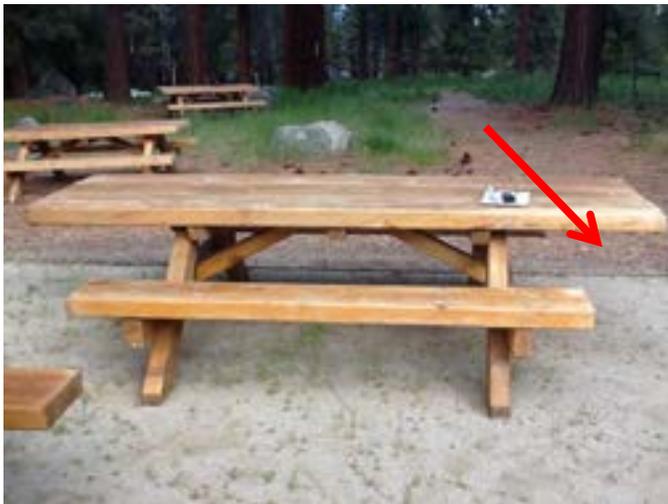
An accessible picnic table must provide a 30"x48" wheelchair space, provide for the allowed knee space within those limits and be located on an accessible route.
