NORTH TAHOE BEACH

CALIFORNIA TAHOE CONSERVANCY

ADA SELF-EVALUATION AND TRANSITION PLAN

PATTON LANDING

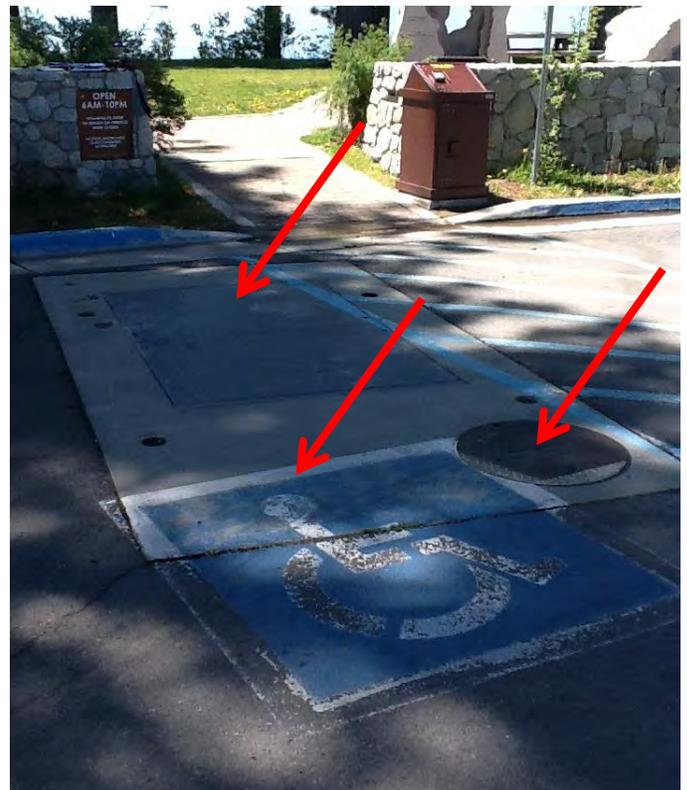
1.B: Cross Slope and Surface	Cross slope in accessible aisle is greater than 2% (2.2%). Uneven surface and inconsistent striping of accessible spaces due, respectively, to parking space location over concrete storm filter vault and the inconsistent replacement of the manhole cover.	With the relocation of parking spaces to the restroom area, re-grade parking area if needed so that cross slope does not exceed 2% and provide appropriate striping.	Long-term

Cross slopes exceed 2%. Surface paint is difficult to maintain over storm drain facilities

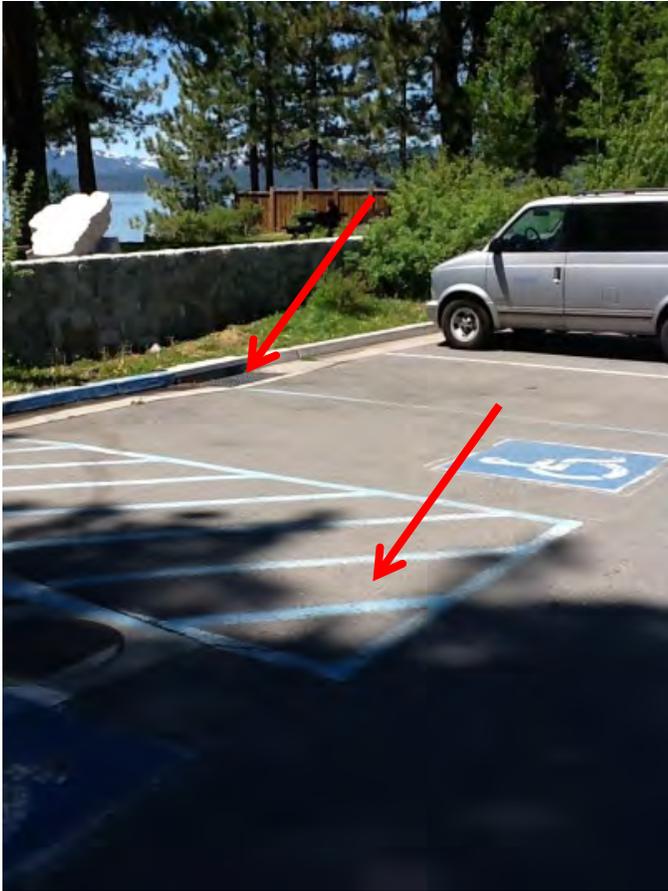
1.C: Lettering	The words "NO PARKING" are not provided in the access aisle.	Revise access aisle striping to include required lettering at appropriate dimensions.	Done

*Excessive cross slopes in parking area due to drain.
Striped area lacks the words "NO PARKING".*

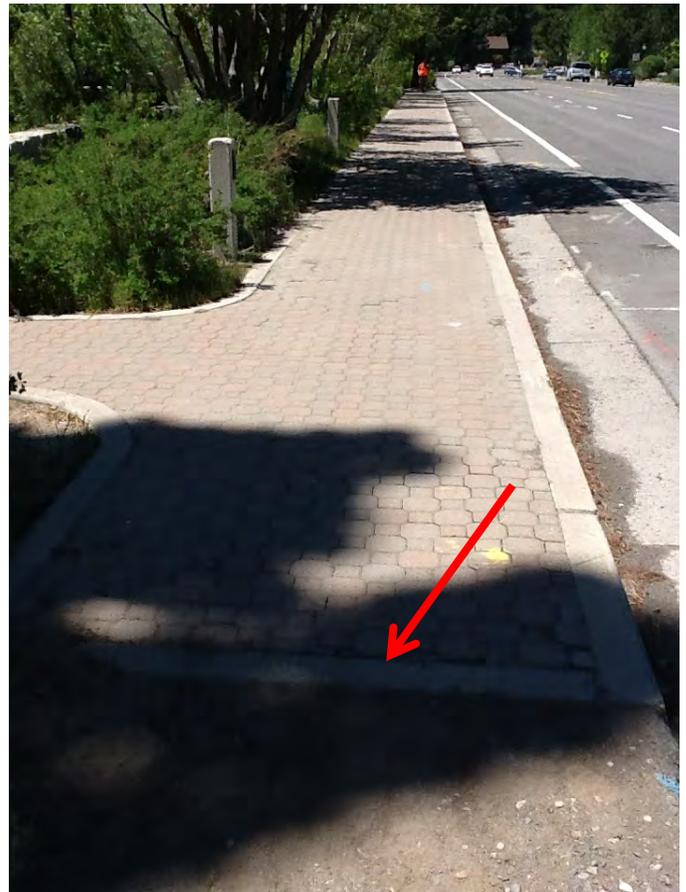
Excessive vertical change exists at the walk's terminus.

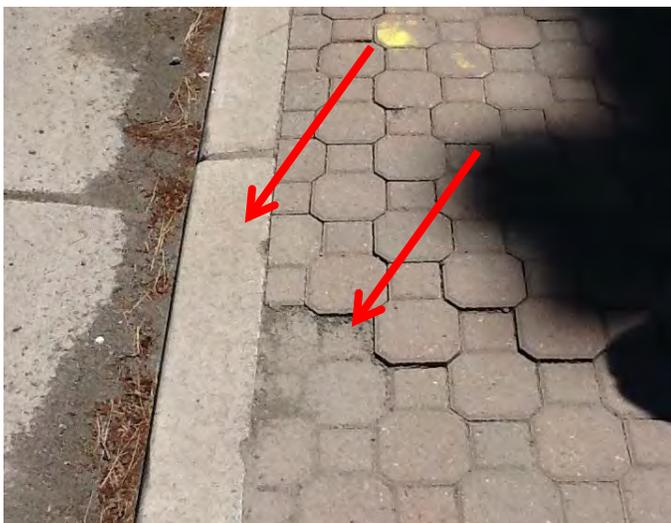
Differential settling causes both non-conforming cross slopes as well as excessive vertical change.

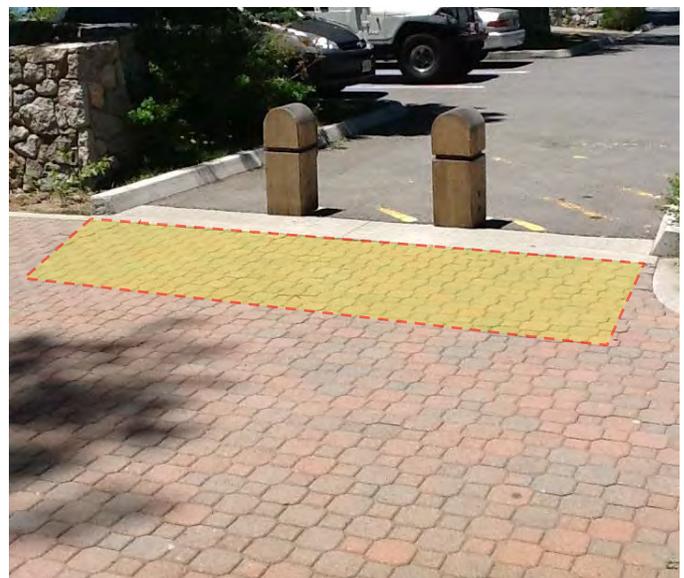
3.H: Hazardous Vehicular Areas – Detectable Warnings	The curb ramp servicing the accessible parking, the turn-around space adjacent to the restroom facility and the walkway connection to the drive aisle at the terminus of the drive aisle/entry do not have adequate separation or detectable warnings.	Where pedestrian areas cross or adjoin a vehicular way, either separate the walkway from the vehicular way with a curb, a railing or other element or provide a continuous detectable warning at least 36" wide.	Long-term

Walkway lacks truncated domes at flush transition to vehicular way.

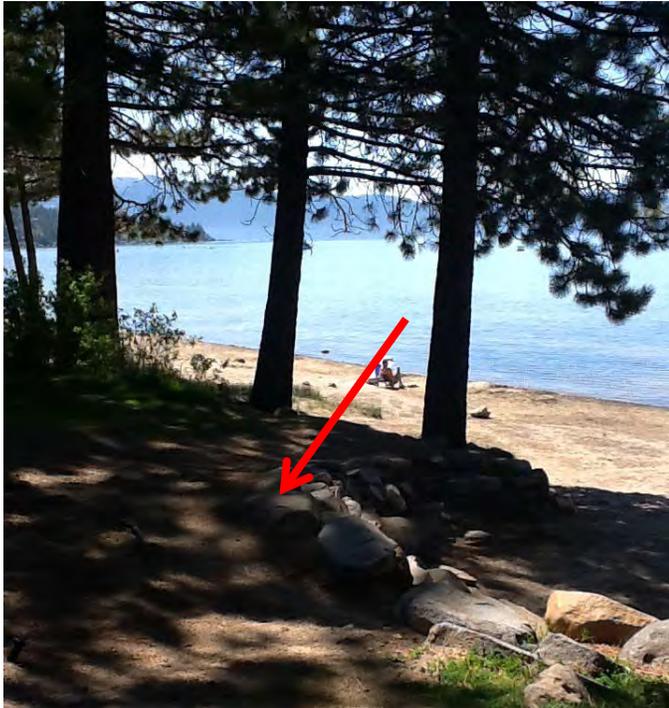
3.B: Connection of Facilities	No accessible route connects a user to the beach, to the sand volleyball courts, or to the horseshoe pits.	Provide an accessible route that connects all accessible facilities on the site to one another and to site amenities such as waste receptacles, picnic tables and barbecues.	Long-term

An accessible path is not provided to the beach.

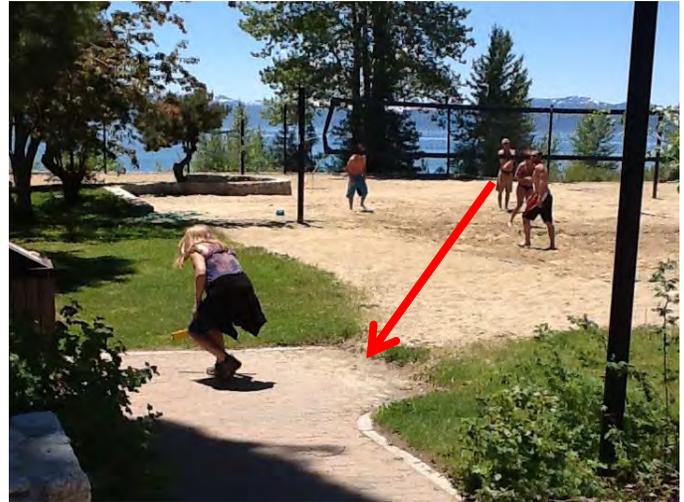
Path terminus has excessive slopes and vertical transition.

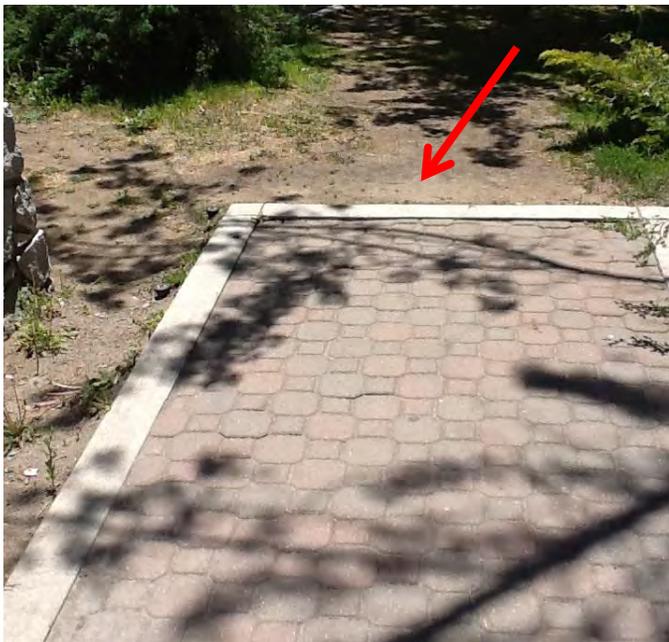
Terminus of improve path of travel has excessive vertical drop. If not considered part of the accessible route, a sign with the ISA symbol is required to direct individuals to an accessible route.

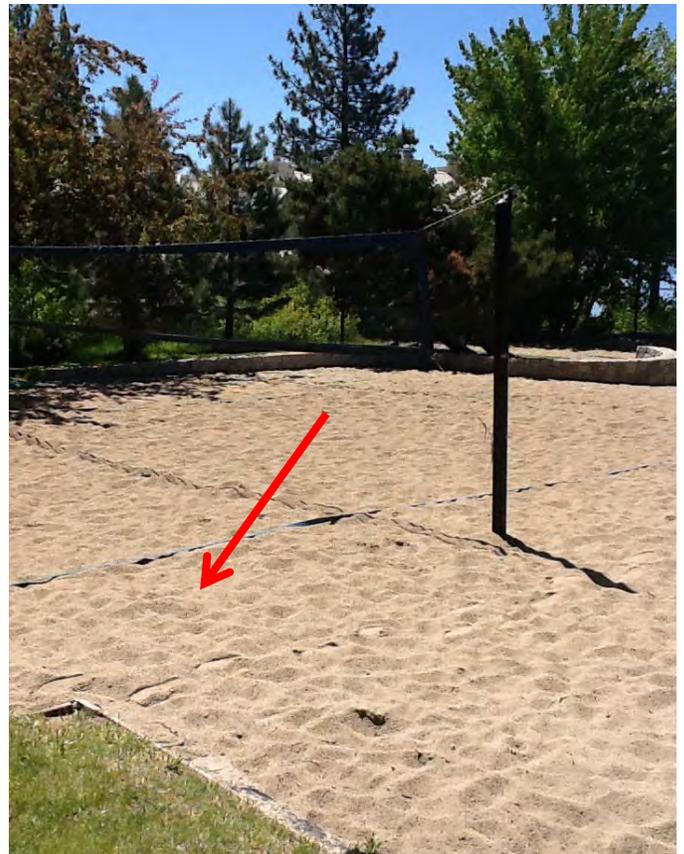
The path of travel that leads to the volleyball courts does not coincide with the path available to the general public.

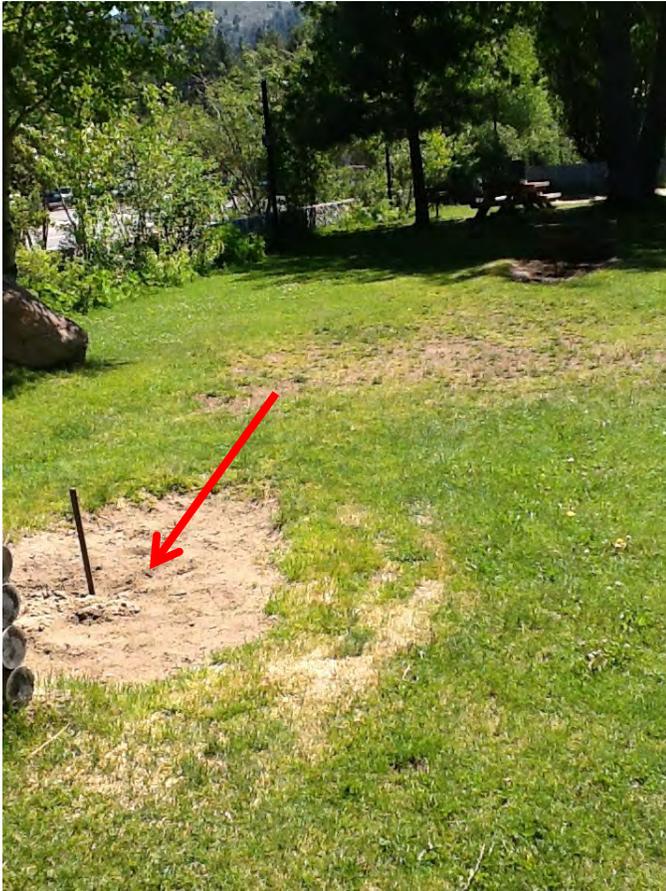
Horseshoe pits are not on an accessible route.

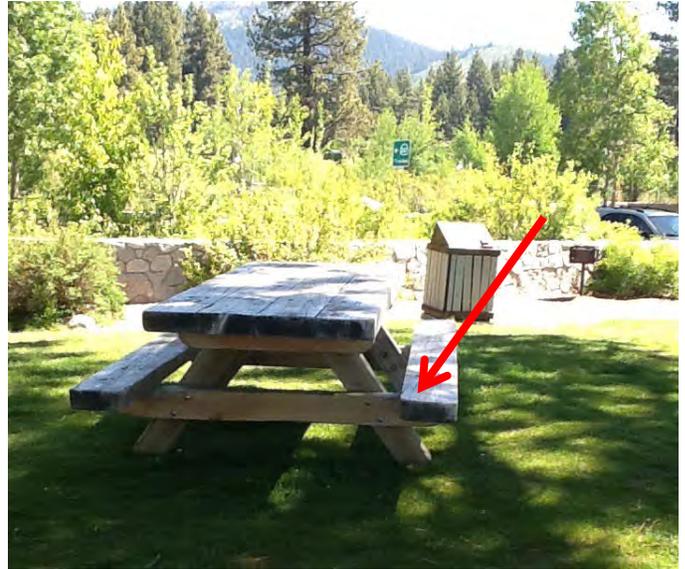
Picnic tables in the lawn area are not on an accessible route or an accessible surface.

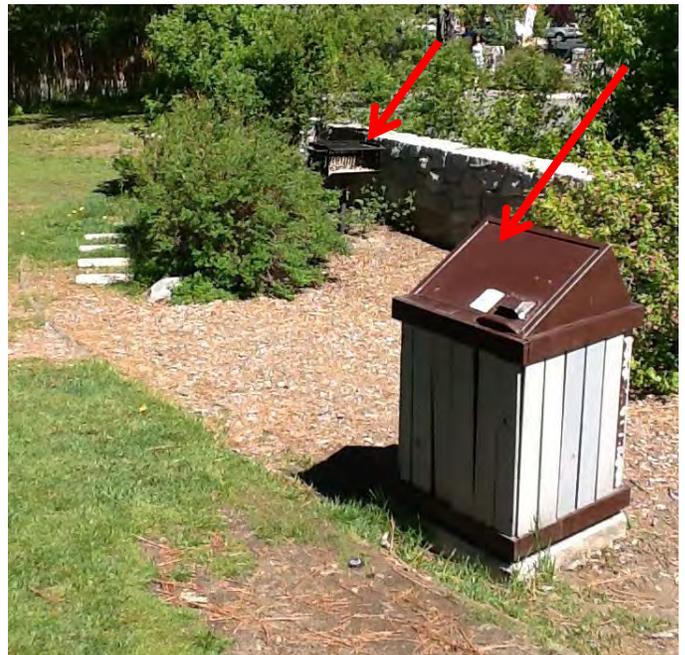
Barbecue and trash receptacle are not on an accessible path.

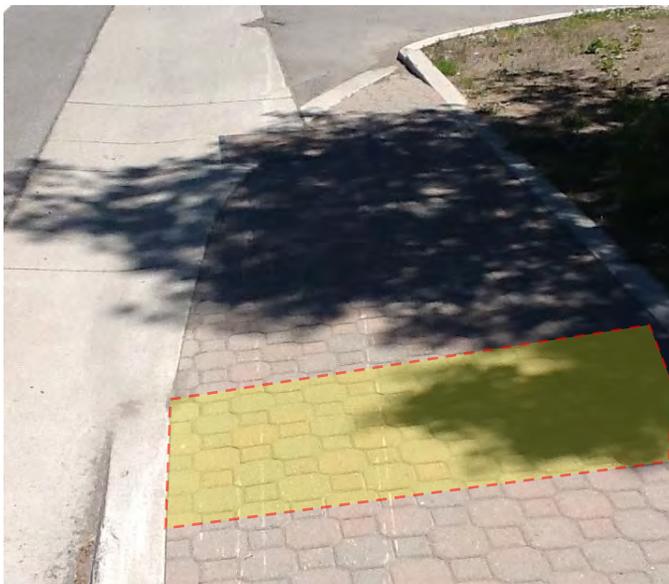
4.F: Cross Slope	The path of travel crossing the drive entrance includes a V-gutter. The cross slopes created by the V-gutter exceed 2%.	Regrade and replace v-gutter if possible to create a path of travel with a cross slope that does not exceed 2%. Coordination with Placer County public works may be required. Consider creating a new curb cut and pedestrian crossing that does not coincide with the v-gutter.	Mid-term

Ramp/flush transition lacks truncated domes. The V-gutter cross slope exceeds 2%.

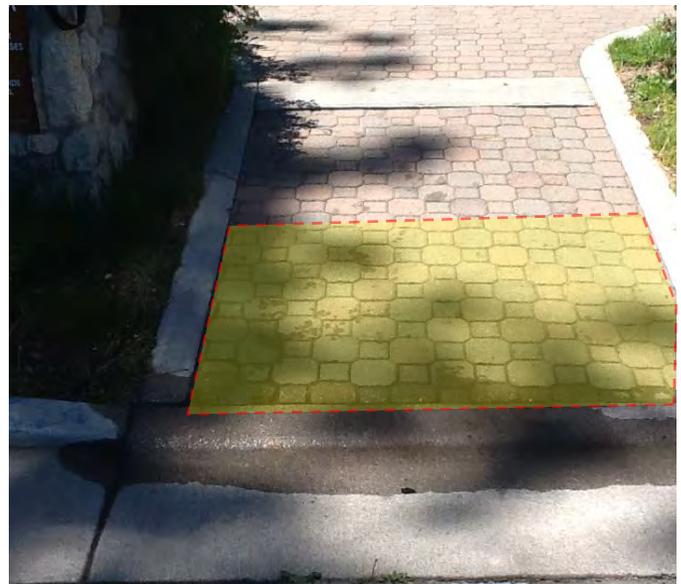
Walkway lacks truncated domes at flush transition to vehicular way. Excessive slopes exist at rolled portion of curb.

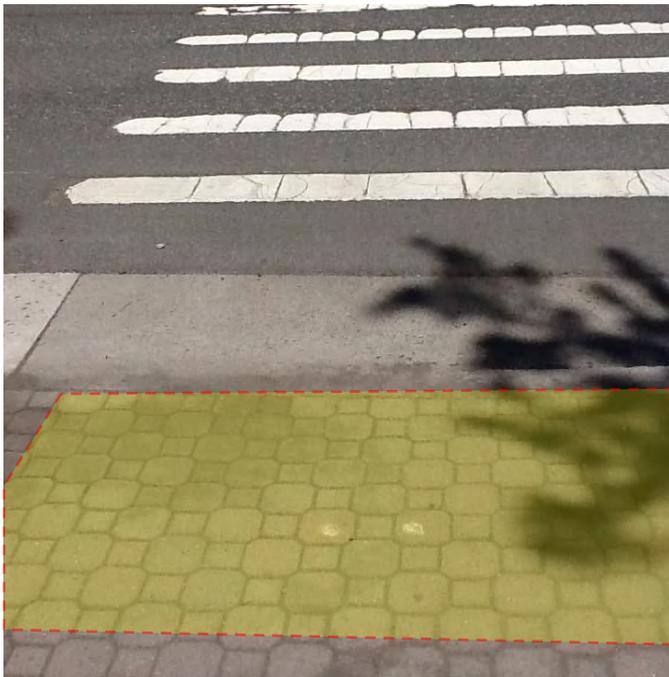
Walkway lacks truncated domes at flush transition to vehicular way.

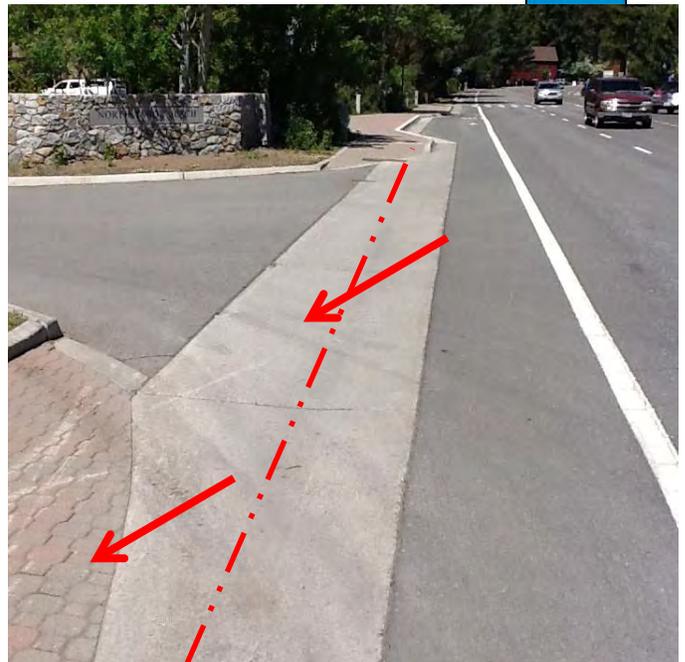
V-gutter cross slopes exceed 2%. Curb ramp lacks truncated domes on both sides of the vehicular way. The property line appears to be at the back of the curb placing the walkway on Conservancy property.

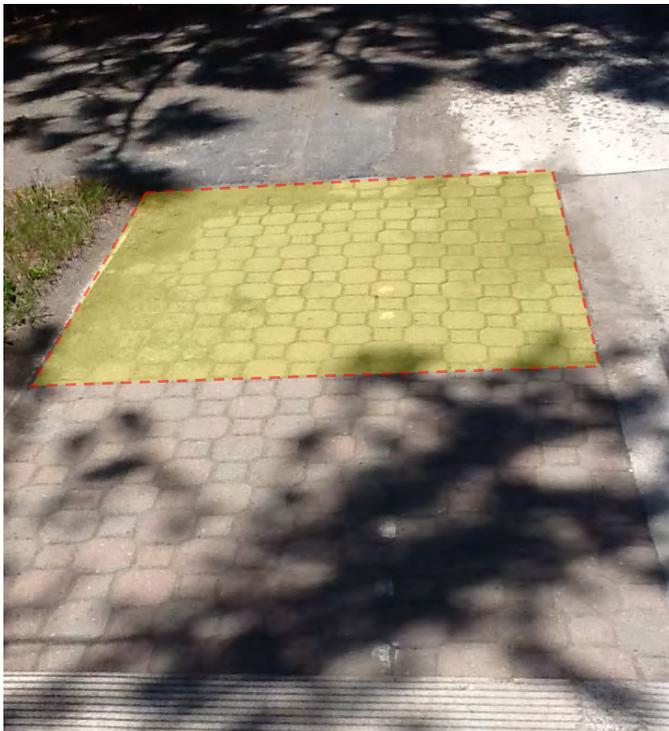
Ramp lacks truncated domes at flush transition to vehicular way. Slope of gutter exceeds 5%.

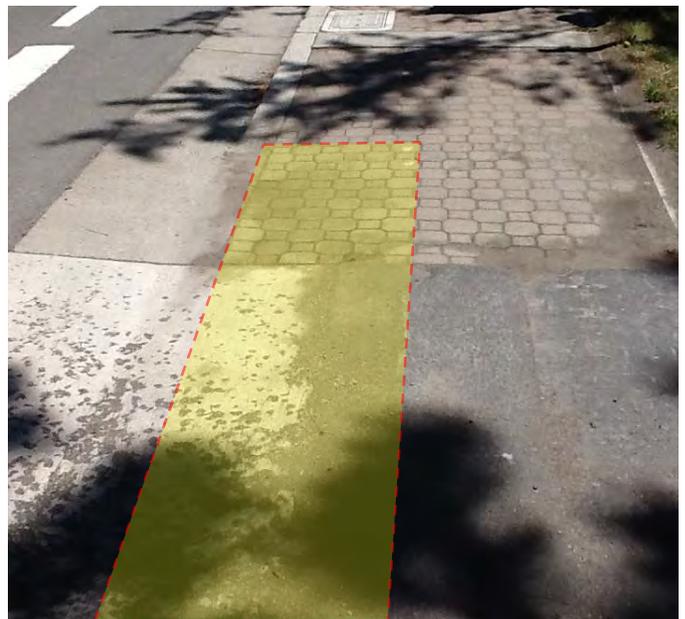
Cross slope exceeds 2% at flared edges. Walkway lacks truncated domes at flush transition to vehicular way. The property line appears to be at the back of curb placing the walkway on Conservancy property.

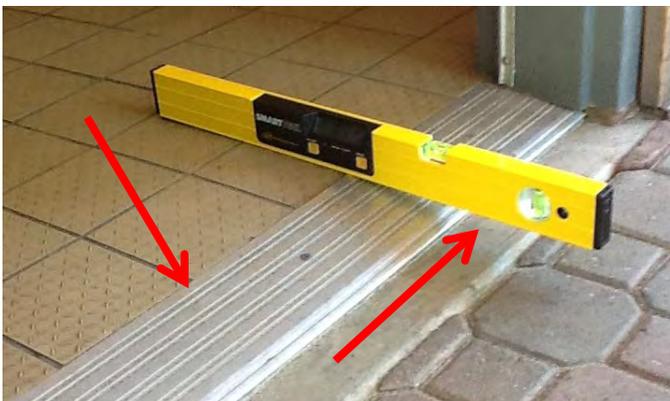
5.G: Door Threshold	The threshold of the accessible restroom exceeds the ½" maximum requirement.	Adjust the finish grade of the surrounding surfaces to provide a threshold that does not exceed ½" vertical rise. Potential solutions include: <ul style="list-style-type: none"> • Raise the entire landing at the exterior walk to include the 48" approach side plus the 12" strike side landing, or • Lower the level of the interior floor surface by removing the tile and lowering the associated drain as well as all fixtures and accessories adversely affected. 	Short-term

Threshold vertical rise exceeds 1/2" overall maximum. An extended sloped transition is not possible as landings at doors must be a maximum of 2%. Potential solutions include raising the entire landing at the exterior walk or lowering the level of the interior floor as well as the associated fixtures and accessories adversely affected.

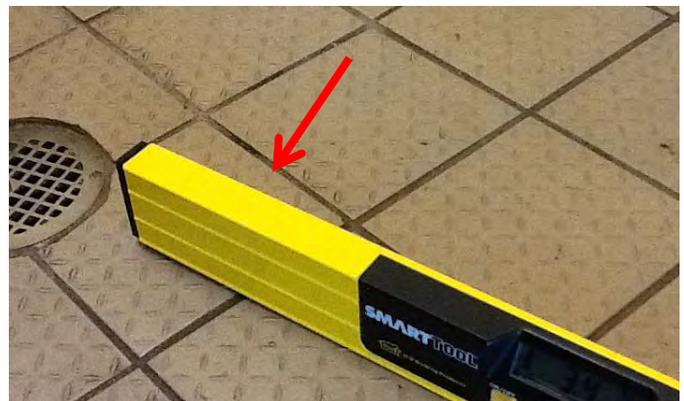
5.H: Slope	The slope of the floor in the accessible restroom exceeds 2% as it slopes to the drain.	Remove the tile and adjust slope of floor to the drain so that it does not exceed 2%. Check all fixtures and accessories to ensure they are not adversely affected by the modification or adjust accordingly.	Long-term

Slope at drain exceeds slope requirements.

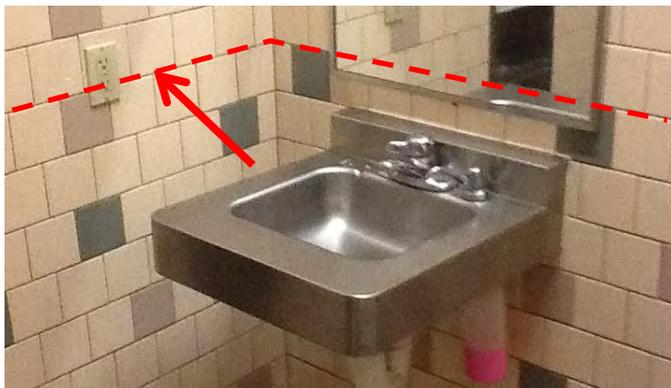
5.F: Dispensers Operating Height	The electrical outlet adjacent to the lavatory is 41 ½" to the center. The highest operable part should be at 40".	Lower the electrical outlet to be no higher than 40" above finish floor.	Mid-term

Electrical outlet exceeds maximum height above finish floor (41 1/2" instead of 40" allowable maximum).

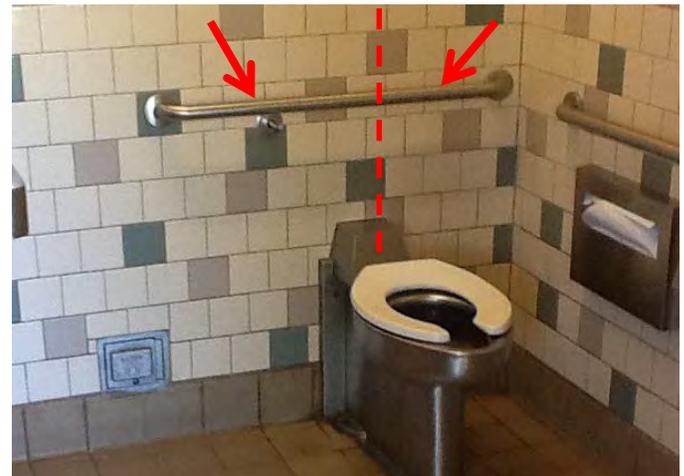
5.C: Water Closet Seat	There is 19 ½" between the top of the water closet seat and the finish floor.	Replace water closet seat or water closet so that the distance between the top of the water closet seat and the finish floor is between 17" and 19".	Mid-term

5.D: Rear Grab Bar	The rear grab bar only extends 21" on one of the sides. (It extends 15" on the other side.)	Adjust grab bar location so that it extends from the centerline of the water closet a minimum of 12" on one side and a minimum of 24" on the other side.	Short-term

Grab bar is incorrectly offset. A 12" and 24" offset is required. The toilet seat exceeds maximum height above finish floor (19 1/2" instead of 19" maximum).

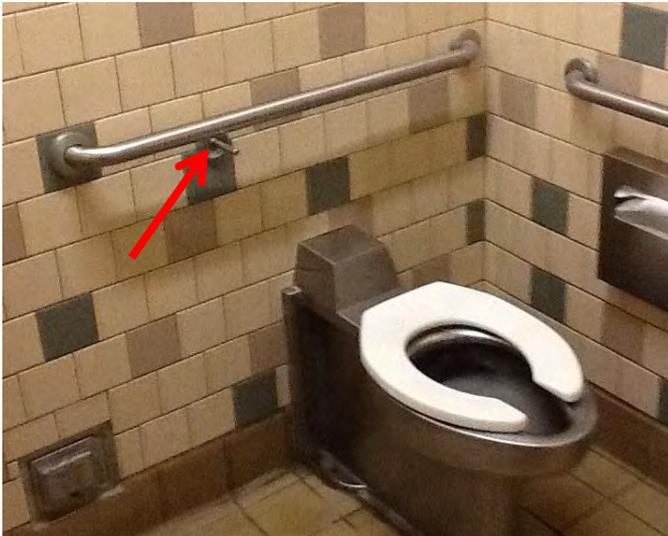
Control is set approximately 1 ½" below the grab bar as required, but it may be difficult to operate.

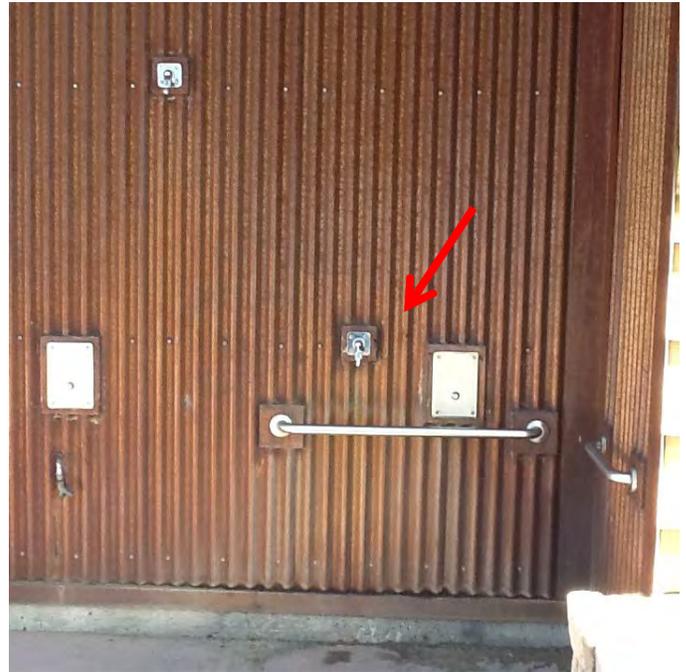
It appears that at the time of construction this low shower may have been intended for a wheelchair user but this does not comply with either the CBC or ADA.

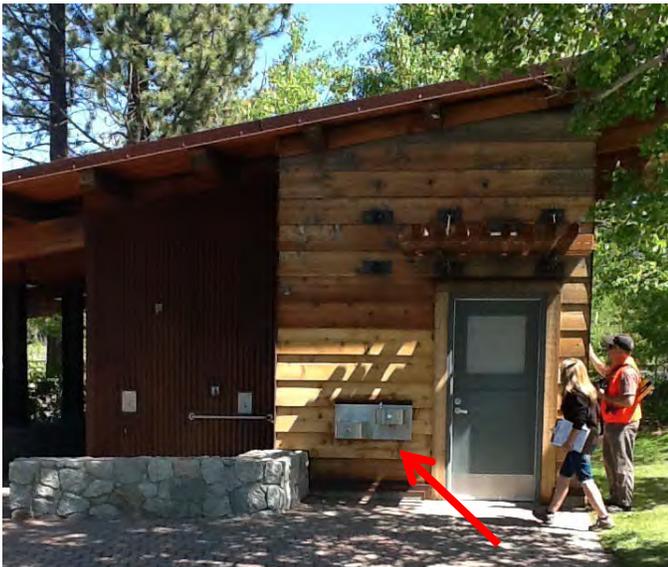
ITEM	EXISTING BARRIER	BARRIER REMOVAL METHOD	CORRECTIVE TIMELINE
NORTH TAHOE BEACH			
5: Restrooms			
5.J: Exterior Rinse Shower	Exterior shower does not have folding seats, appropriate grab bar configurations or a flexible 59" long shower spray unit that can be used in a fixed position and as a hand-held unit.	Identify the intended purpose of the lower shower head. If this is a foot rinse shower, CTC should adopt standards for such elements in its program and ensure the standards comply with the related similar elements in the CBC and/or ADA.	Long-term

Outdoor showers have a number of non-conforming items, including slope, lack of folding benches and lack of a shower spray unit that can be used either fixed or hand-held. The hi-low drinking fountain is not in an alcove nor does it have rails for cane detection on either side. Should rails be installed, ensure the rails do not encroach into door clearance.

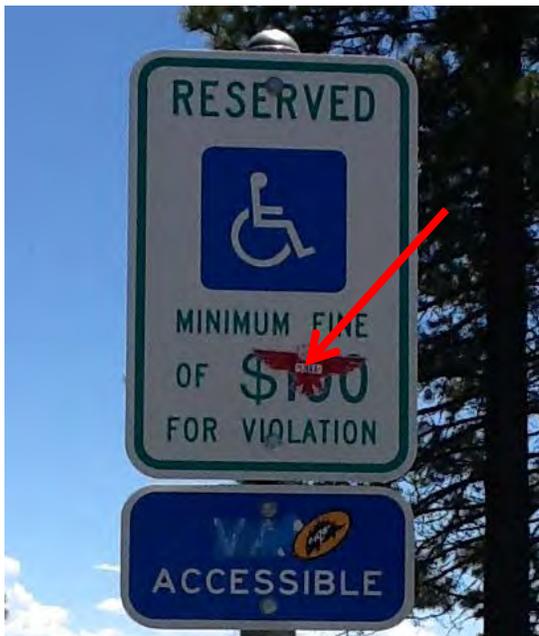
6.D: Accessible Parking Signage	The sign indicating the minimum fine is outdated and reads \$100 instead of \$250.	Replace with corrected fee amount.	Done

Fine should read \$250, not \$100. Vandalized sign is not legible.

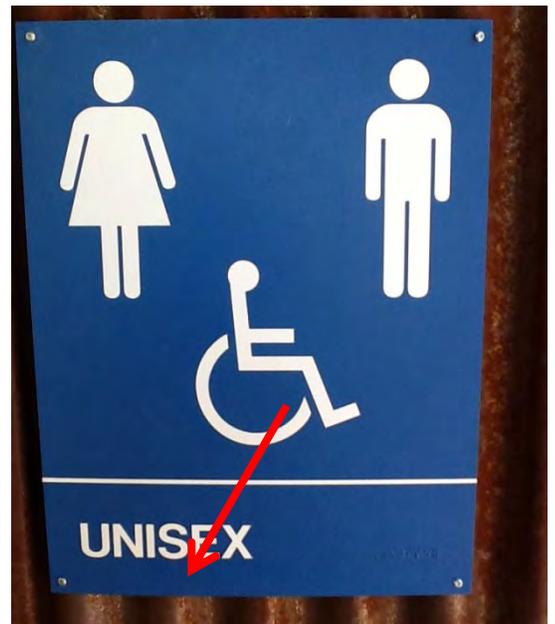
6.E: Identification Symbols	Restroom signage is not compliant. The geometric symbol's circle does not contrast with the triangle and the identification sign's braille is placed to the side of the sign instead of below the tactile characters.	Replace the geometric symbol so that its contrast is distinctly different than the contrast with the door. Replace the identification sign with one in which the braille is below the text between 3/8" - 1/2" either centered or left justified.	Short-term

Braille is required to be below the text between 3/8" - 1/2" either center or left justified, not set to the side.

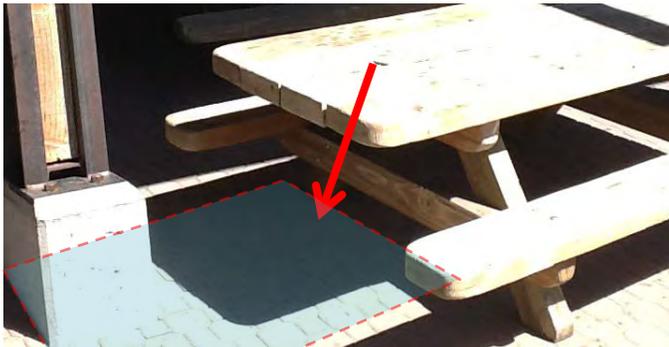
7.B: Picnic Tables	Accessible picnic table does not provide 30"x48" wheelchair space nor the allowed knee space within those limits.	Replace picnic table with a table that meets accessibility requirements.	Short-term

Inadequate clear space is provided on the approach to the accessible table. An accessible picnic table must provide a 30"x48" wheelchair space and provide for the allowed knee space within those limits.

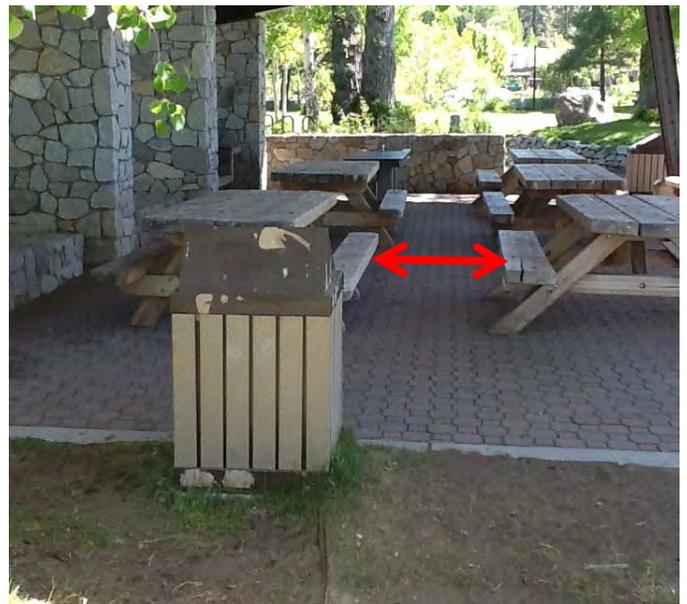
ITEM	EXISTING BARRIER	BARRIER REMOVAL METHOD	CORRECTIVE TIMELINE
NORTH TAHOE BEACH			
7: Site Furnishings & Amenities			
7.A: Picnic Tables	Adequate clear floor space is around the accessible picnic table in the pavilion.	Move the accessible picnic table to allow for 48" clear space from the edge of the table.	Short-term

The current layout does not provide the required 36" clear space between and around the tables.

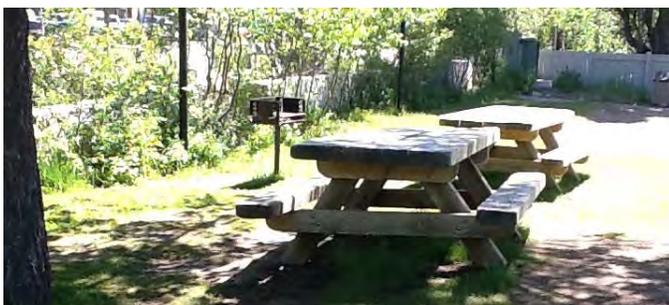
These inaccessible picnic tables and barbecue are provided in an alternative area from the accessible picnic tables and may offer a different experience.

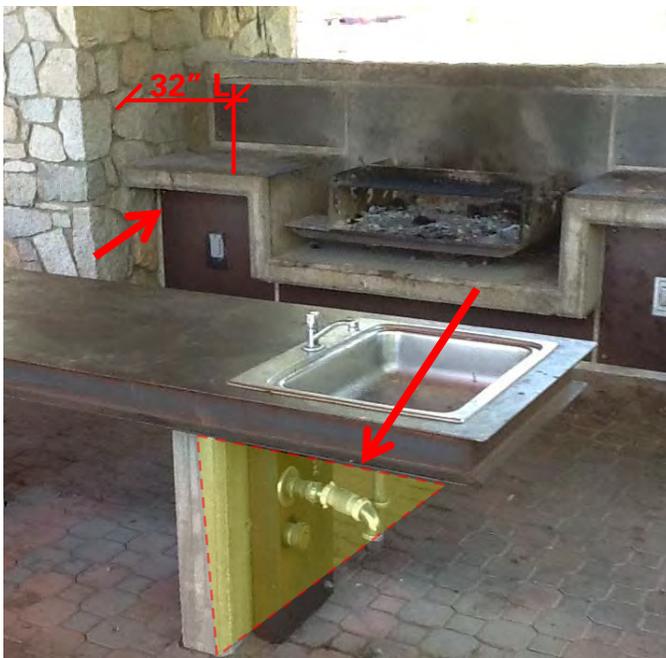
ITEM	EXISTING BARRIER	BARRIER REMOVAL METHOD	CORRECTIVE TIMELINE
NORTH TAHOE BEACH			
8: Pavilion-Kitchen Area			
8.A: Pavilion Sink – Protruding Object	Pavilion sink extends into the path of travel without sides or posts for cane detection.	Incorporate sides or post into sink design to allow for cane detection. Ensure a 30" forward approach is provided.	Long-term

8.B: Pavilion Sink – Knee Clearance	Bottom of sink is 26 ½" above finish floor; less than the 27" minimum required clear for knee space.	Replace sink design with a sink that has a minimum 27" clear space under the sink; maximum 34" height for the top of the counter.	Long-term

Knee clearance to the bottom of the sink counter is only 26 ½", not the required 27" minimum. The sink is also considered a protruding object as it lacks sides or posts to allow for cane detection.

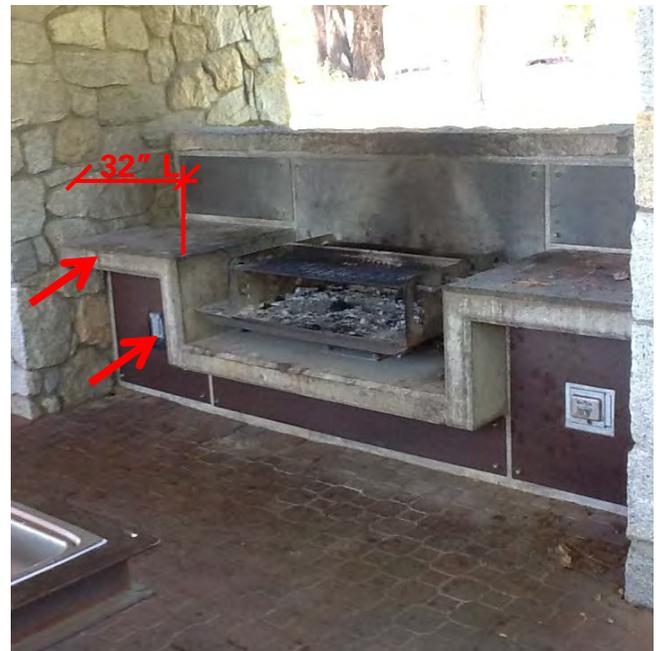
8.C: Pavilion Counter – Approach/Knee Space	Counter at the built-in barbecue does not have adequate knee space or, as an alternative, a 36" long parallel approach (only 32" long).	Revise counter to either provide appropriate knee space with clear approach space or extend the counter 4".	Long-term

8.D: Pavilion Counter – Electrical Outlets Obstructed	Electrical outlets placed under counters of built-in barbecue are difficult to reach as they are recessed under the counter (not specifically addressed in CBC or ADA, but it is generally accepted that for wheelchair users it is ergonomically difficult to reach under obstructions).	Consider relocating electrical outlets to a location not under a counter and within appropriate height requirements (minimum 15" above finish floor).	Long-term

The counters do not provide adequate knee space and the far right counter does not allow for a 36" parallel approach. The electric outlets are set at appropriate height; however, it is ergonomically difficult for wheelchair users to reach under obstructions as designed.

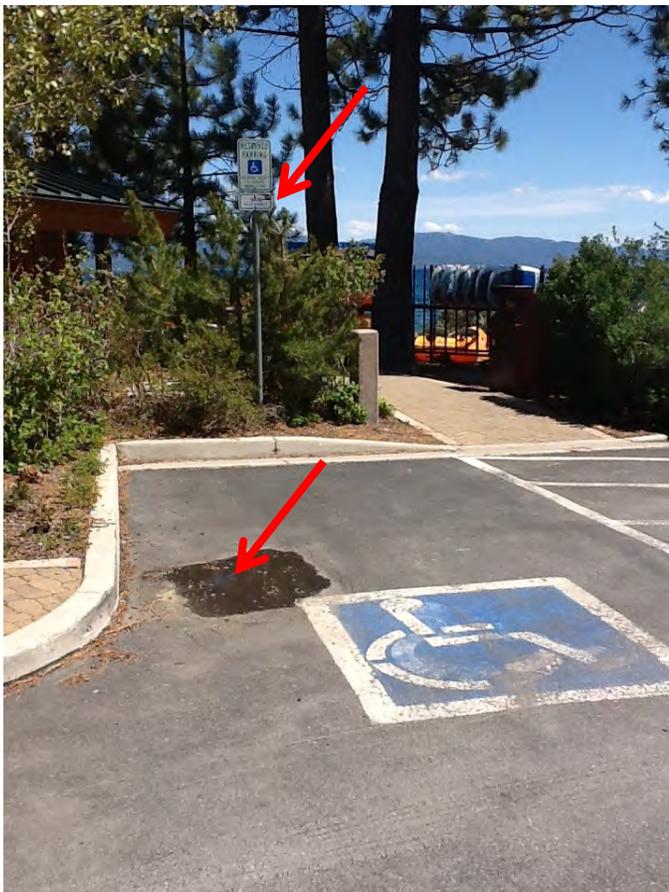
An excessive cross slope creates a bird bath area in the accessible parking space. The sign lacks the "Minimum Fine \$250" text.

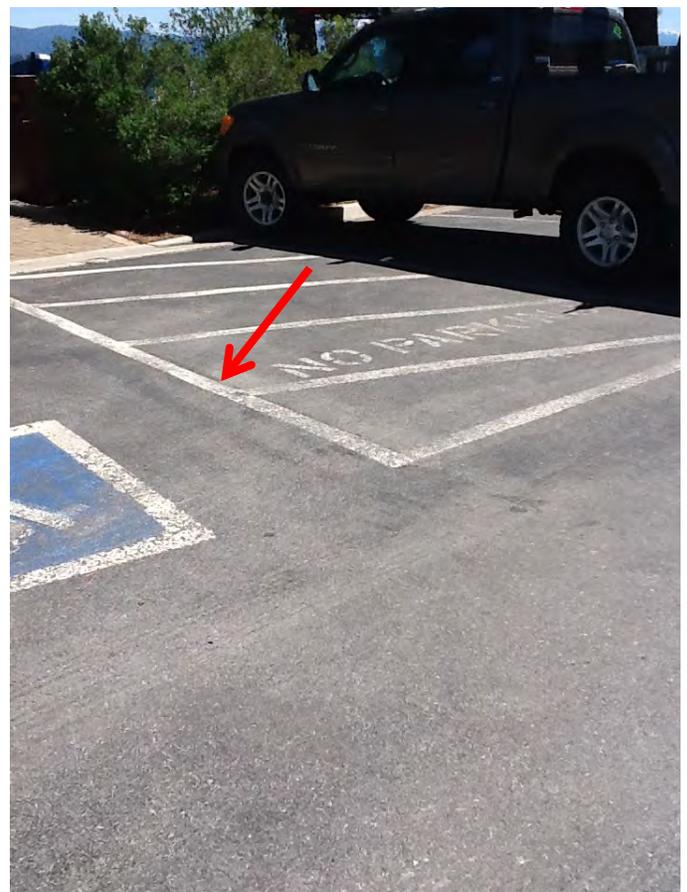
The border of the accessible aisle should be blue.

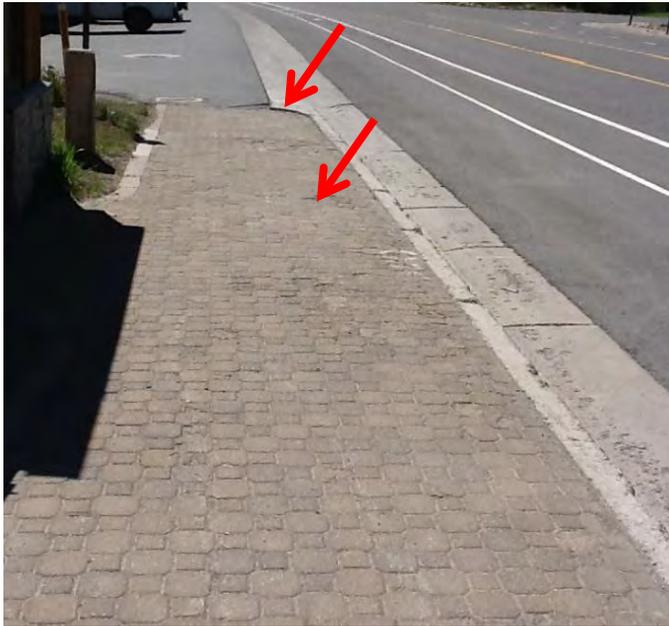
2.C: Changes in Level	Changes in walkway levels are greater than ¼" at transitions from paver to concrete or asphalt due to settling. Transitions at concrete utility inlets or concrete utility access boxes are not compliant. The terminus of the paver system at either end of the site exceeds ¼" where the paver system transitions to the adjacent surface. A few areas of general settlement have created sunken areas that are non-compliant.	Replace or reinstall the sections of walkway to provide transitions less than ¼".	Long-term

Excessive vertical change where pavers abut concrete curbs. Pavers are degraded in areas due to effects of snow and ice.

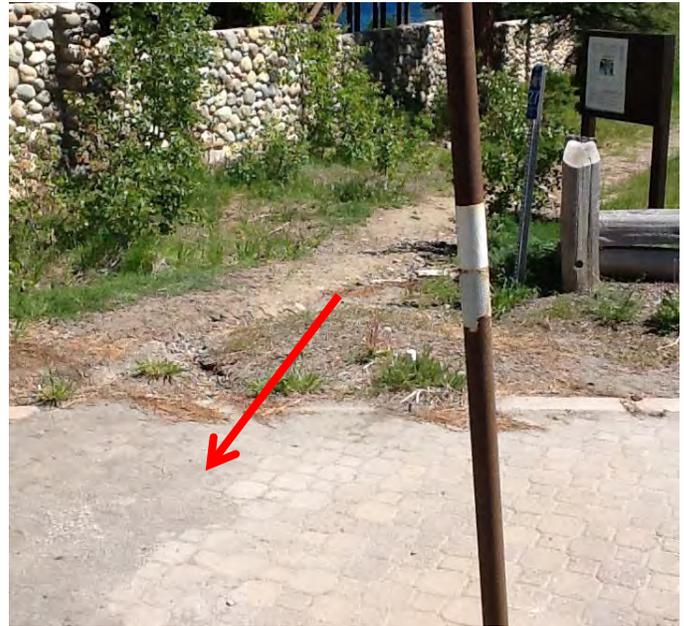
Walkway transitions to a dirt/decomposed granite material that is not stable or slip resistant.

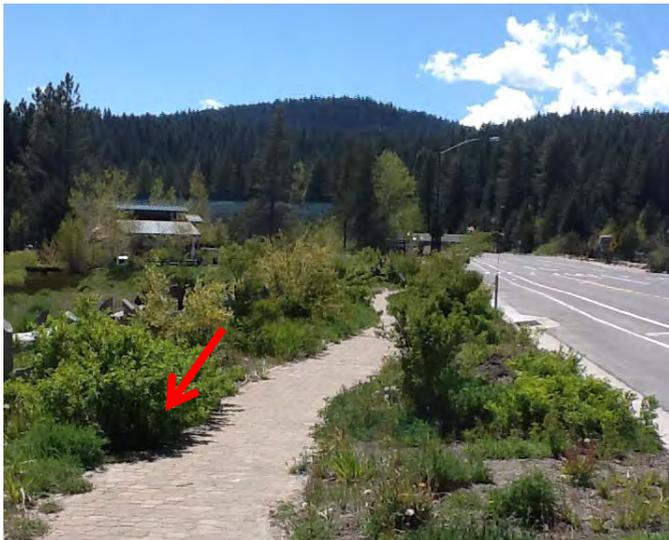
Plants reduce the width of the accessible route to less than 48".

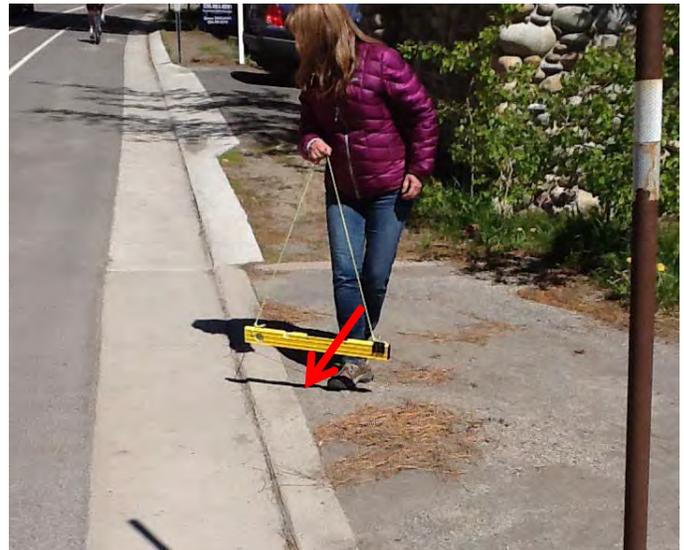
A detectable warning system or truncated domes are required at flush transitions from walkways to vehicular ways.

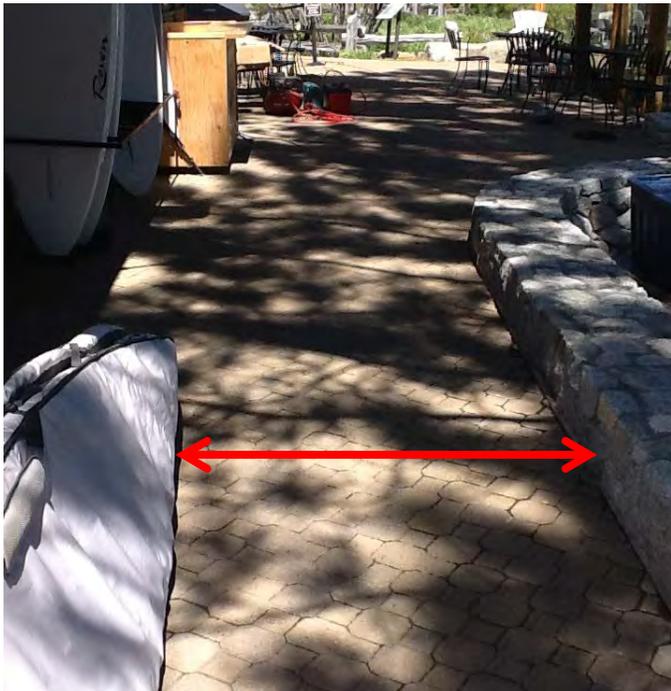
Storage reduces the path of travel to less than 48" minimum clear.

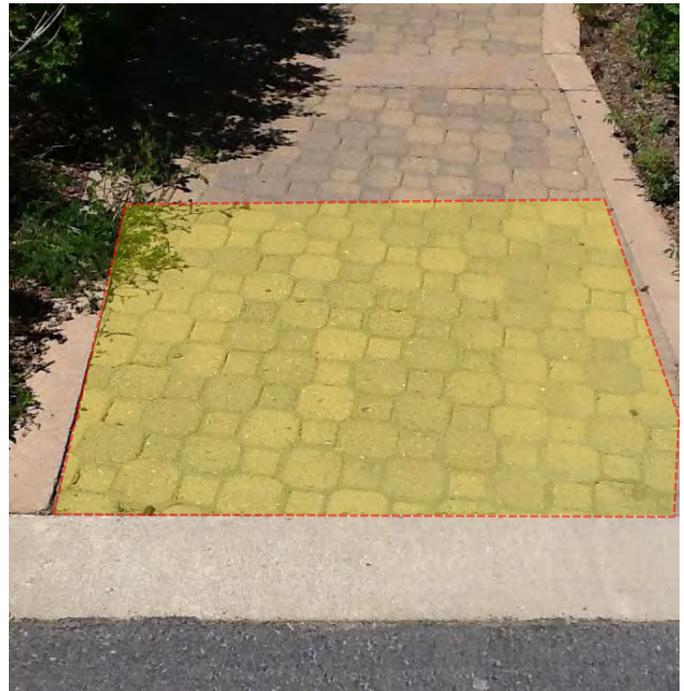
3.F: Detectable Warning	Detectable warnings are not provided where walkway transitions to vehicular way.	Install appropriate detectable warnings on walkways that transition vehicular ways.	Mid-term

Flush transition to vehicular way lacks truncated domes.

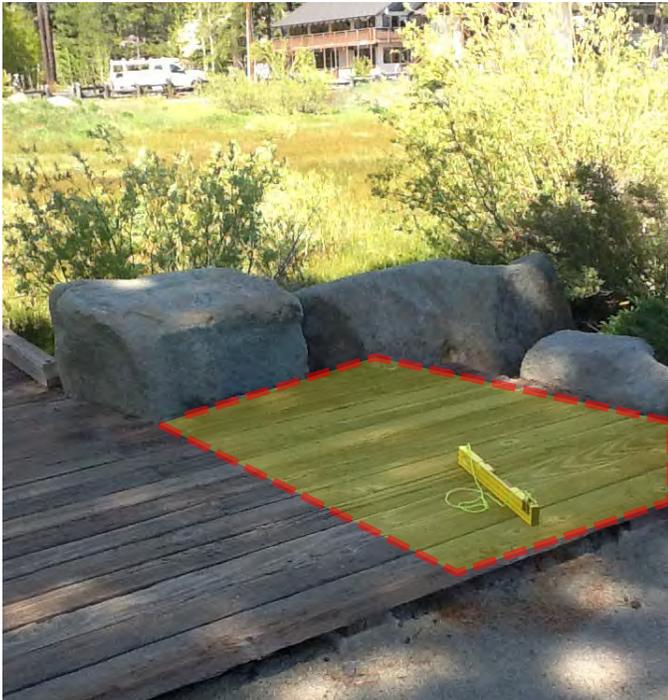
The wheelchair observation space is appropriately sized at 30"x48". However, this would not be considered an accessible beach entrance when judged against other standards since it lacks the appropriate transition from boardwalk to beach.

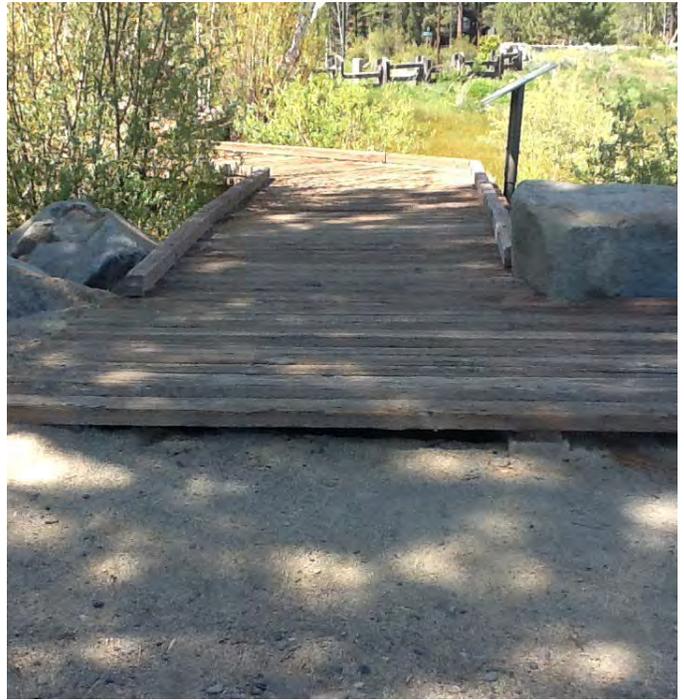
The terminus of the boardwalk and the accessible path to the beach is in excess of 1/2" vertical rise making the beach inaccessible.

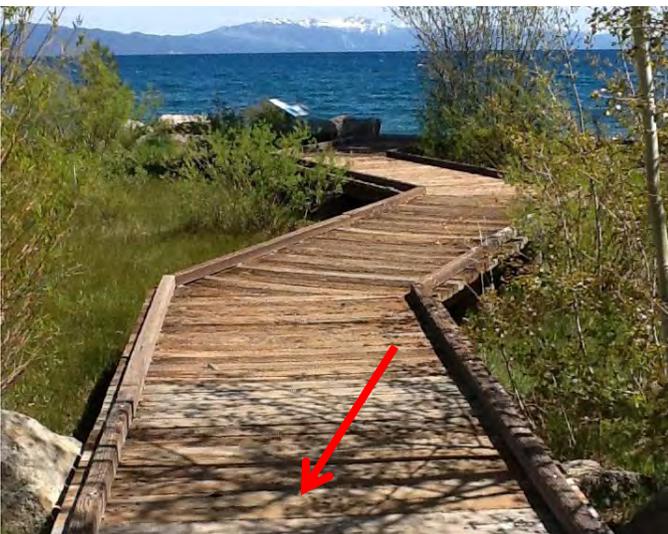
Boardwalk wood members have decayed creating excessive vertical change leading to the lake access.

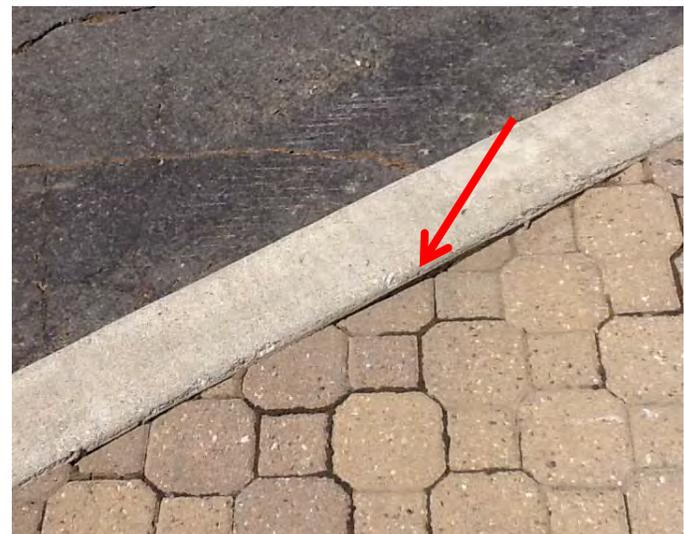
Excessive vertical change exists between the pavers and concrete curb.

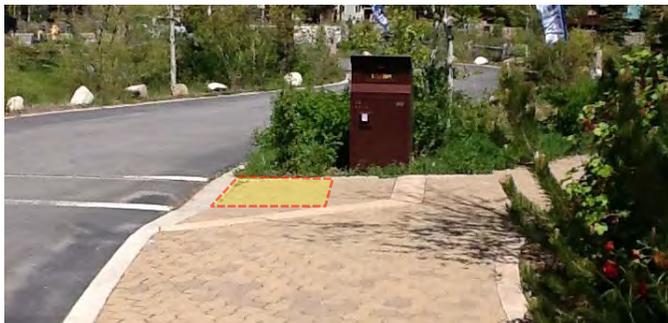
4.D: Detectable Warning	The curb ramps do not have detectable warnings.	Install appropriate detectable warnings on the curb ramps.	Mid-term
4.E: Straight Curb	No 24" segment of straight curb is located on each side of the diagonal curb ramp.	Reconstruct curb ramp to meet accessibility requirements.	Mid-term

The curb ramp lacks truncated domes and does not meet other accessibility requirements.
