NORTH TAHOE BEACH

CALIFORNIA TAHOE CONSERVANCY

ADA SELF-EVALUATION AND TRANSITION PLAN

PATTON LANDING

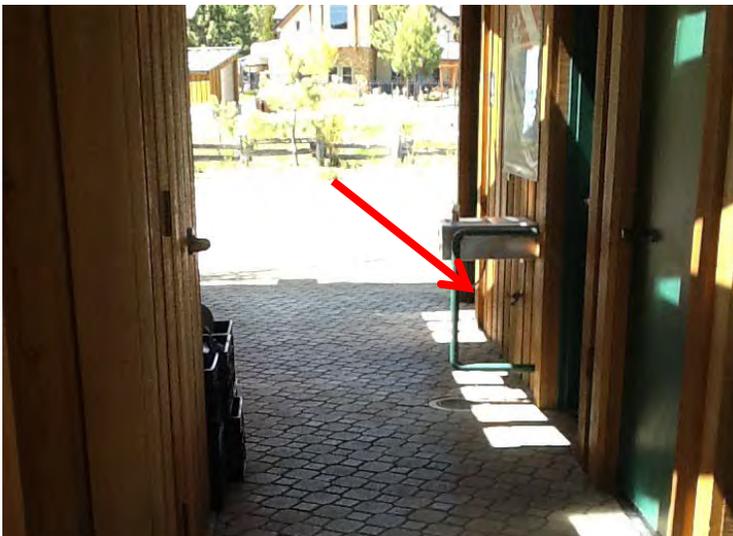
ITEM	EXISTING BARRIER	BARRIER REMOVAL METHOD	CORRECTIVE TIMELINE
PATTON LANDING			
5: Drinking Fountains			
5.A: Drinking Fountains	Only one "low" drinking fountain exists.	Provide a "high" drinking fountain that is accessible to persons who have difficulty bending or stooping.	Mid-term
5.B: Protruding Objects	The wall-mounted drinking fountain is only protected by a rail on one side and is considered a protruding object.	Install an additional side rail to meet accessibility requirements for protruding objects.	Mid-term

No "high" drinking fountain provided. Only a "low" fountain provided. Drinking fountain is considered a protruding object because it is not installed in an alcove or rails are not provided on both sides for cane detection.

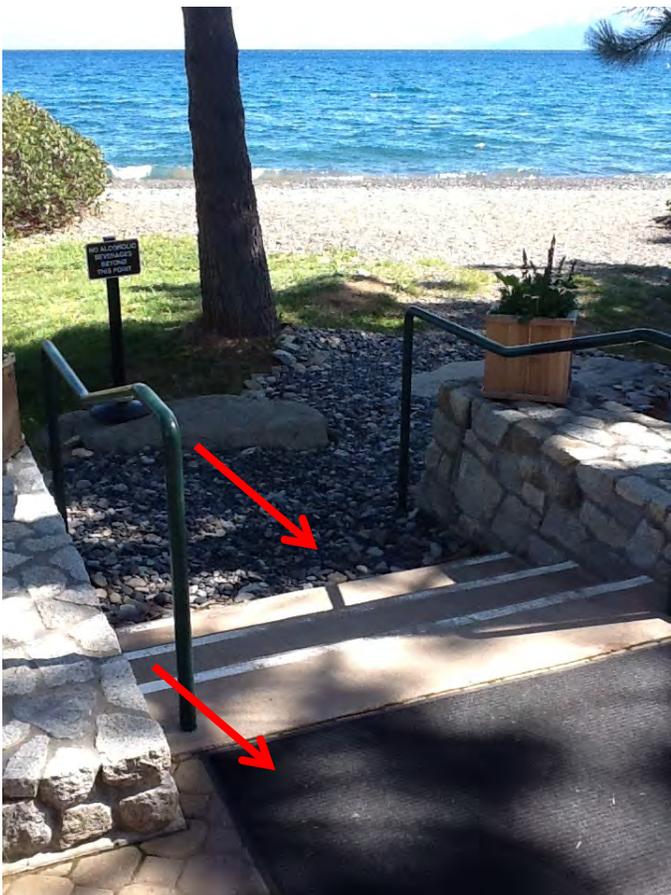
ITEM	EXISTING BARRIER	BARRIER REMOVAL METHOD	CORRECTIVE TIMELINE
PATTON LANDING			
6: Stairs			
6.A: Landing Materials	The bottom landing is constructed of cobble and should be concrete.	Reconstruct the bottom landing with concrete.	Long-term
6.B: Top Landing	A rug was placed at the top landing that was not attached. The slope of the top landing was 3.7%.	Attach rug to the top landing. Reconstruct top landing to be level to meet accessibility requirements.	Long-term

The stair's bottom landing is not level, firm or stable and the top landing is not level and the rug is not attached.
