## ADA SELF-EVALUATION AND TRANSITION PLAN

### VAN SICKLE BI-STATE PARK

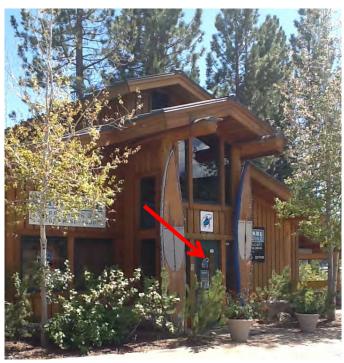
Primary entrance lacks the International Symbol of Accessibility (ISA) sign.

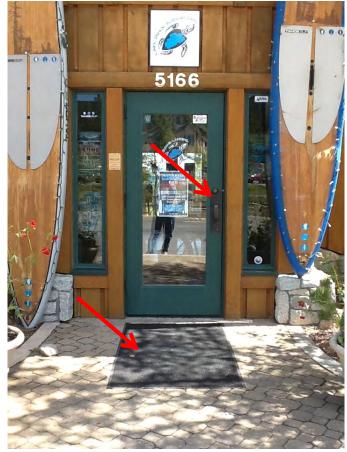
The rug is not firmly attached and the door operating effort requires more than 5 lbs of force.

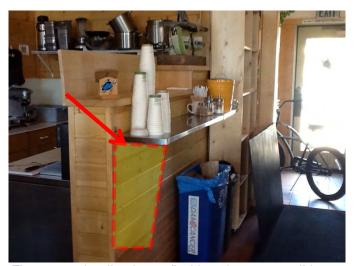
The counter is taller than 34" with no lower accessible portion. An end panel is required down to 27" above finish floor for cane detection. Shelving provides the cane detection on the far end.

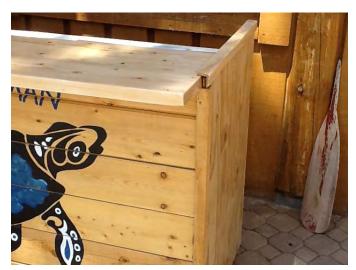
Outdoor counter height is greater than 34" with no lower accessible portion.

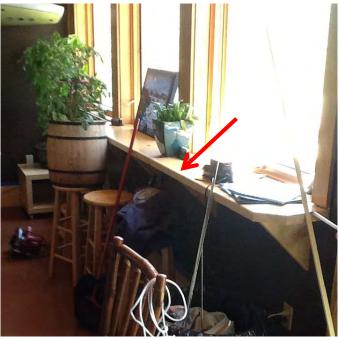
The standing eating area does not provide a lower section (34" maximum height) for wheelchair users.

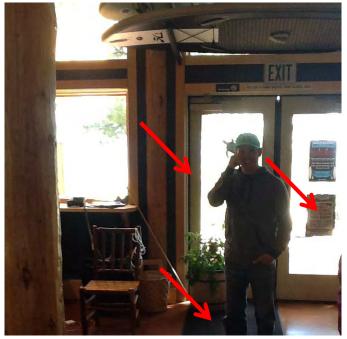
Rug is not firmly attached and no ISA is provided at the entry. A tactile and braille "EXIT" sign should be provided.

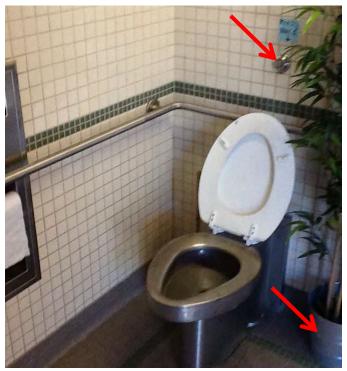
9.B: Maneuvering Space	A potted plant was placed in the clear space, reducing required 28" width required for a side transfer to the water closet.	Remove the potted plant from the clear space.	Short-term

9.D: Water Closet Flush Controls	The push button is centered behind the toilet and controls exceed 5 lbs. operating pressure.	Replace and relocate push button to meet accessibility requirements and be located on the wide side of the water closet where clear floor space is provided.	Short-term

The flush controls are centered on the toilet instead of being located on the fixture's wide side. The potted plant should not be located in the fixture's clear space.

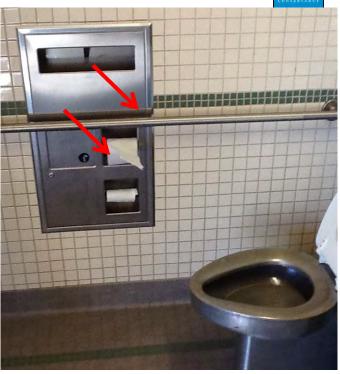
9.F: Grab Bar Wall Clearance	The space between the grab bar and the wall is less than 1-1/2" where the toilet paper dispenser passes behind the grab bar.	Recess the toilet paper dispenser or replace with a unit that allows for 1-1/2" between the grab bar and the wall.	Short-term

The toilet paper/seat cover dispenser reduces the clear space behind the grab bar to less than 1-1/2". The top roll of toilet paper is not compliant. Should the lower roll be empty, the upper roll would not comply.

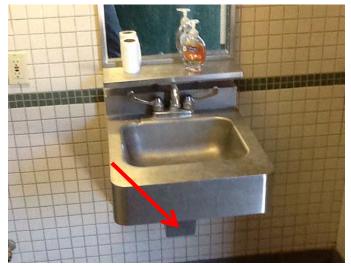
9.G: Lavatory Knee Clearance	Knee clearance does not extend 8" from the front edge of the lavatory.	Replace lavatory or adjust stainless steel shroud over piping so that it allows for the required knee clearance.	Mid-term

The metal shroud invades the knee space so that the knee clearance does not extend 8" from the front edge of the lavatory.

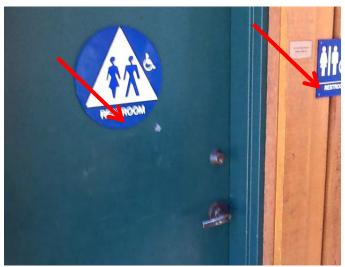
Braille should not be on door signs and the sign mounted on the side of the building should indicate "UNISEX" in raised characters and braille.

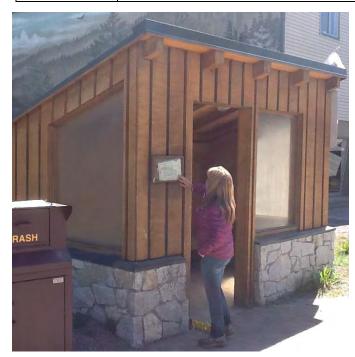
The bus shelter's bench reduces the turning area inside the shelter to less than 60" and does not have an accessible space to the side.

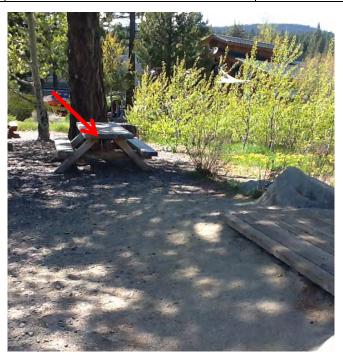
Picnic tables are provided but none are located on an accessible route.

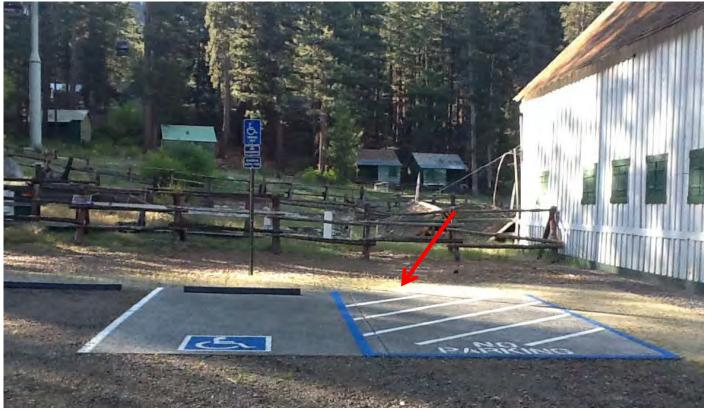
Access path from parking is decomposed granite which has no overall standards to confirm its ability to be firm and slip resistant.

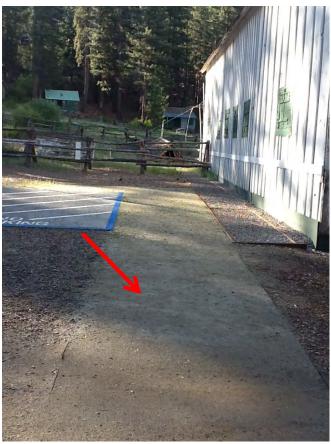
No overall standards exist for decomposed granite to confirm its ability to be firm and slip resistant.

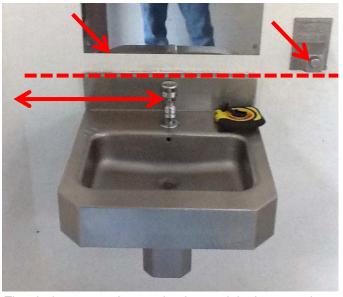
4.E: Side Clearance of Lavatory	There is 16¼" to the wall from the centerline of the lavatory. A minimum of 18" is required.	Adjust lavatory so that the centerline of the fixture is a minimum of 18" from the nearest sidewall or partition. Ensure that other accessibility requirements are maintained.	Long-term

4.F: Mirror	The bottom edge of the mirror's reflecting surface is more than 40" above finish floor.	Lower mirror so the bottom edge of the reflecting surface is no more than 40" above finish floor.	Short-term

4.G: Dispensers Operating Height	The air hand dryer control is 41" above finish floor (greater than the maximum 40" standard).	Lower hand dryer so that control is a maximum of 40" above finish floor.	Long-term

The air dryer operating mechanism and the bottom edge of the mirror exceed the maximum 40" allowed height above finish floor. The center of the lavatory is located less than the 18" minimum distance from the edge of wall.

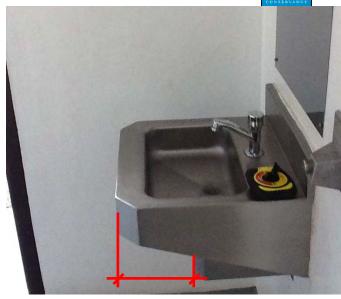
4.D: Lavatory Knee Clearance	Knee clearance does not extend 8" from the front edge of the lavatory. It extends 7½".	Replace lavatory or adjust stainless steel shroud over piping so that it allows for the required knee clearance.	Long-term

The metal shroud is 7  $\frac{1}{2}$ " from the leading edge of lavatory. An 8" minimum id allowed.

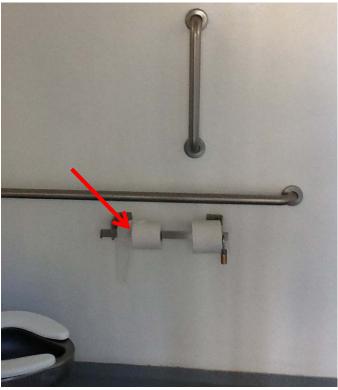
4.B: Toilet Paper Dispenser	The dispenser allows for multiple rolls and is mounted at 27½" above finish floor. The end of the roll is beyond the allowable horizontal reach for a toilet paper dispenser.  (Note the requirements for toilet paper dispensers have changed in the 2013 CBC. 2010 standard was for dispenser to be centered at least19" above finish floor. 2013 standard is for the dispenser to be below the grab bar, 19" minimum above the finish floor and not located behind the grab bar. The 2013 standard also now states the dispenser should also be 7"minimum and 9" maximum in front of the water closet.)	Reinstall/replace toilet dispenser to meet accessibility requirements: distance from the front edge of the toilet to the centerline of the toilet paper dispenser is to be 7" minimum and 9" maximum. The outlet of the dispenser shall be below the grab bar, 19" minimum above the finish floor.	Short-term

The dispenser allows for multiple rolls and is mounted at 27 ½" above finish floor. The end of the roll is beyond the allowable horizontal reach for a toilet paper dispenser.

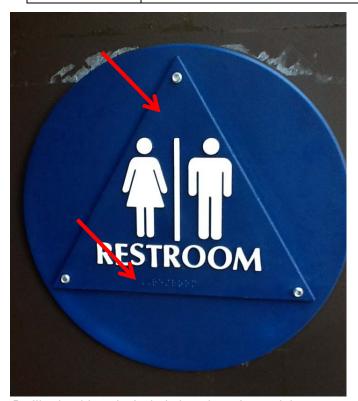
Braille should not be included on door sign and the triangle does not contrast with the circle.

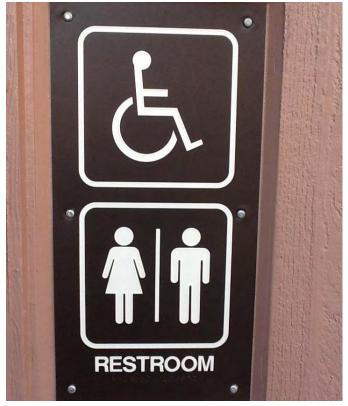
Raised characters must match the pictogram (e.g. "MEN'S OR WOMEN'S" or "UNISEX" and the braille must match the raised characters.

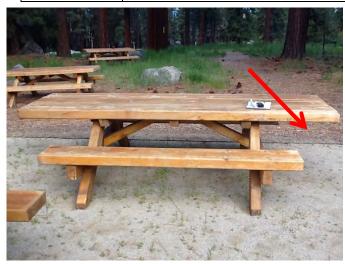
An accessible picnic table must provide a 30"x48" wheelchair space, provide for the allowed knee space within those limits and be located on an accessible route.

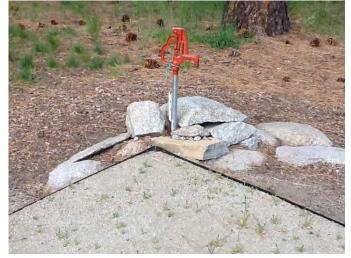
Water spigot location does not provide wheelchair access. Controls exceed 5 lbs. maximum operating pressure and would require tight grasping.
