FIGURE 3.13D: Map indicating location of sewer and water lines relative to the Upper Truckee River (Reaches 7-8).

FIGURE 3.14: Longitudinal profile of Upper Truckee River from Meyers Highway 50 crossing to the South Upper Truckee Road Bridge (Reaches 5-11). Profile and high terrace elevations were created using the 2003 LIDAR survey.

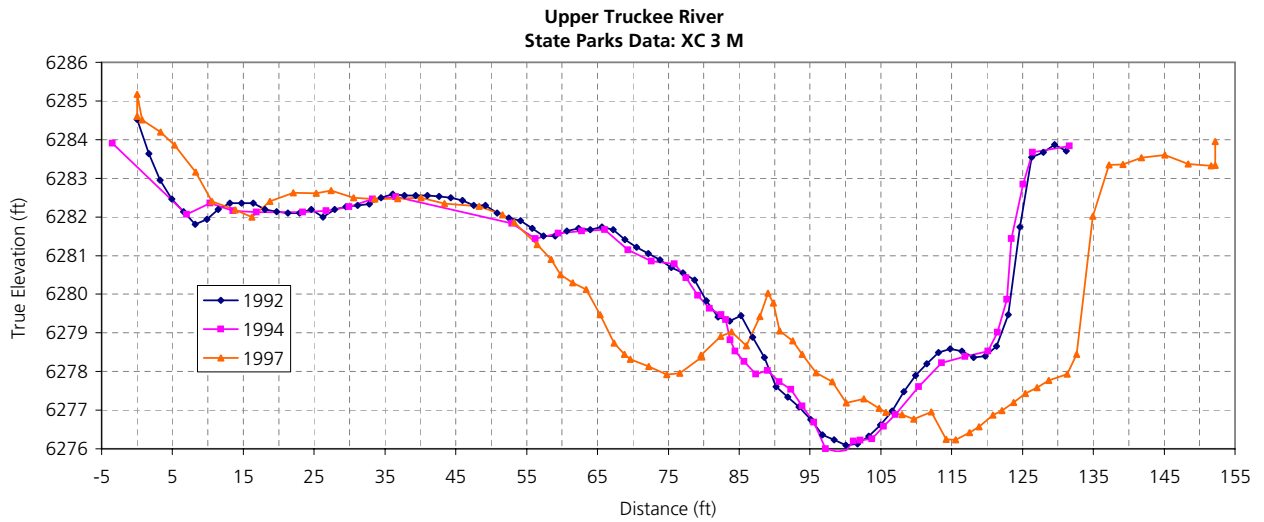
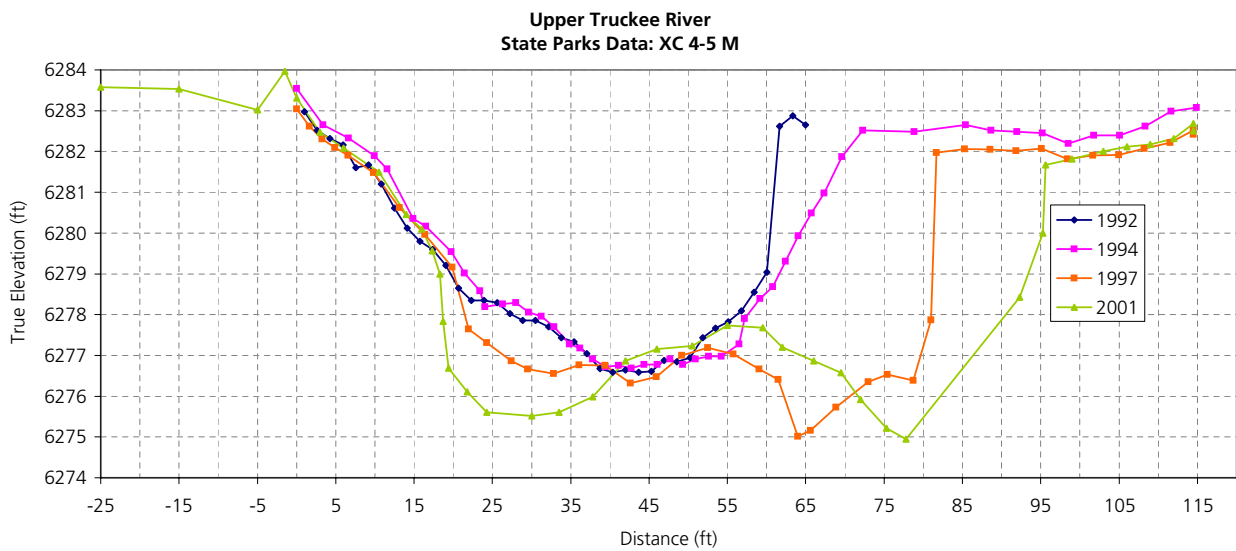
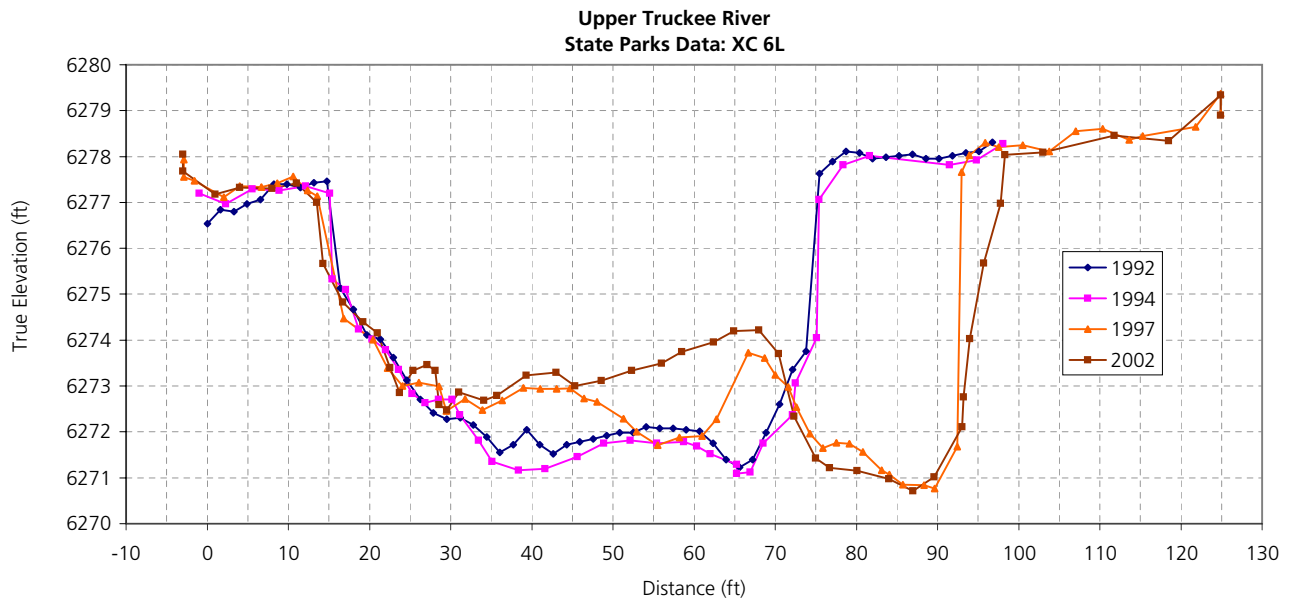
Sequential cross sections (ongoing since 1992) plotted by the CDFG show significant bank erosion and incision in recent years (Appendix A). Some of this change was likely due to the record 1997 flood, however there are changes that do signify ongoing instability in cross section and planform, suggesting continuing adjustment to channelization (Figure 3.19). This must be carefully considered in designing any restoration plan.

FIGURE 3.19: Comparison of cross-section surveys of the Upper Truckee River by California Department of Parks and Recreation from 1992-2002. See Appendix A for locations of cross sections.

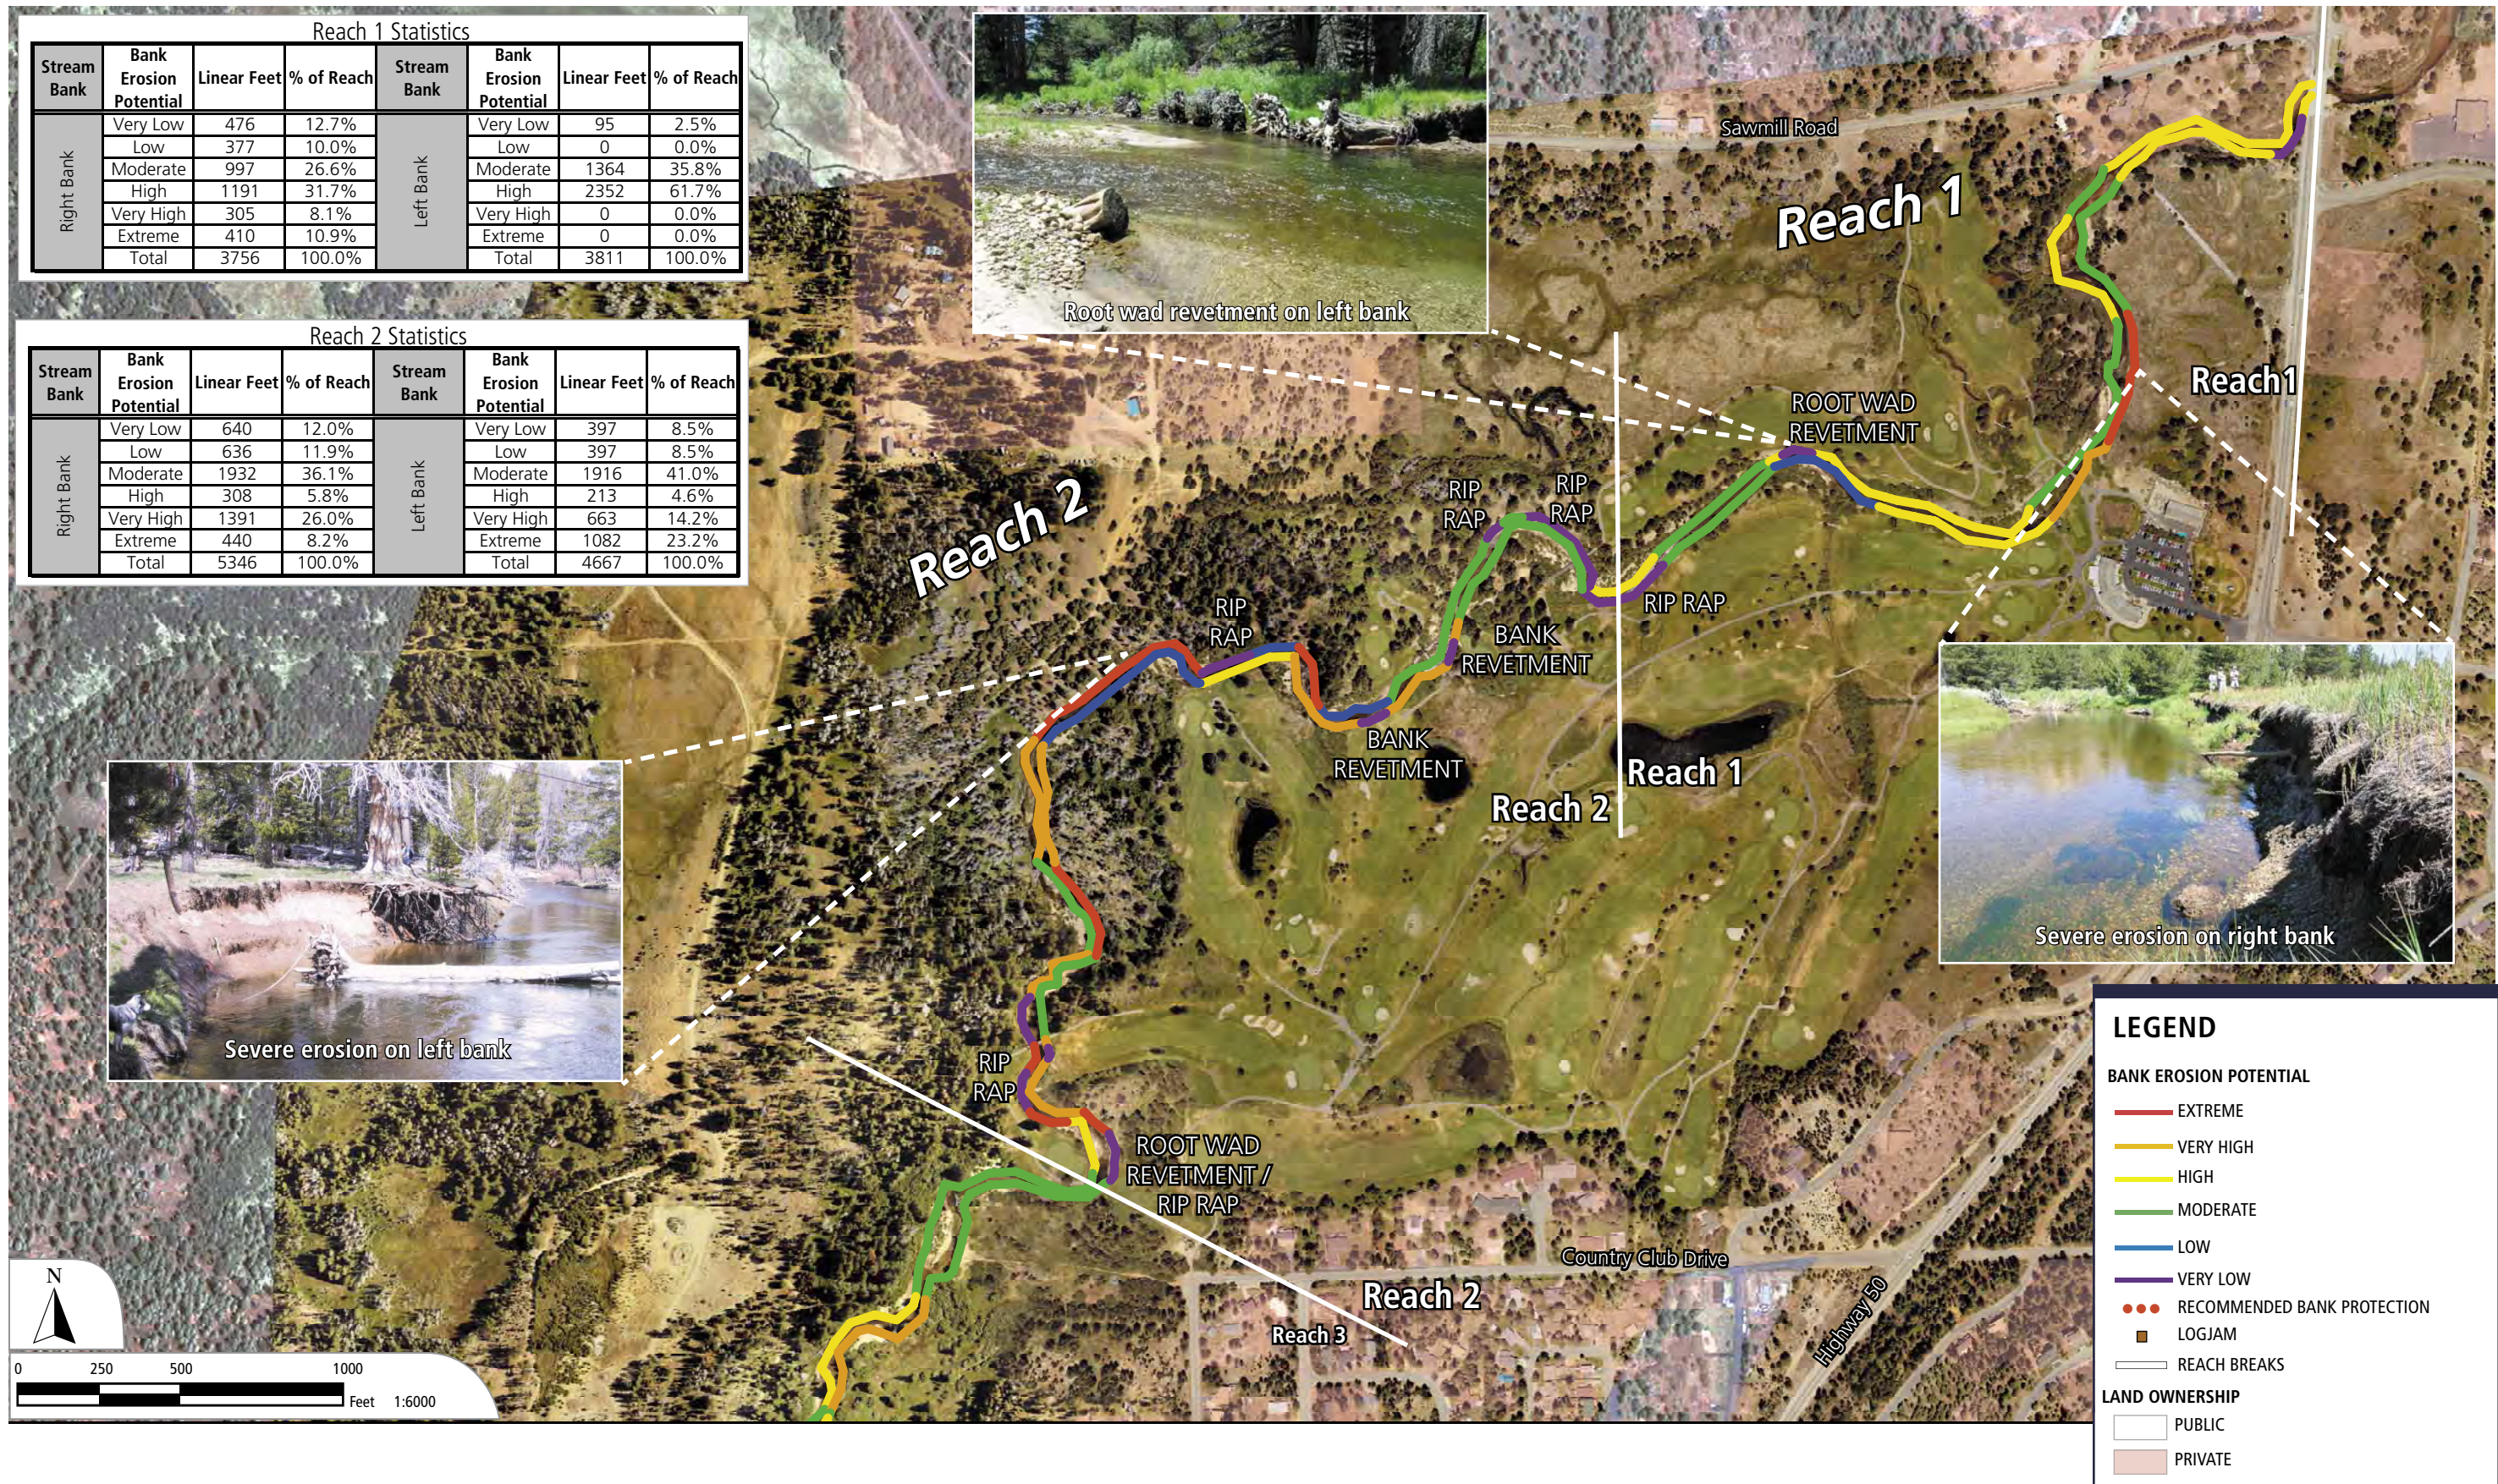
FIGURE 3.20A: Results of channel bank erosion survey for Reaches 1-2. Statistics by reach are summarized and photos provide visual reference for bank erosion potentials. Locations of bank erosion stabilization efforts are noted.

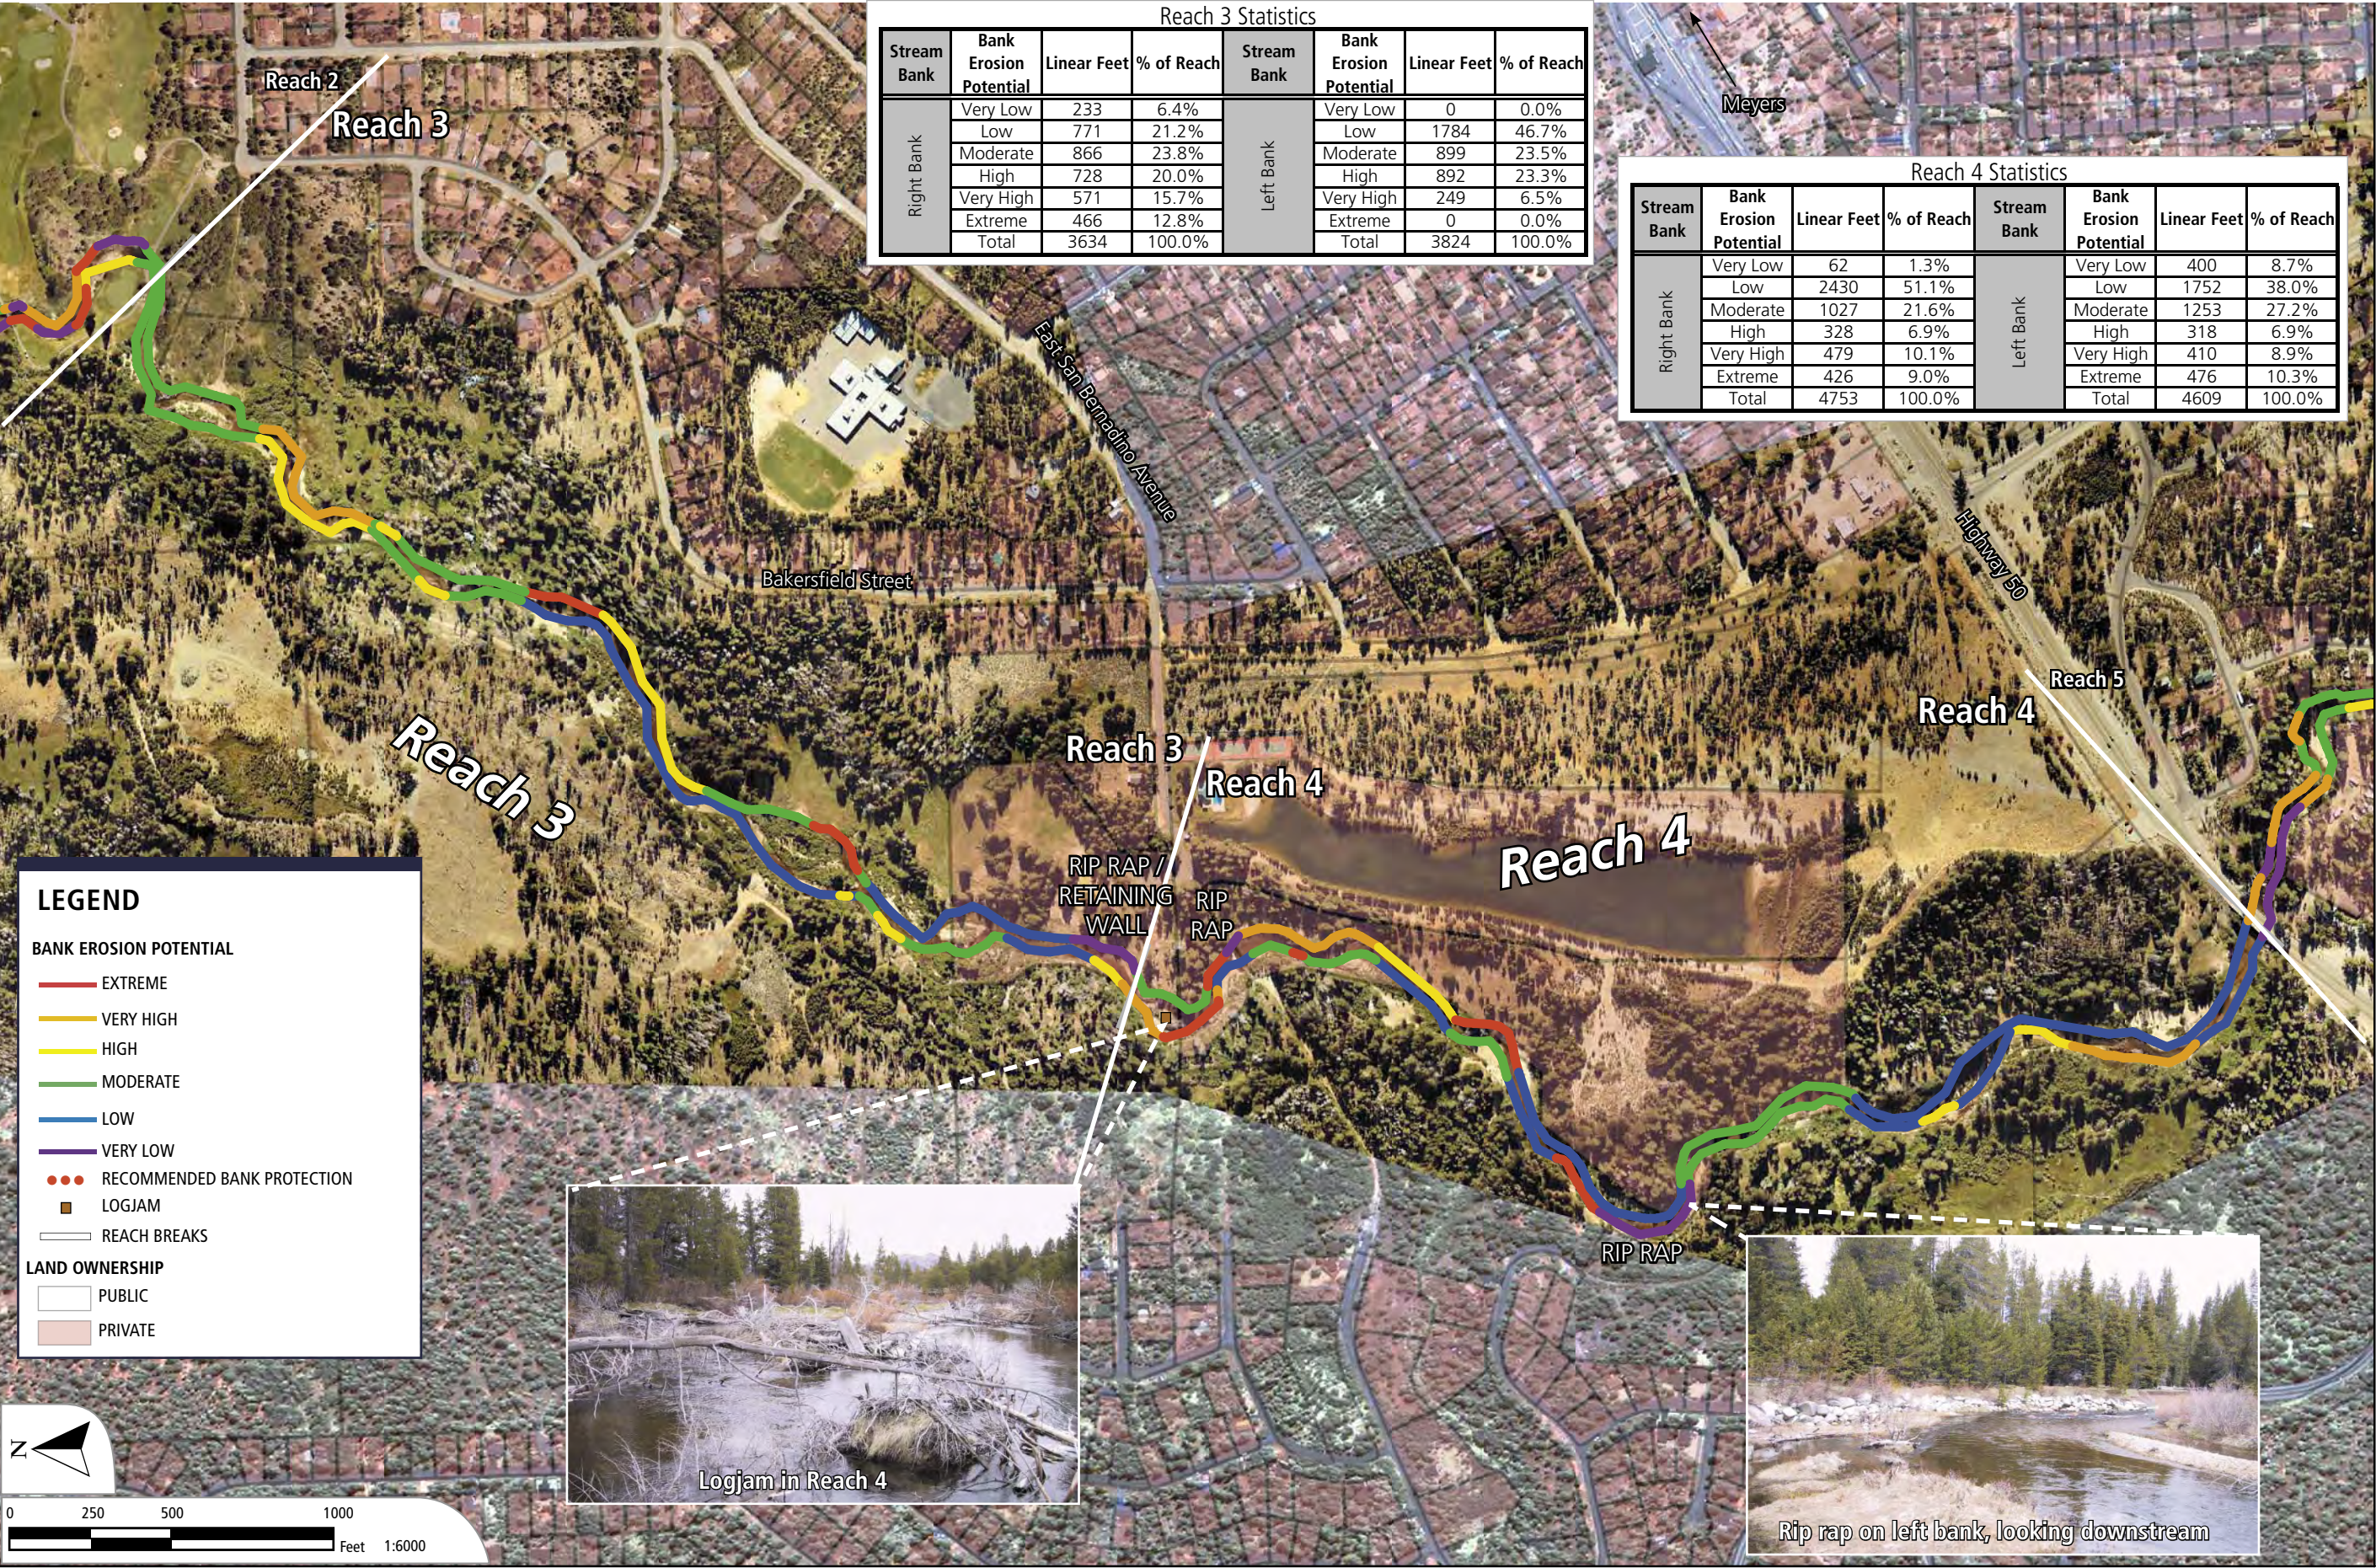
FIGURE 3.20B: Bank erosion potential ratings for Reaches 3 and 4.

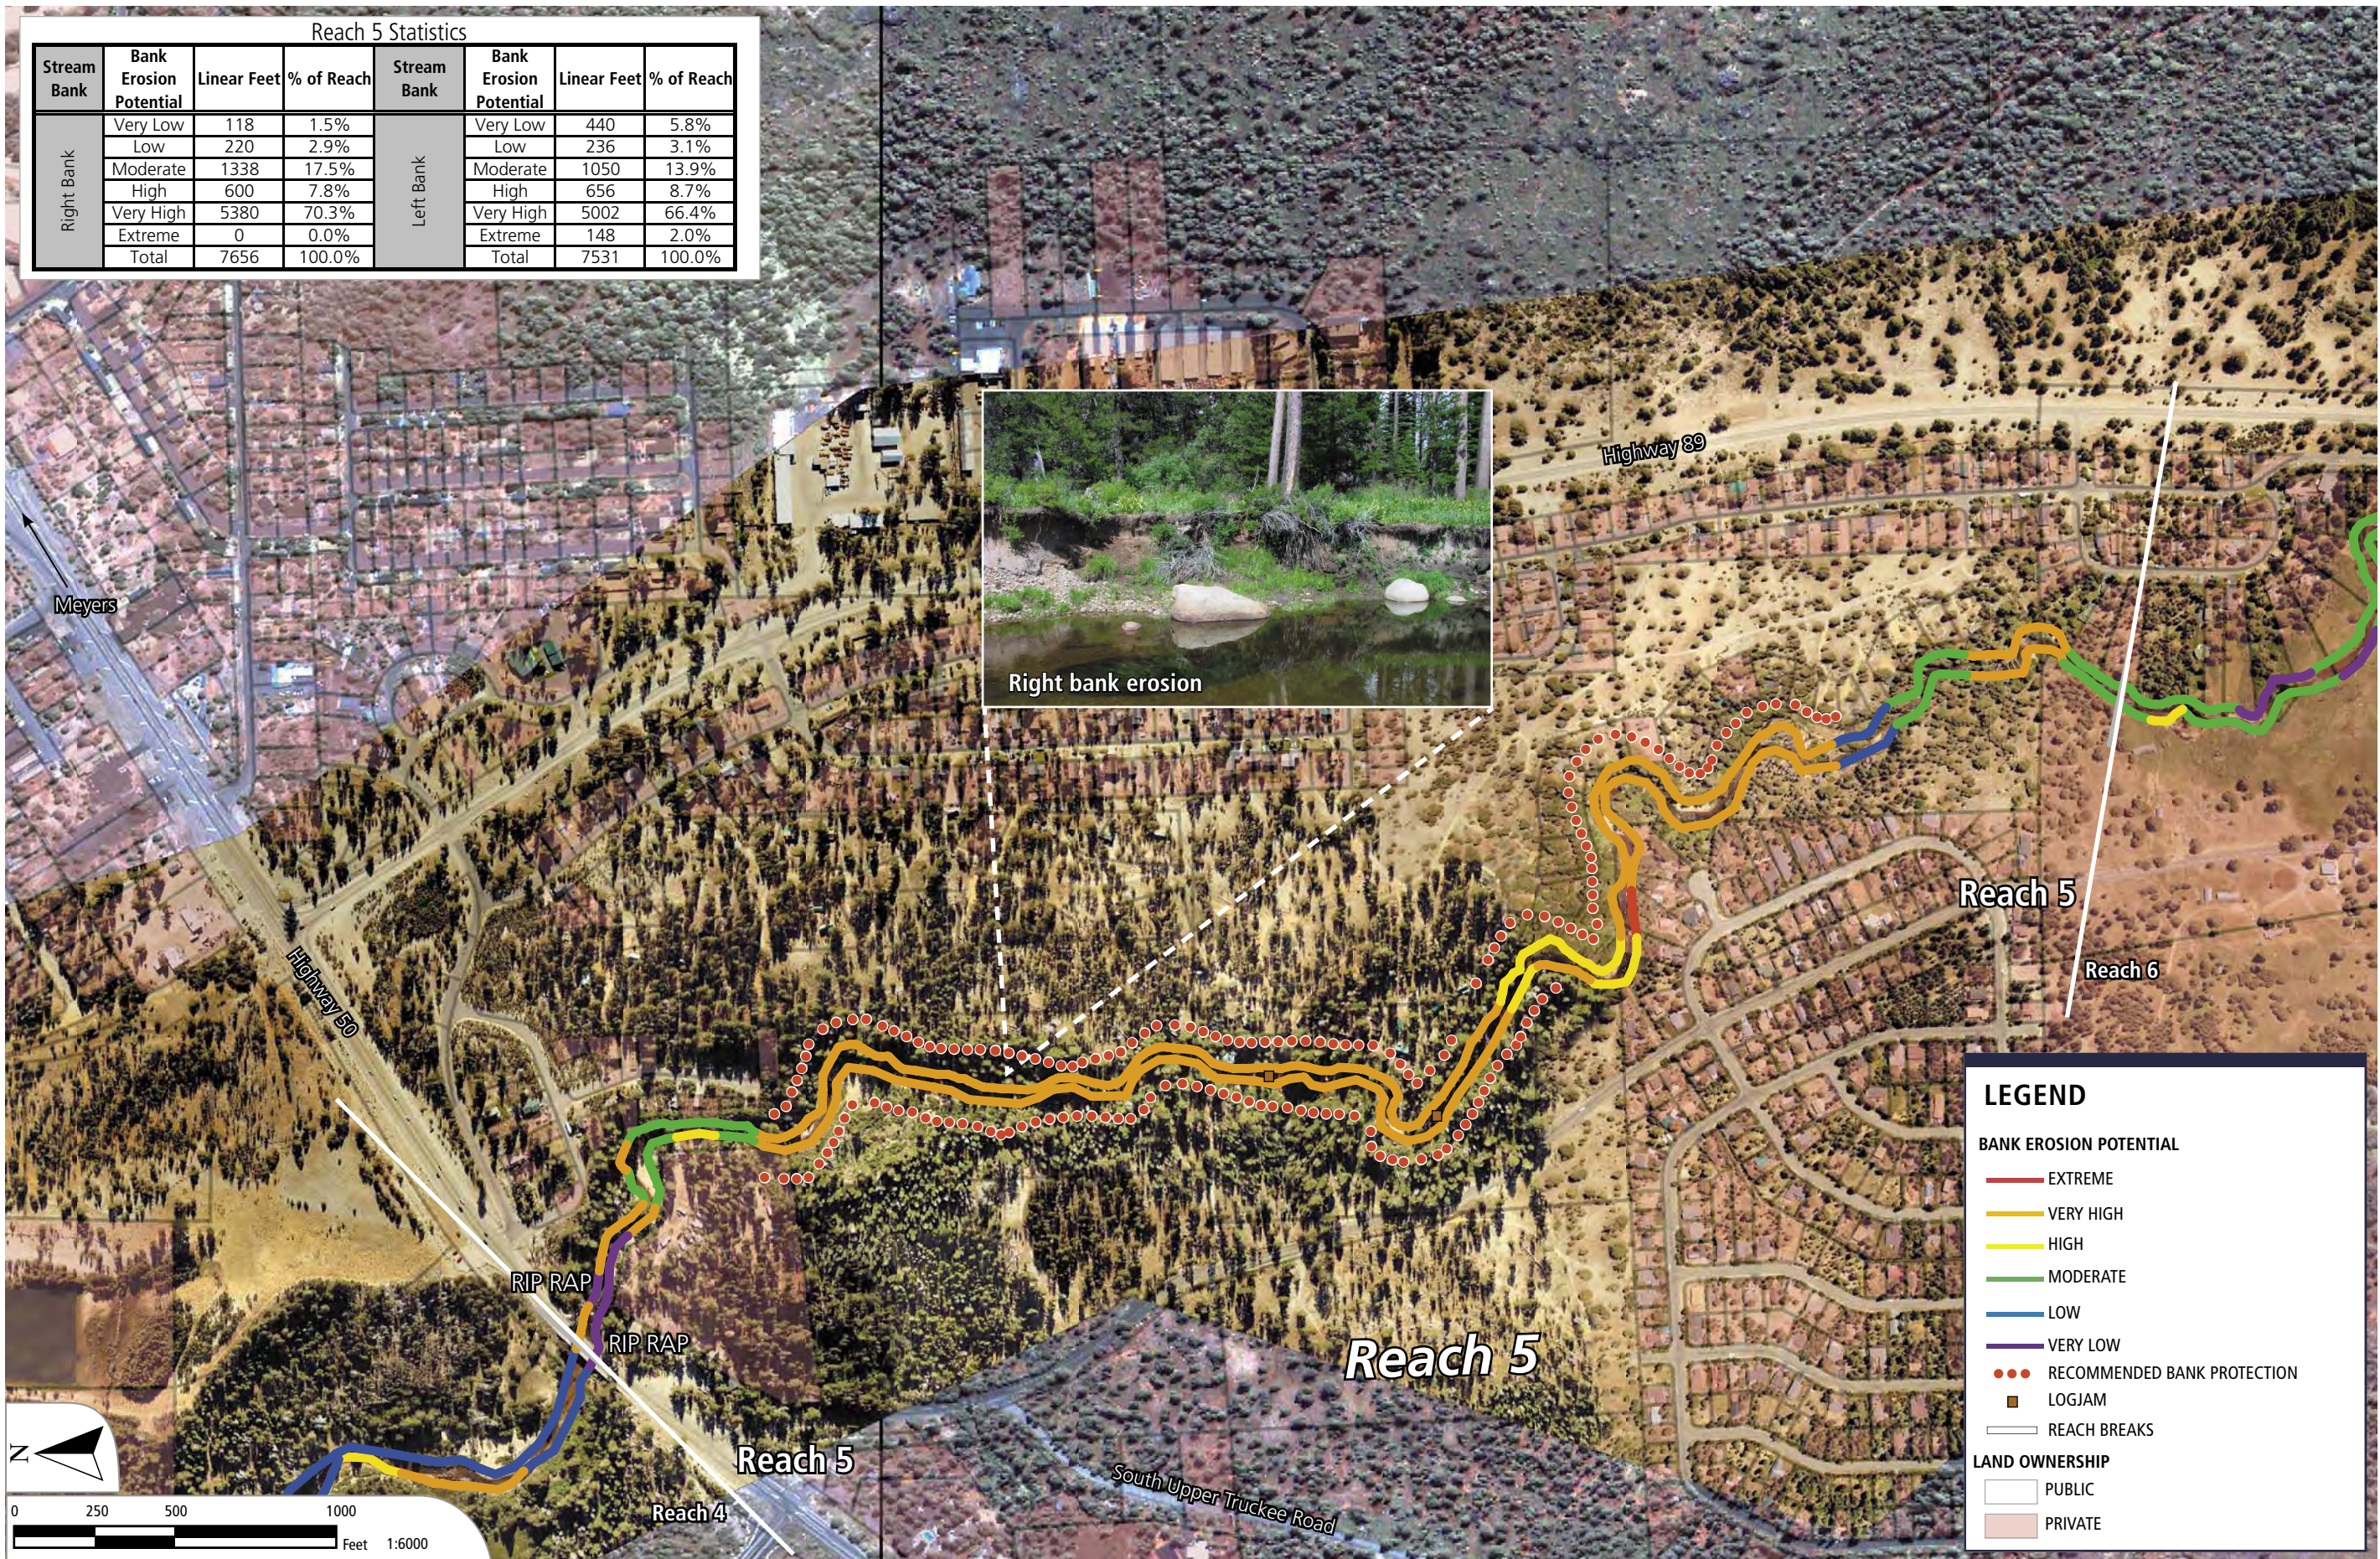
FIGURE 3.20C: Bank erosion potential ratings for Reach 5.

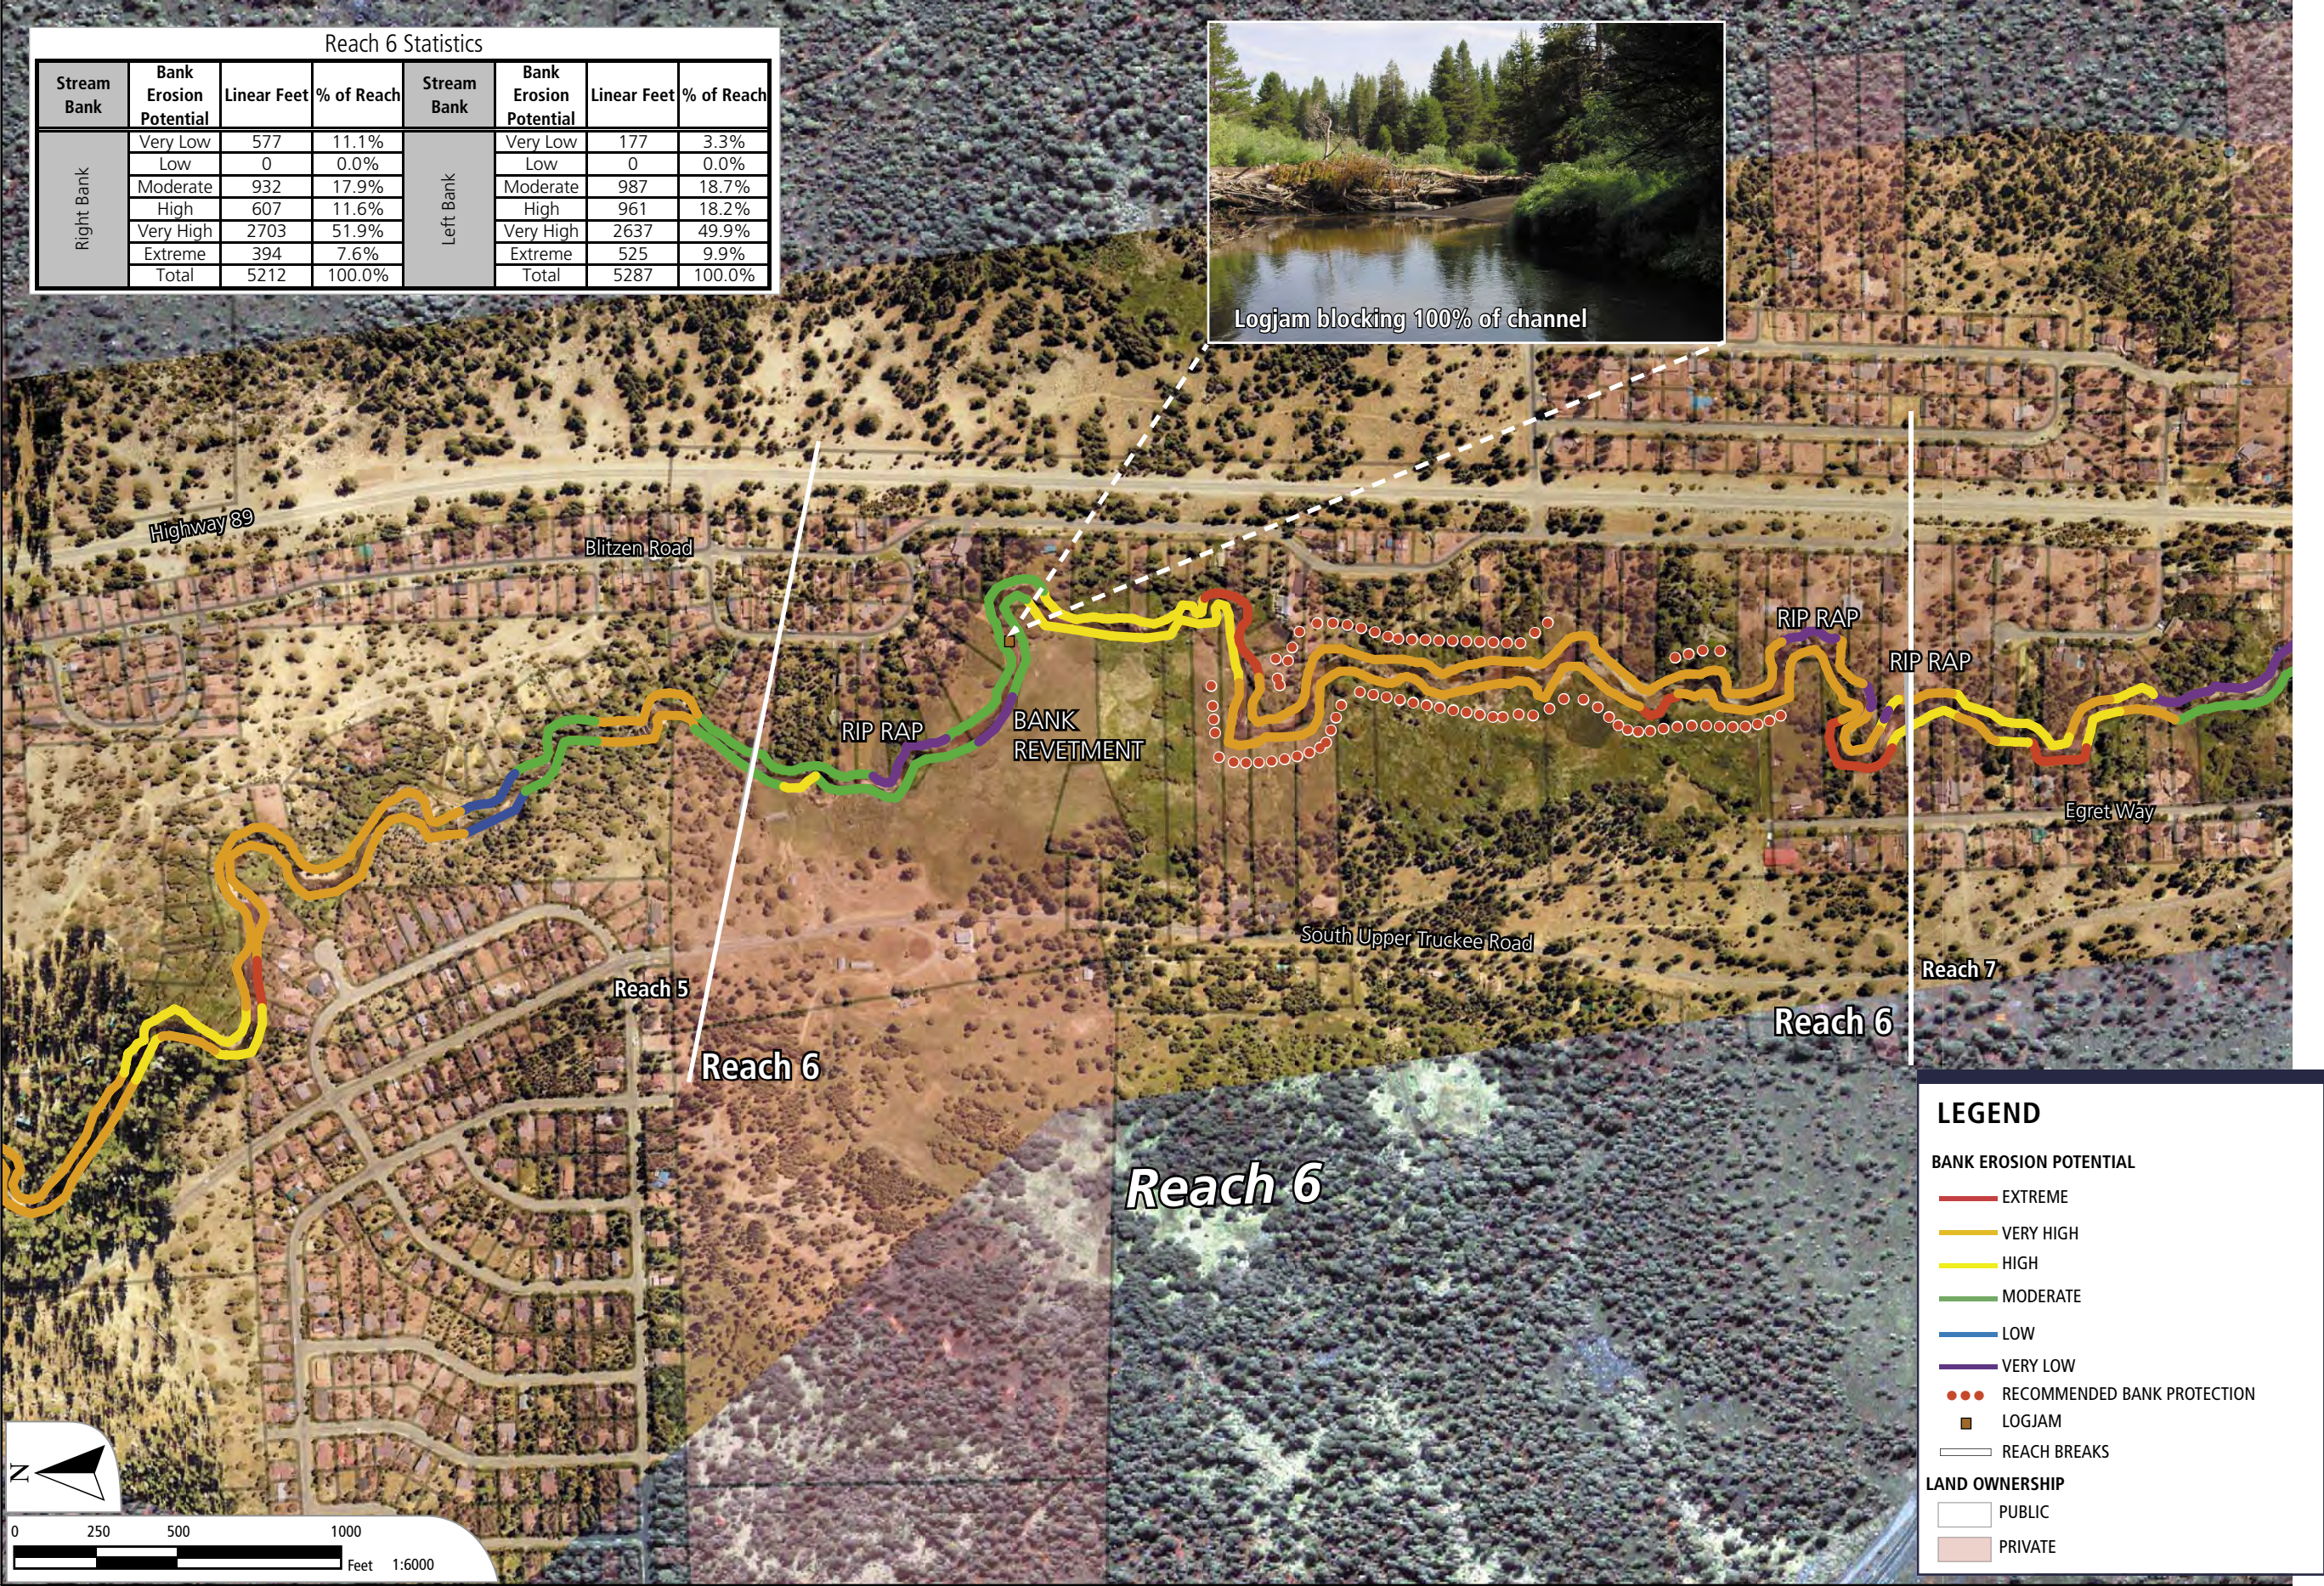
FIGURE 3.20D: Bank erosion potential ratings for Reach 6.

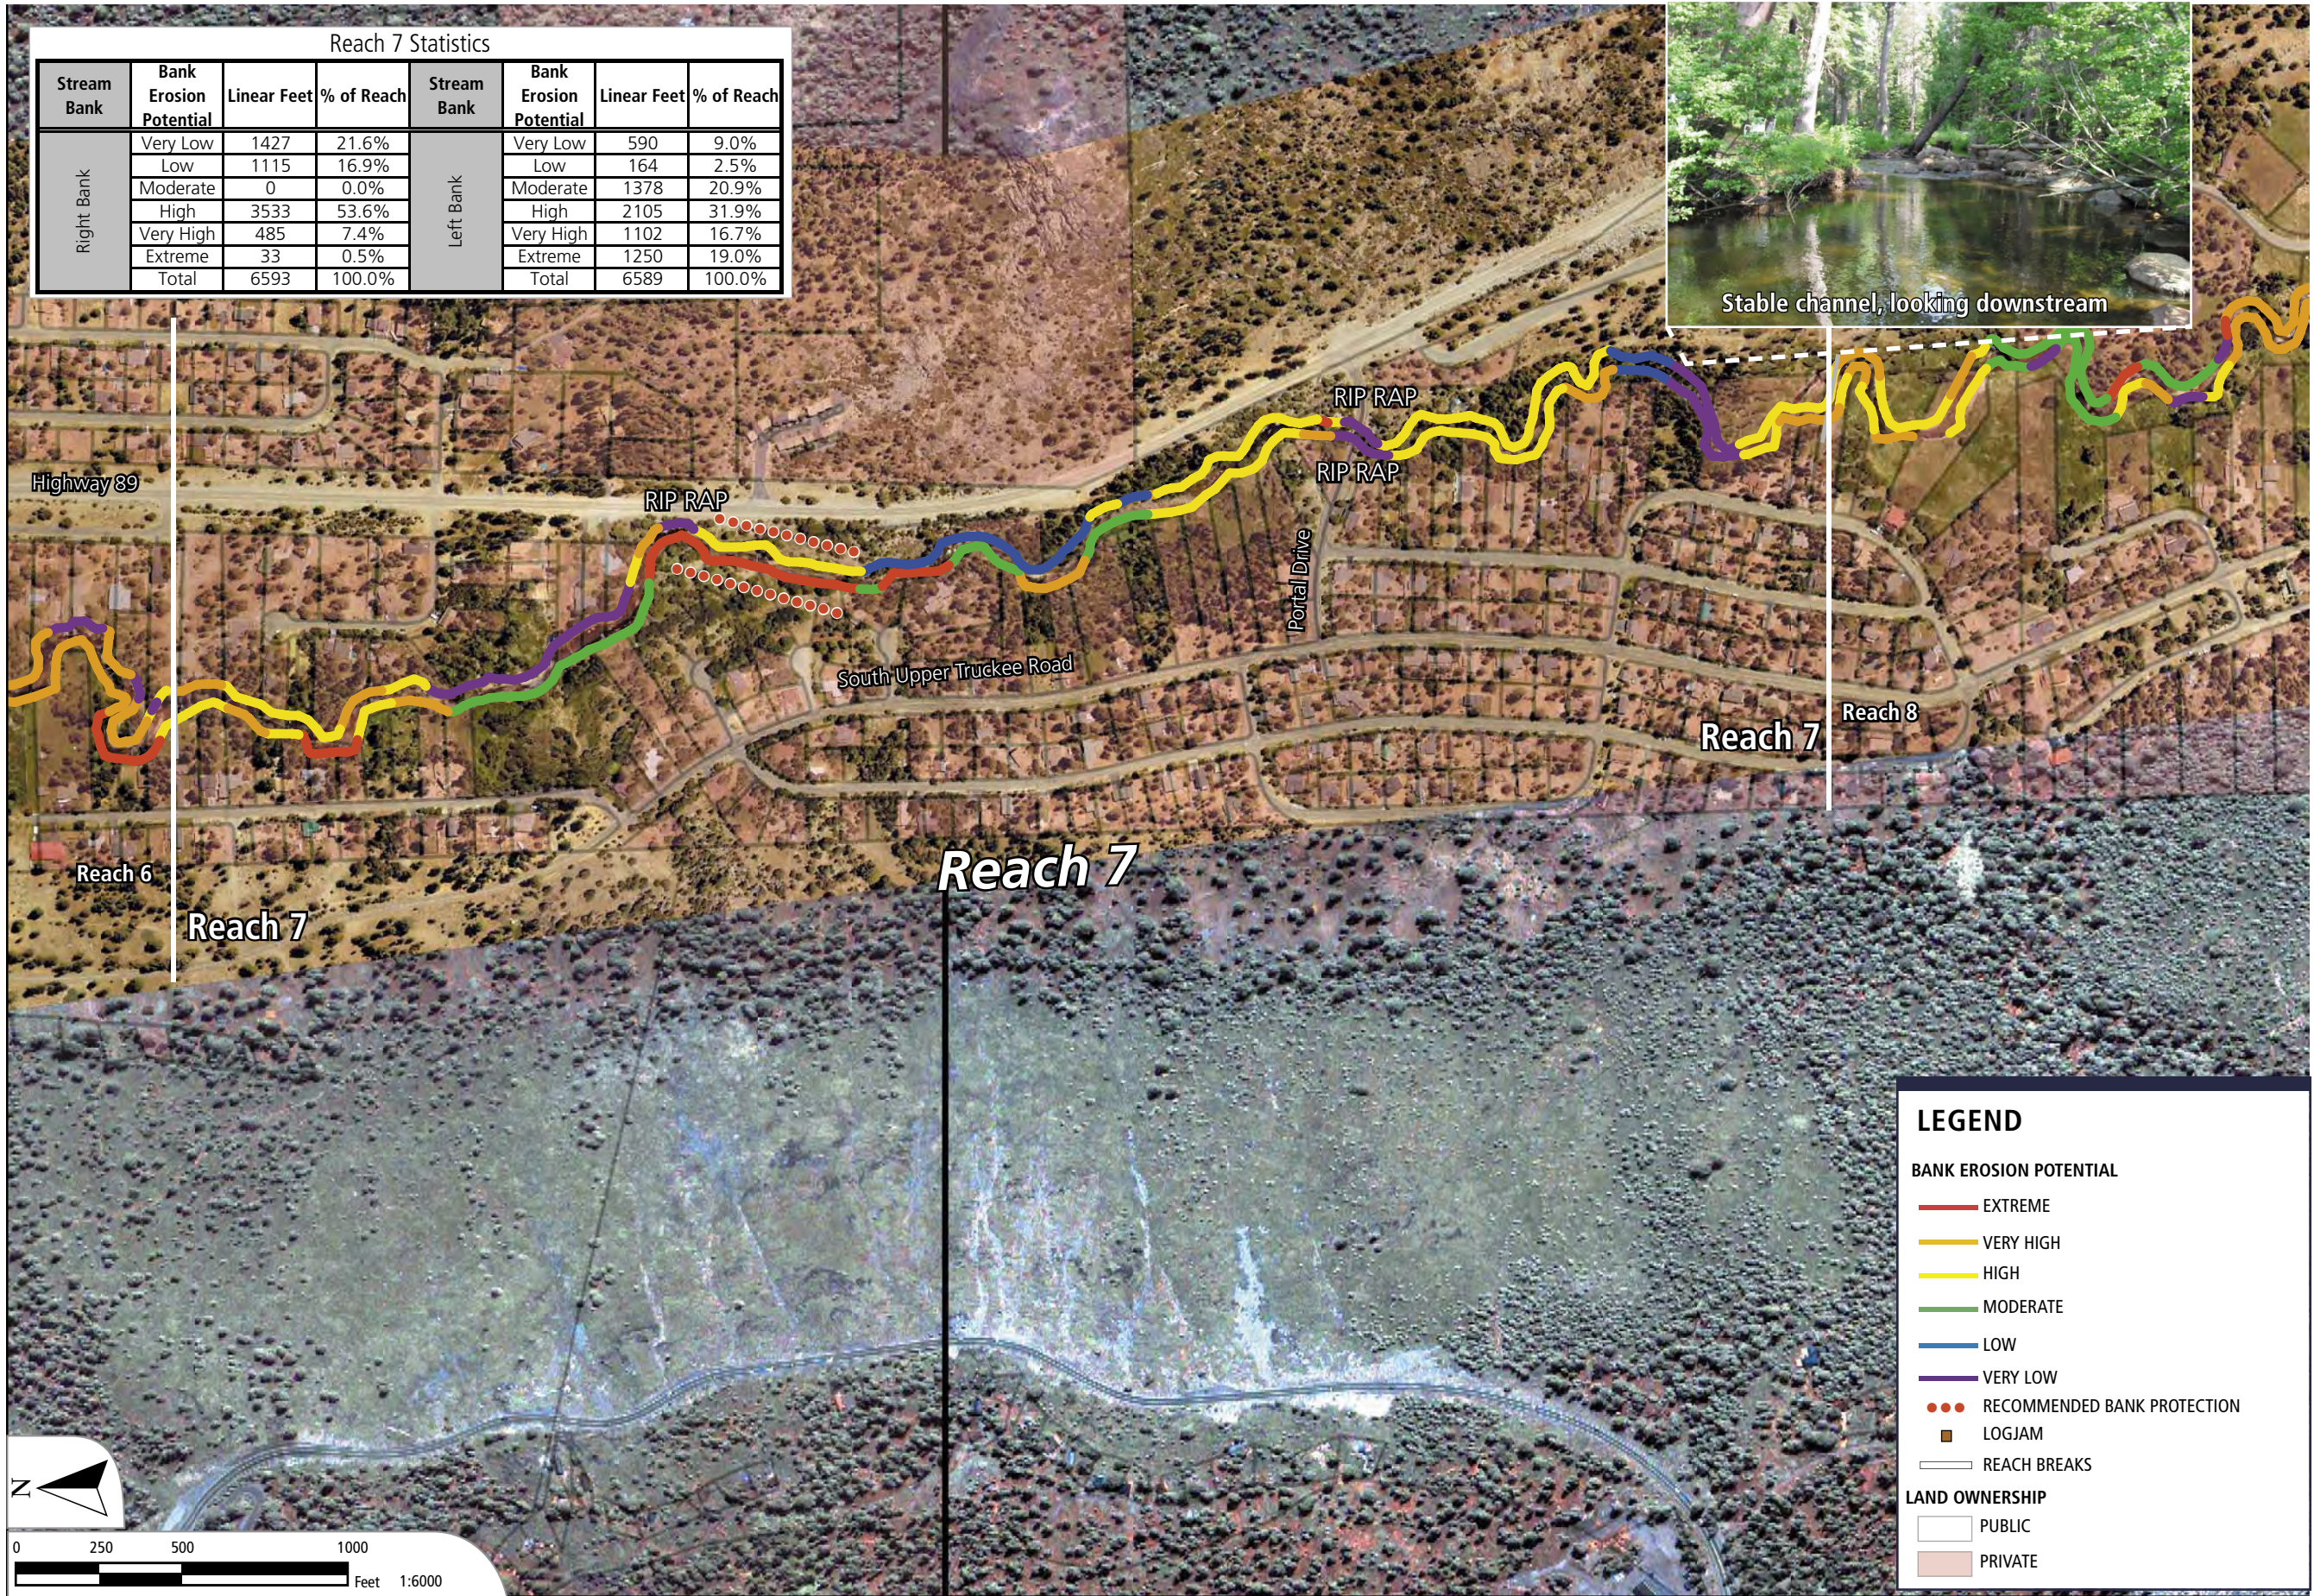
FIGURE 3.20E: Bank erosion potential ratings for Reach 7.
