FIGURE 3.13D: Map indicating location of sewer and water lines relative to the Upper Truckee River (Reaches 7-8).

FIGURE 3.14: Longitudinal profile of Upper Truckee River from Meyers Highway 50 crossing to the South Upper Truckee Road Bridge (Reaches 5-11). Profile and high terrace elevations were created using the 2003 LIDAR survey.

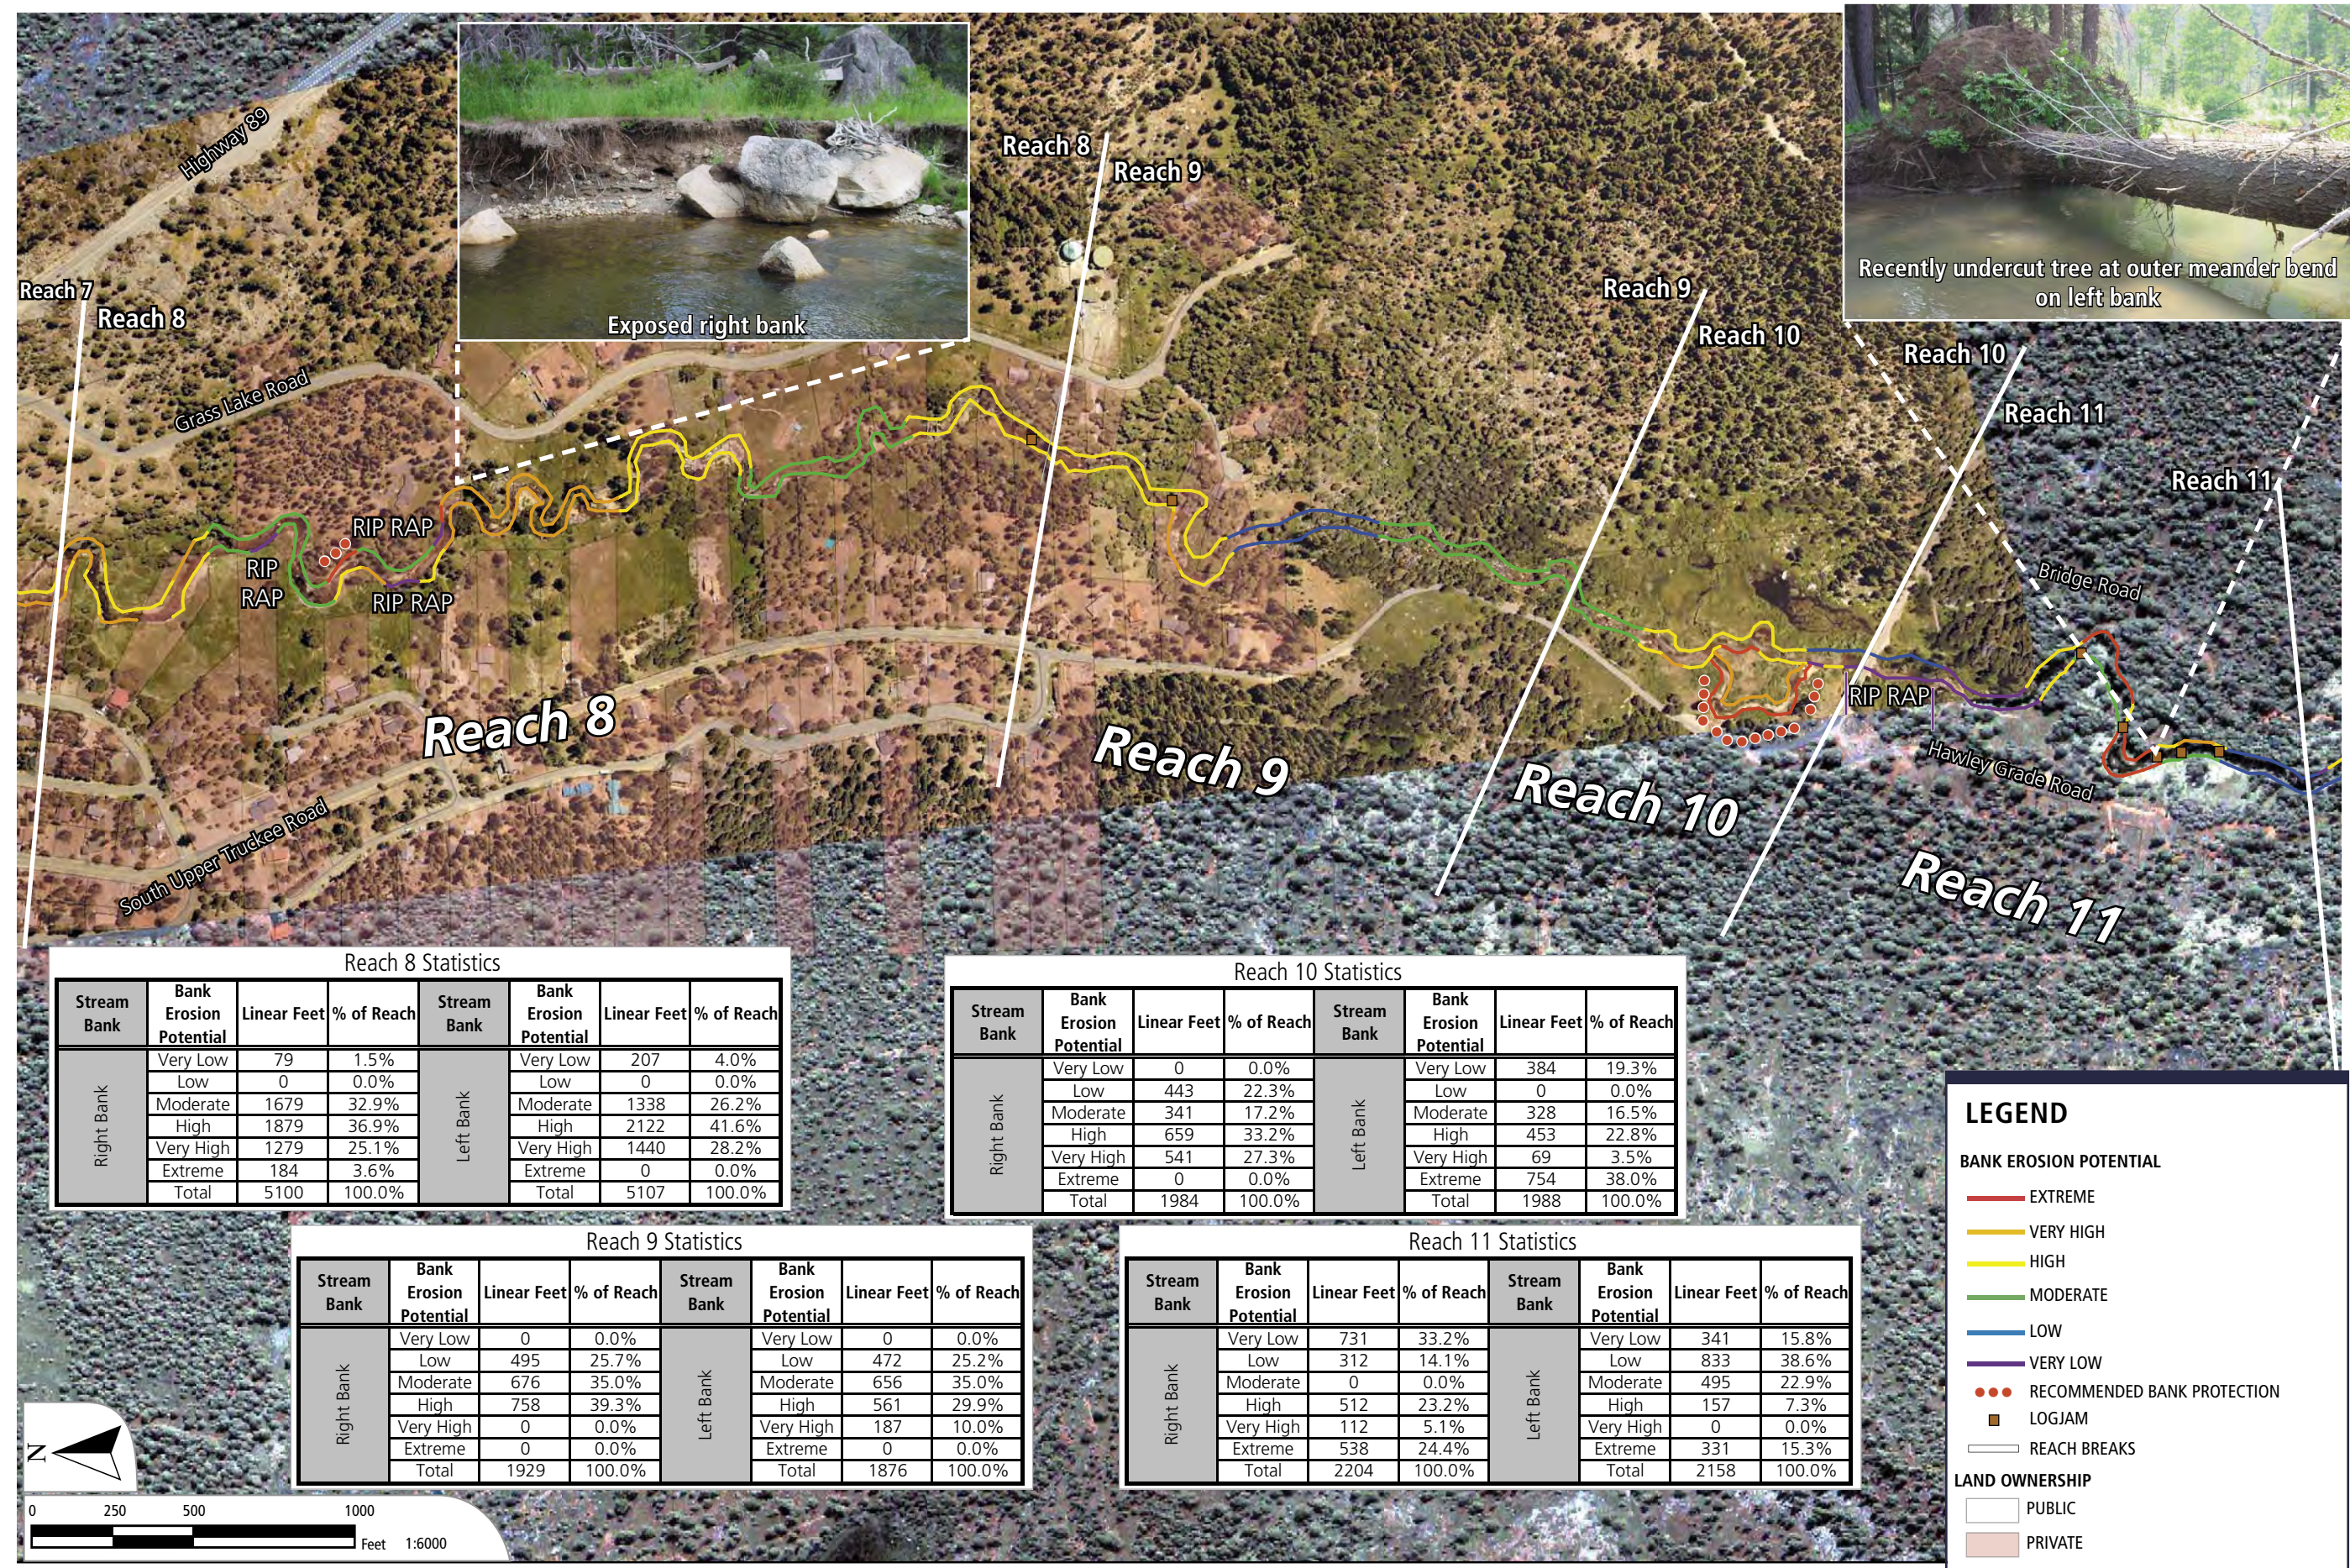
FIGURE 3.20F: Bank erosion potential ratings for Reaches 8, 9, 10, and 11.

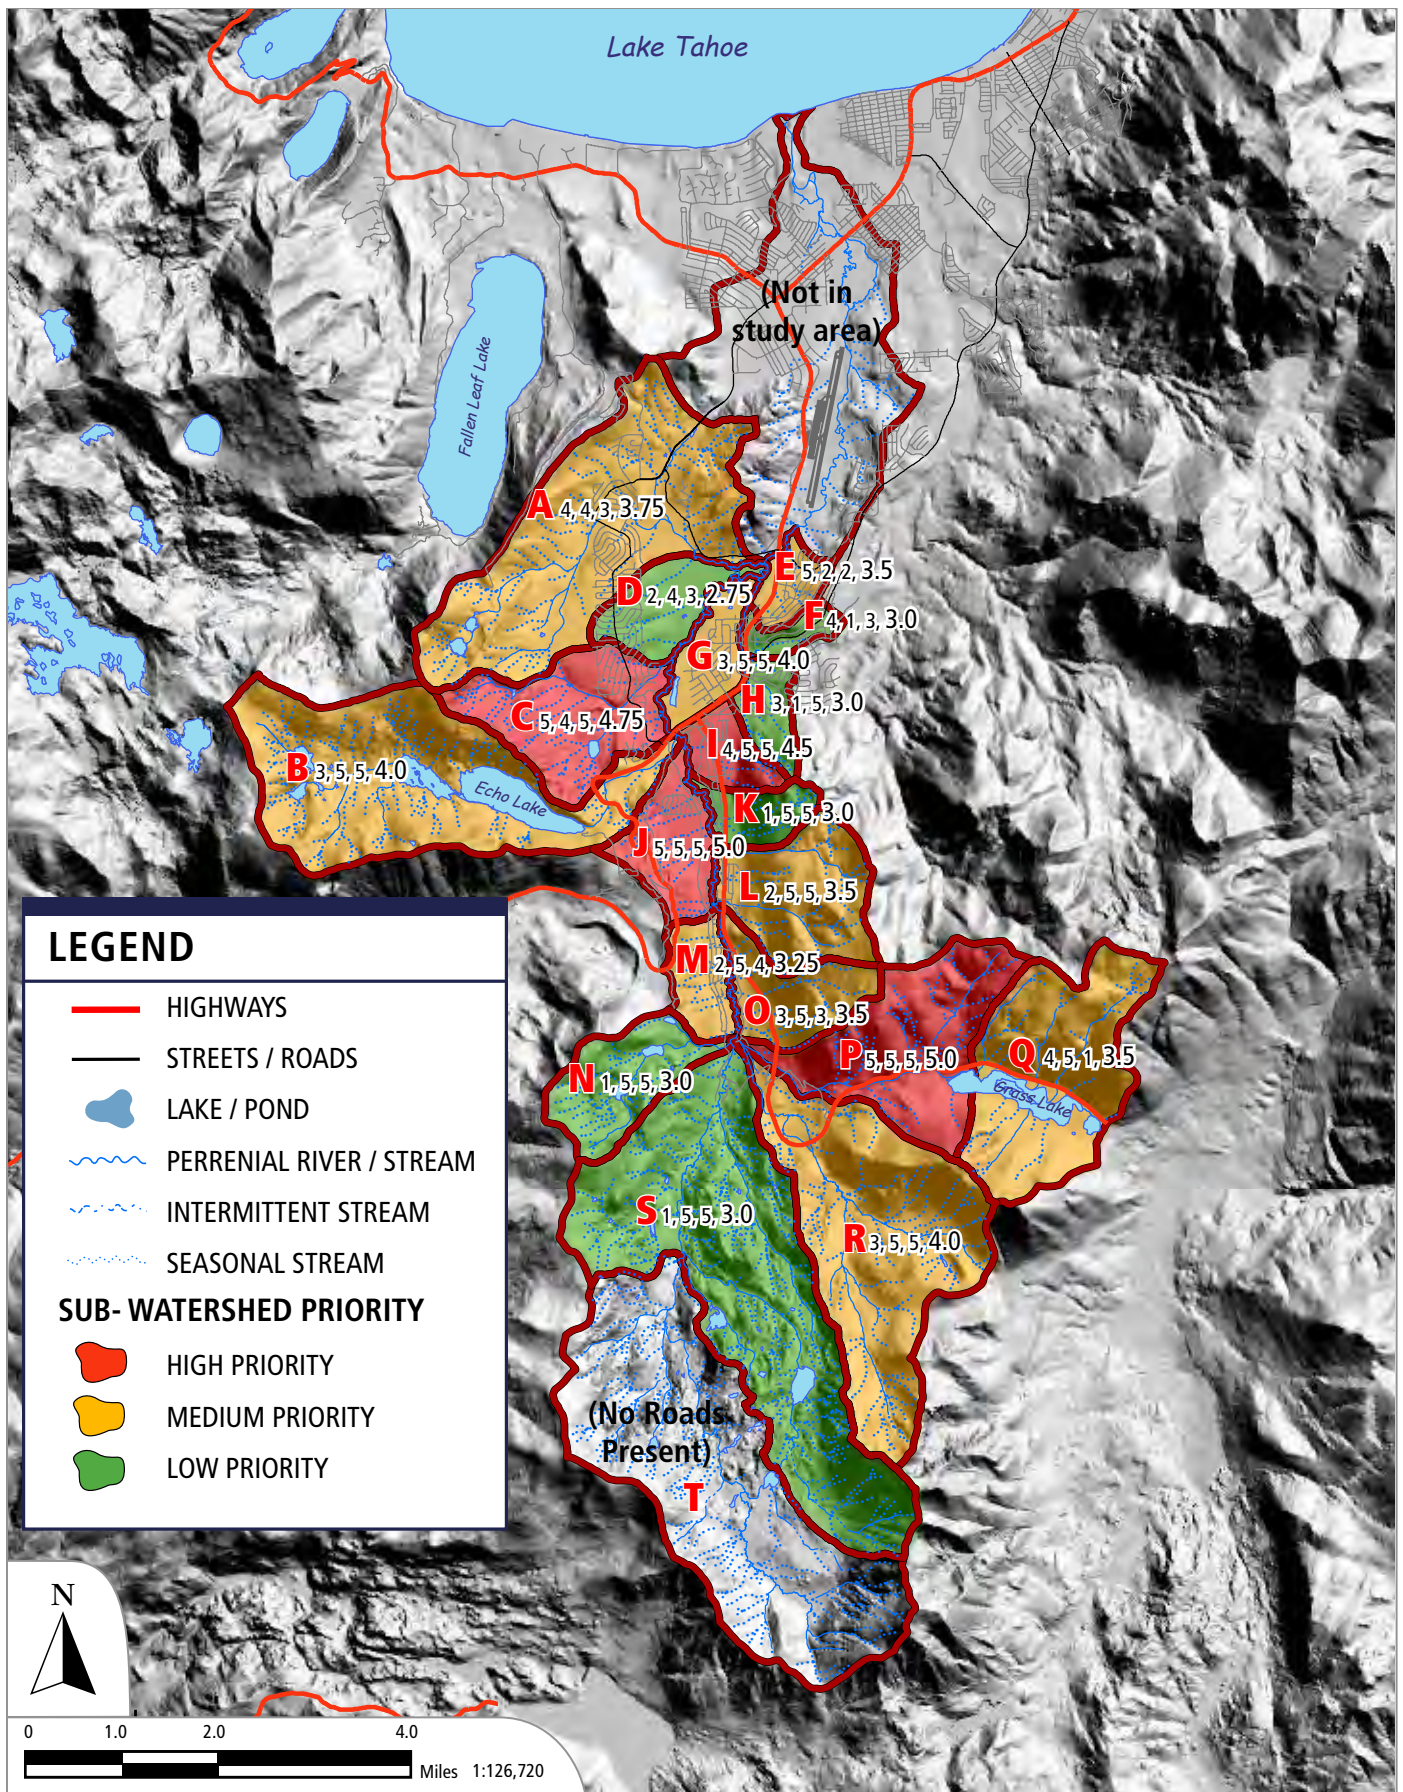
The assessment found that the erosion along Highway 89 (Luther Pass Road) is unusually high. There has been little BMP retrofit (scheduled by Caltrans for 2007/2008) on steep roadcuts of unconsolidated glacial deposits and the sediment discharges directly into Grass Lake and Big Meadow Creeks, which flow along the road corridor. The other high priority watersheds are situated in Meyers and lower Christmas Valley, where steep areas covered in subdivision roads are untreated.

FIGURE 3.23: Map indicating subwatershed priority based on cumulative ranking from the road and subwatershed survey. Numerical rankings are ordered as follows: Erosion Control Rank, Sediment Retention Rank, Connectivity Rank, Final Rank.

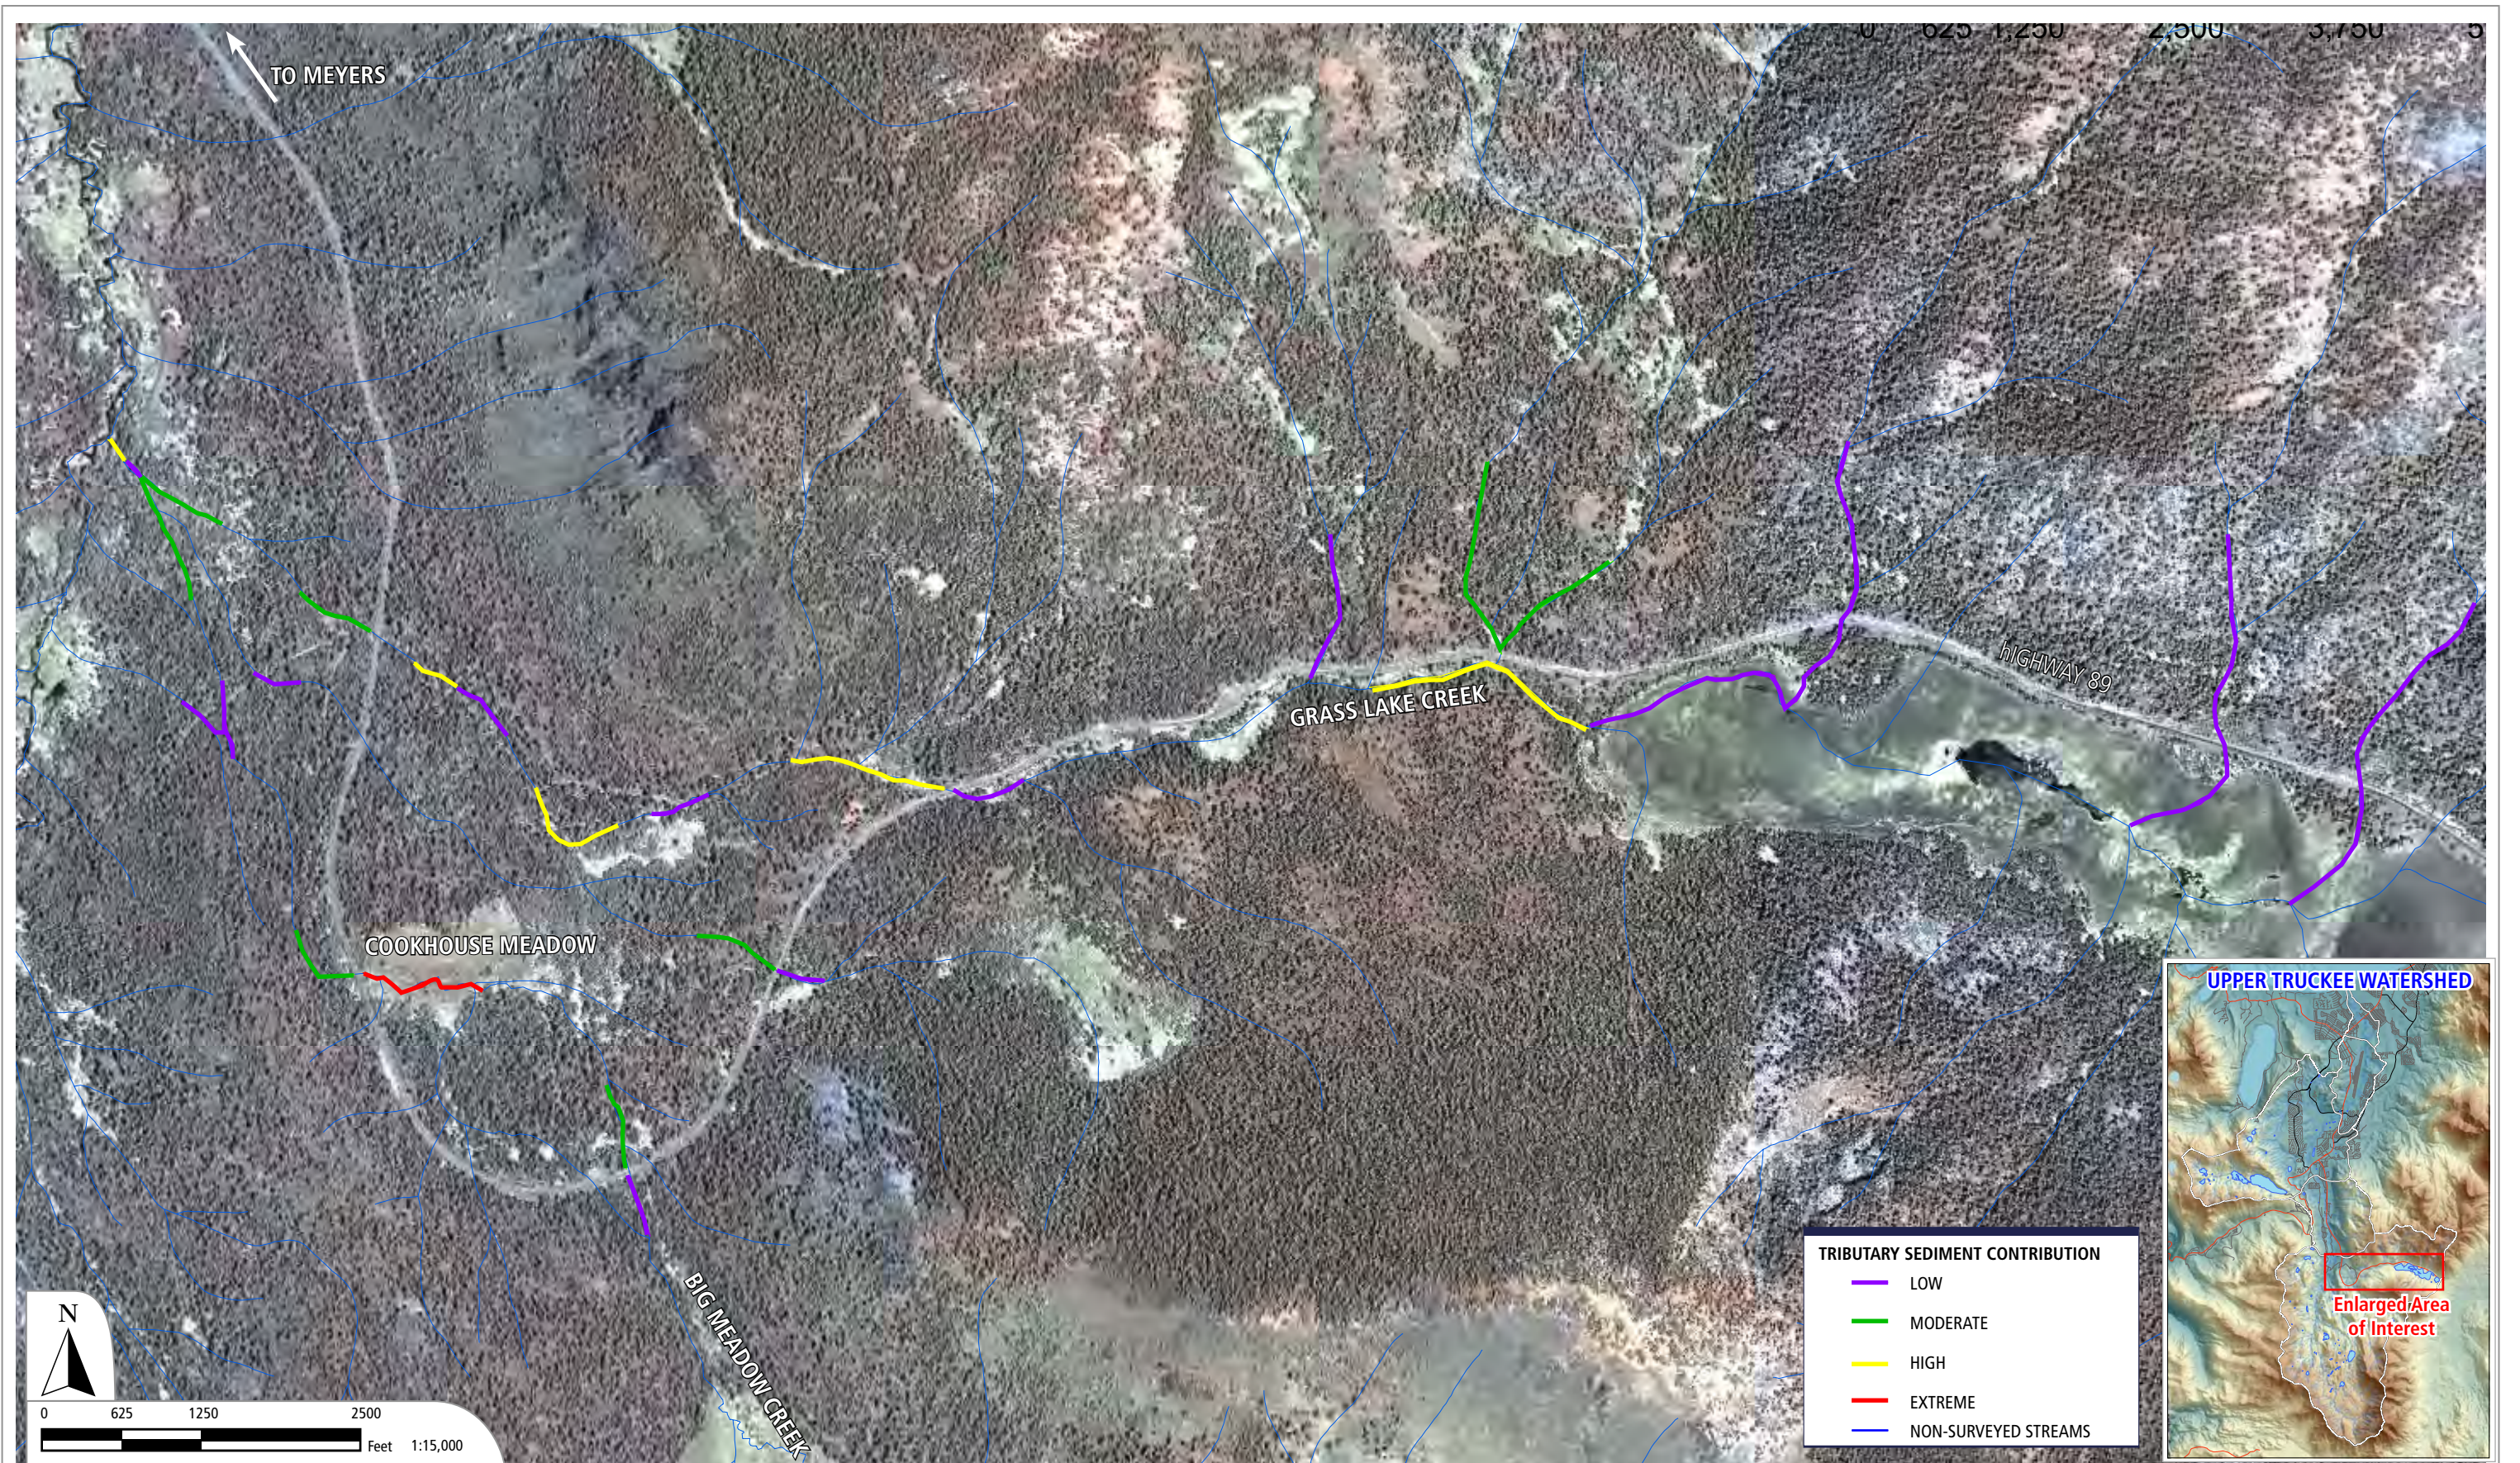
Erosion Survey for the mainstem of the Upper Truckee River. Survey results for the Big Meadow and Grass Lake Creek drainages are presented in Figure 3.24. The Unnamed Tributary was assessed via a detailed walk-through of the channel to identify impacts and potential restoration opportunities.

Morphologically, channels and banks within the Grass Lake and Big Meadow Creek drainages consist of resistant material derived from lateral moraine deposits that have been reworked by periodic channel migrations. Abundant large woody material, natural stable boulder weirs, and access to secondary or floodplain channels during high flow events provide relative stability and a capacity to store and attenuate transport of fine sediment that is delivered to the channel from disturbances within the watershed. Several “alluvial” reaches do occur within these drainages, namely Cookhouse Meadow on Big Meadow Creek and the lower gradient reach of Grass Lake Creek just downstream of Grass Lake.

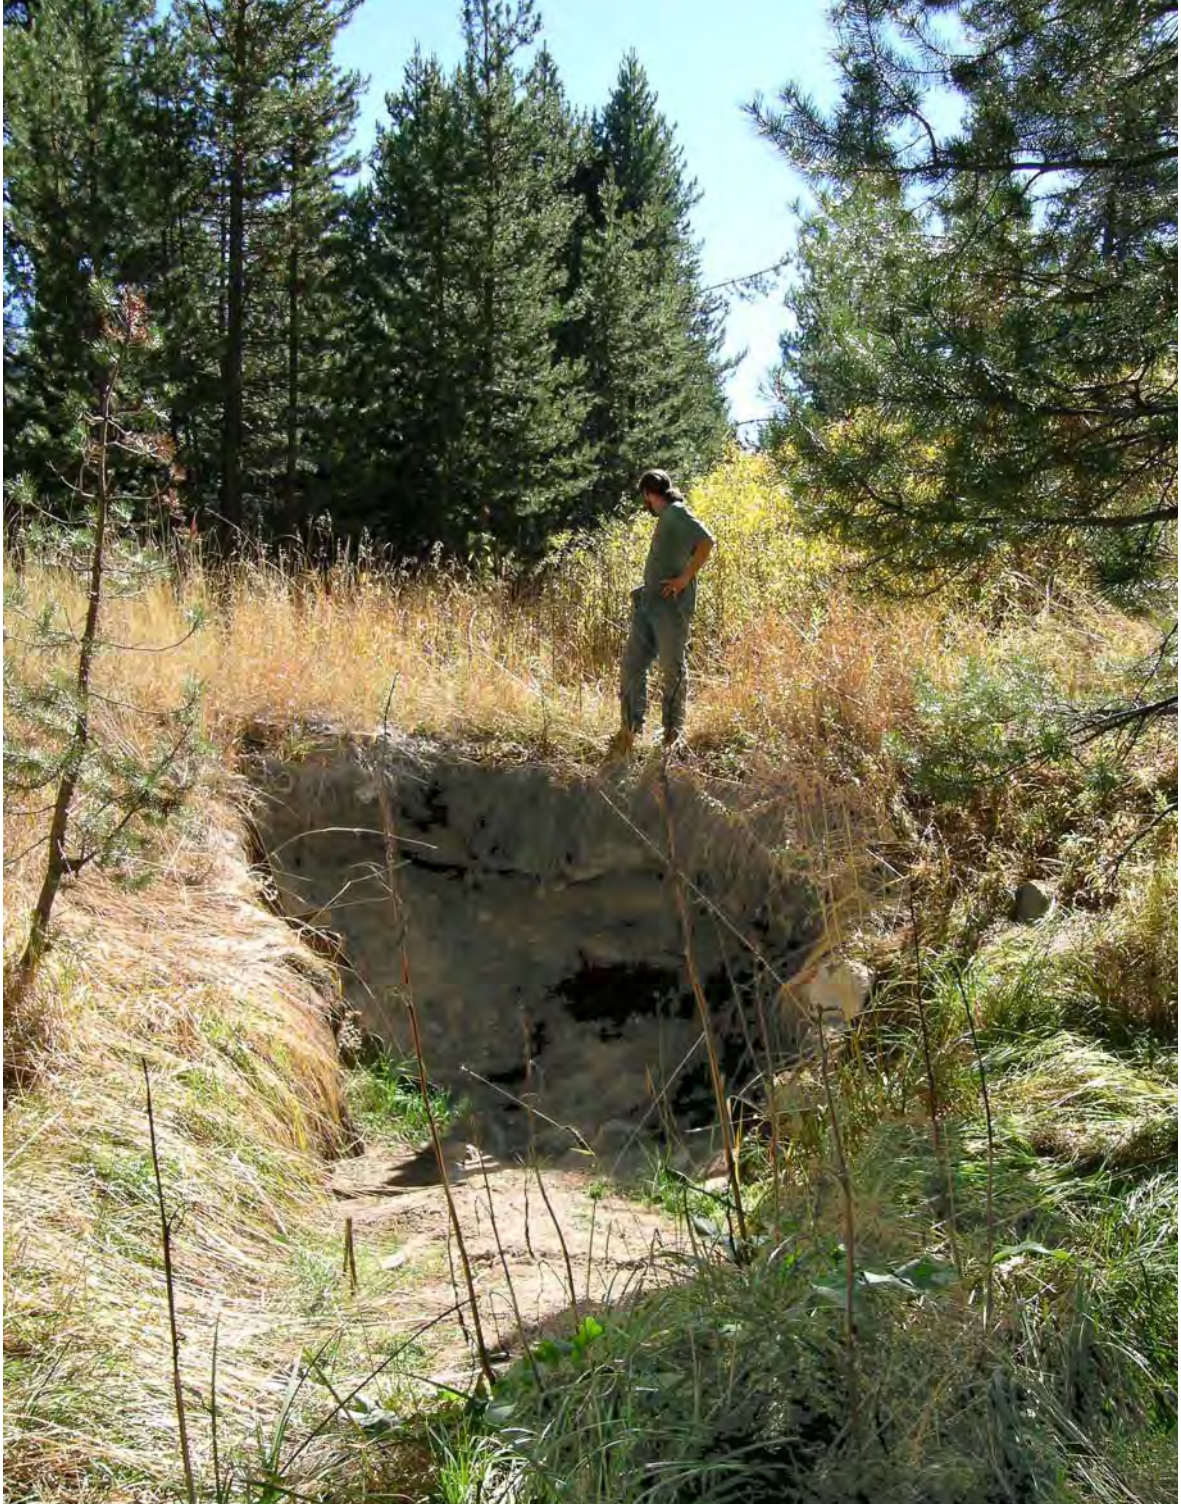
Downstream of the Santa Fe Road crossing, the tributary has been channelized away from a historic wet meadow between Arrowhead Drive and Highway 50. This channelization likely occurred to make room for development of a commercial area along Highway 50. A recent attempt has been made to divert flow out of the channelized section of creek and back into the meadow. To do this a berm was placed across the channel. Subsequent storm flows have overtopped the berm, resulting in a large scour hole downstream that may have initiated or exacerbated downcutting and channel widening within that reach (Figure 3.25). Given the absence of development on the historic wet meadow, there may be an opportunity to restore this feature, providing flow attenuation for downstream residents and water quality treatment for the Paradise Golf Course and adjacent neighborhoods. This and other restoration opportunities are discussed in great detail in Chapter 5.

FIGURE 3.25: Photo of the unnamed tributary near Meyers downstream of the Santa Fe Road crossing. A berm was placed across the channel to divert flow from the channelized creek back to the adjacent floodplain. Subsequent flows have overtopped the berm, creating the large scour hole shown in the photo above.
