# SWANSON HYDROLOGY + GEOMORPHOLOGY

draft final report

## Upper Truckee River Upper Reach Environmental Assessment

for the Bureau of Reclamation, Tahoe Resource Conservation District, and  
Regional Water Quality Control Board - Lahontan Region

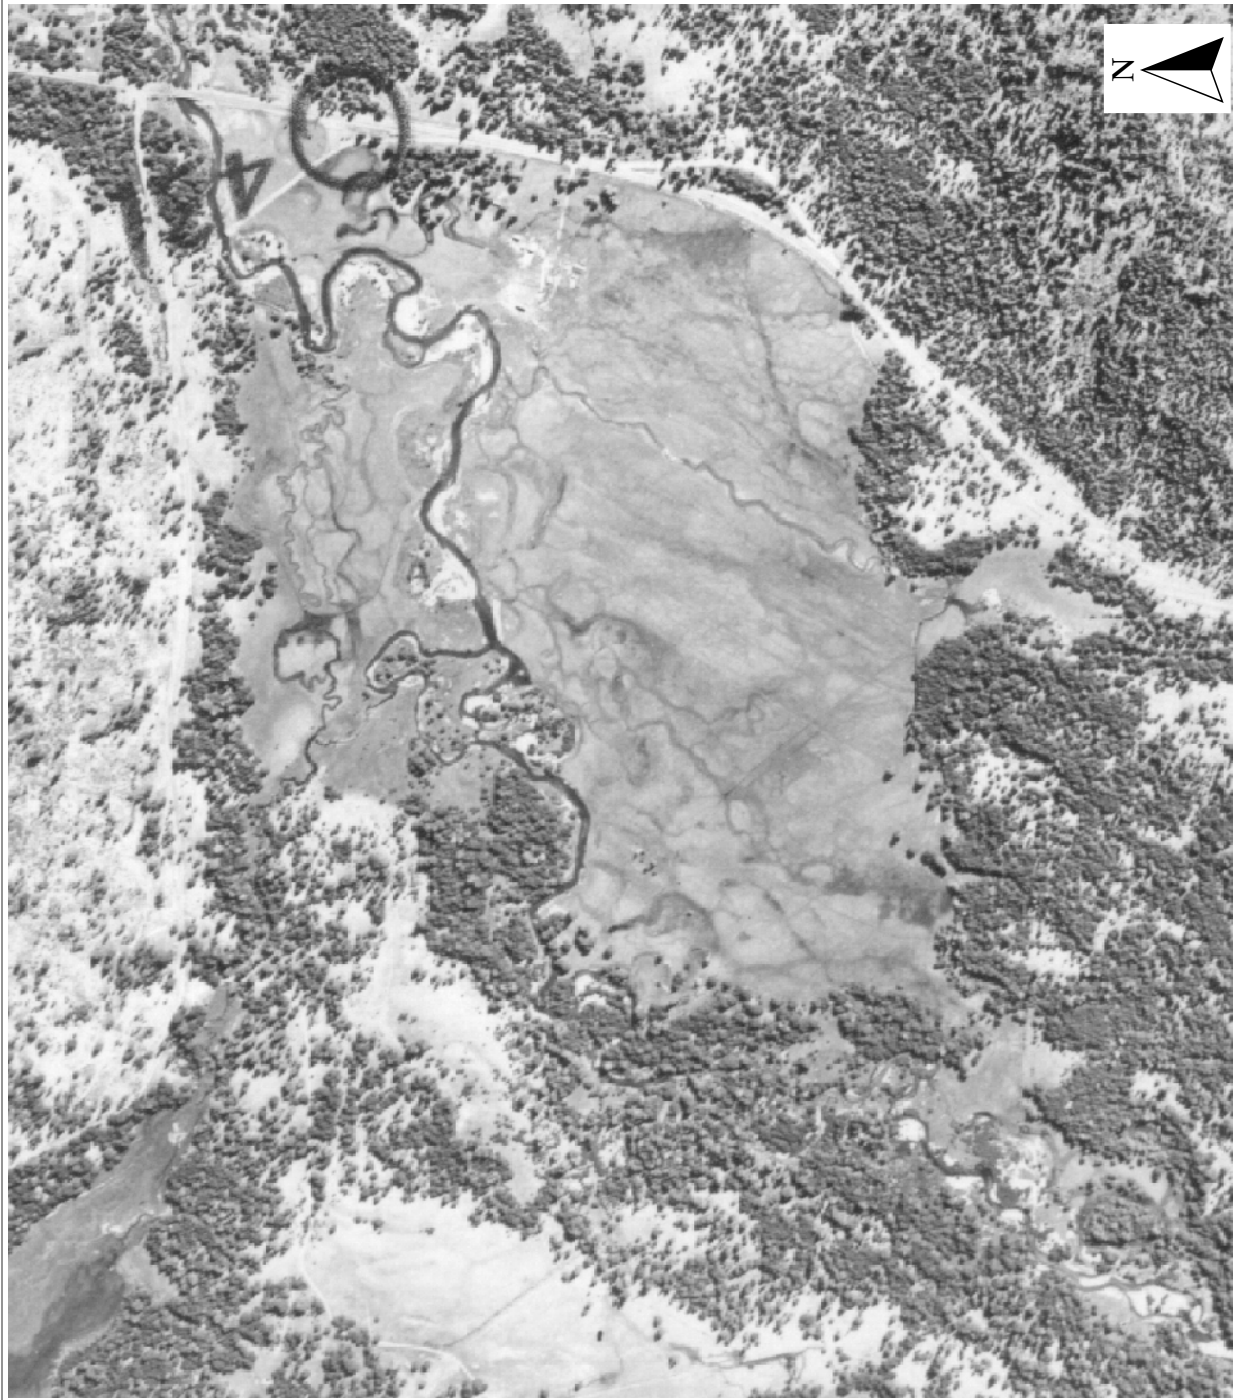
**FIGURE 2.8:** Aerial photograph taken in 1952 of Upper Truckee River upstream of the Elk's Club Highway 50 crossing (Reaches 1-3).
