FIGURE 3.13D: Map indicating location of sewer and water lines relative to the Upper Truckee River (Reaches 7-8).

FIGURE 3.14: Longitudinal profile of Upper Truckee River from Meyers Highway 50 crossing to the South Upper Truckee Road Bridge (Reaches 5-11). Profile and high terrace elevations were created using the 2003 LIDAR survey.

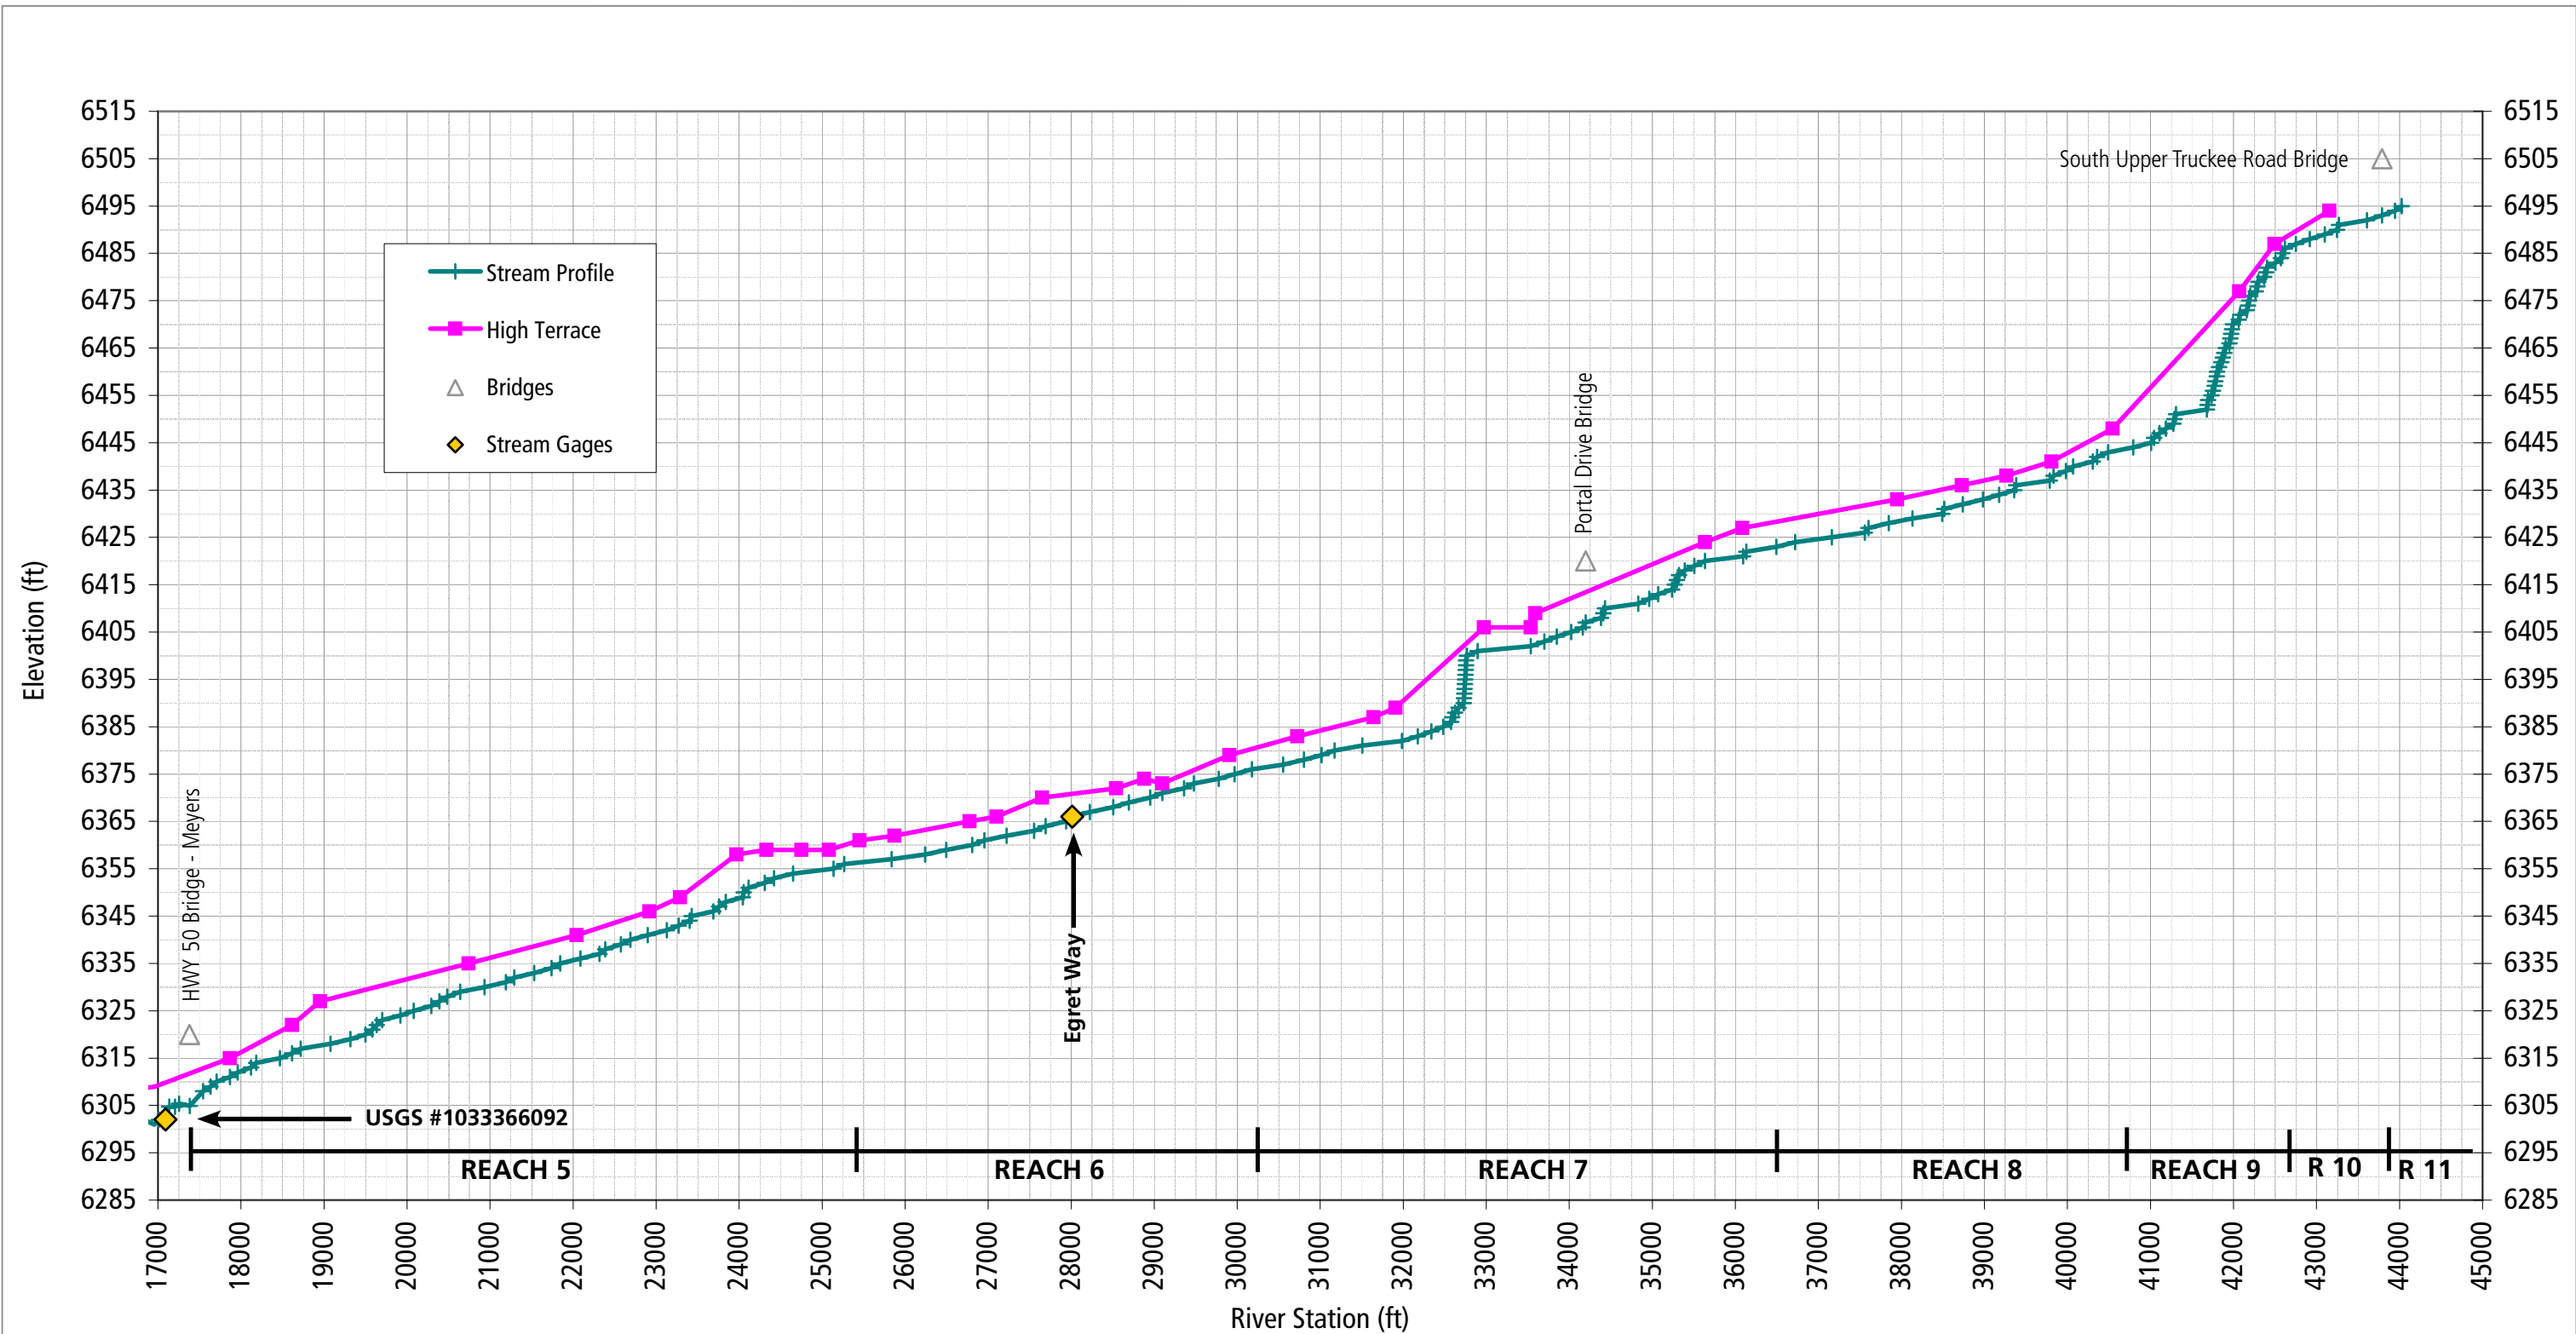
the profile. The Christmas Valley profile reveals several significant steep bedrock or boulder control reaches separated by several reaches of flatter meadow sections.

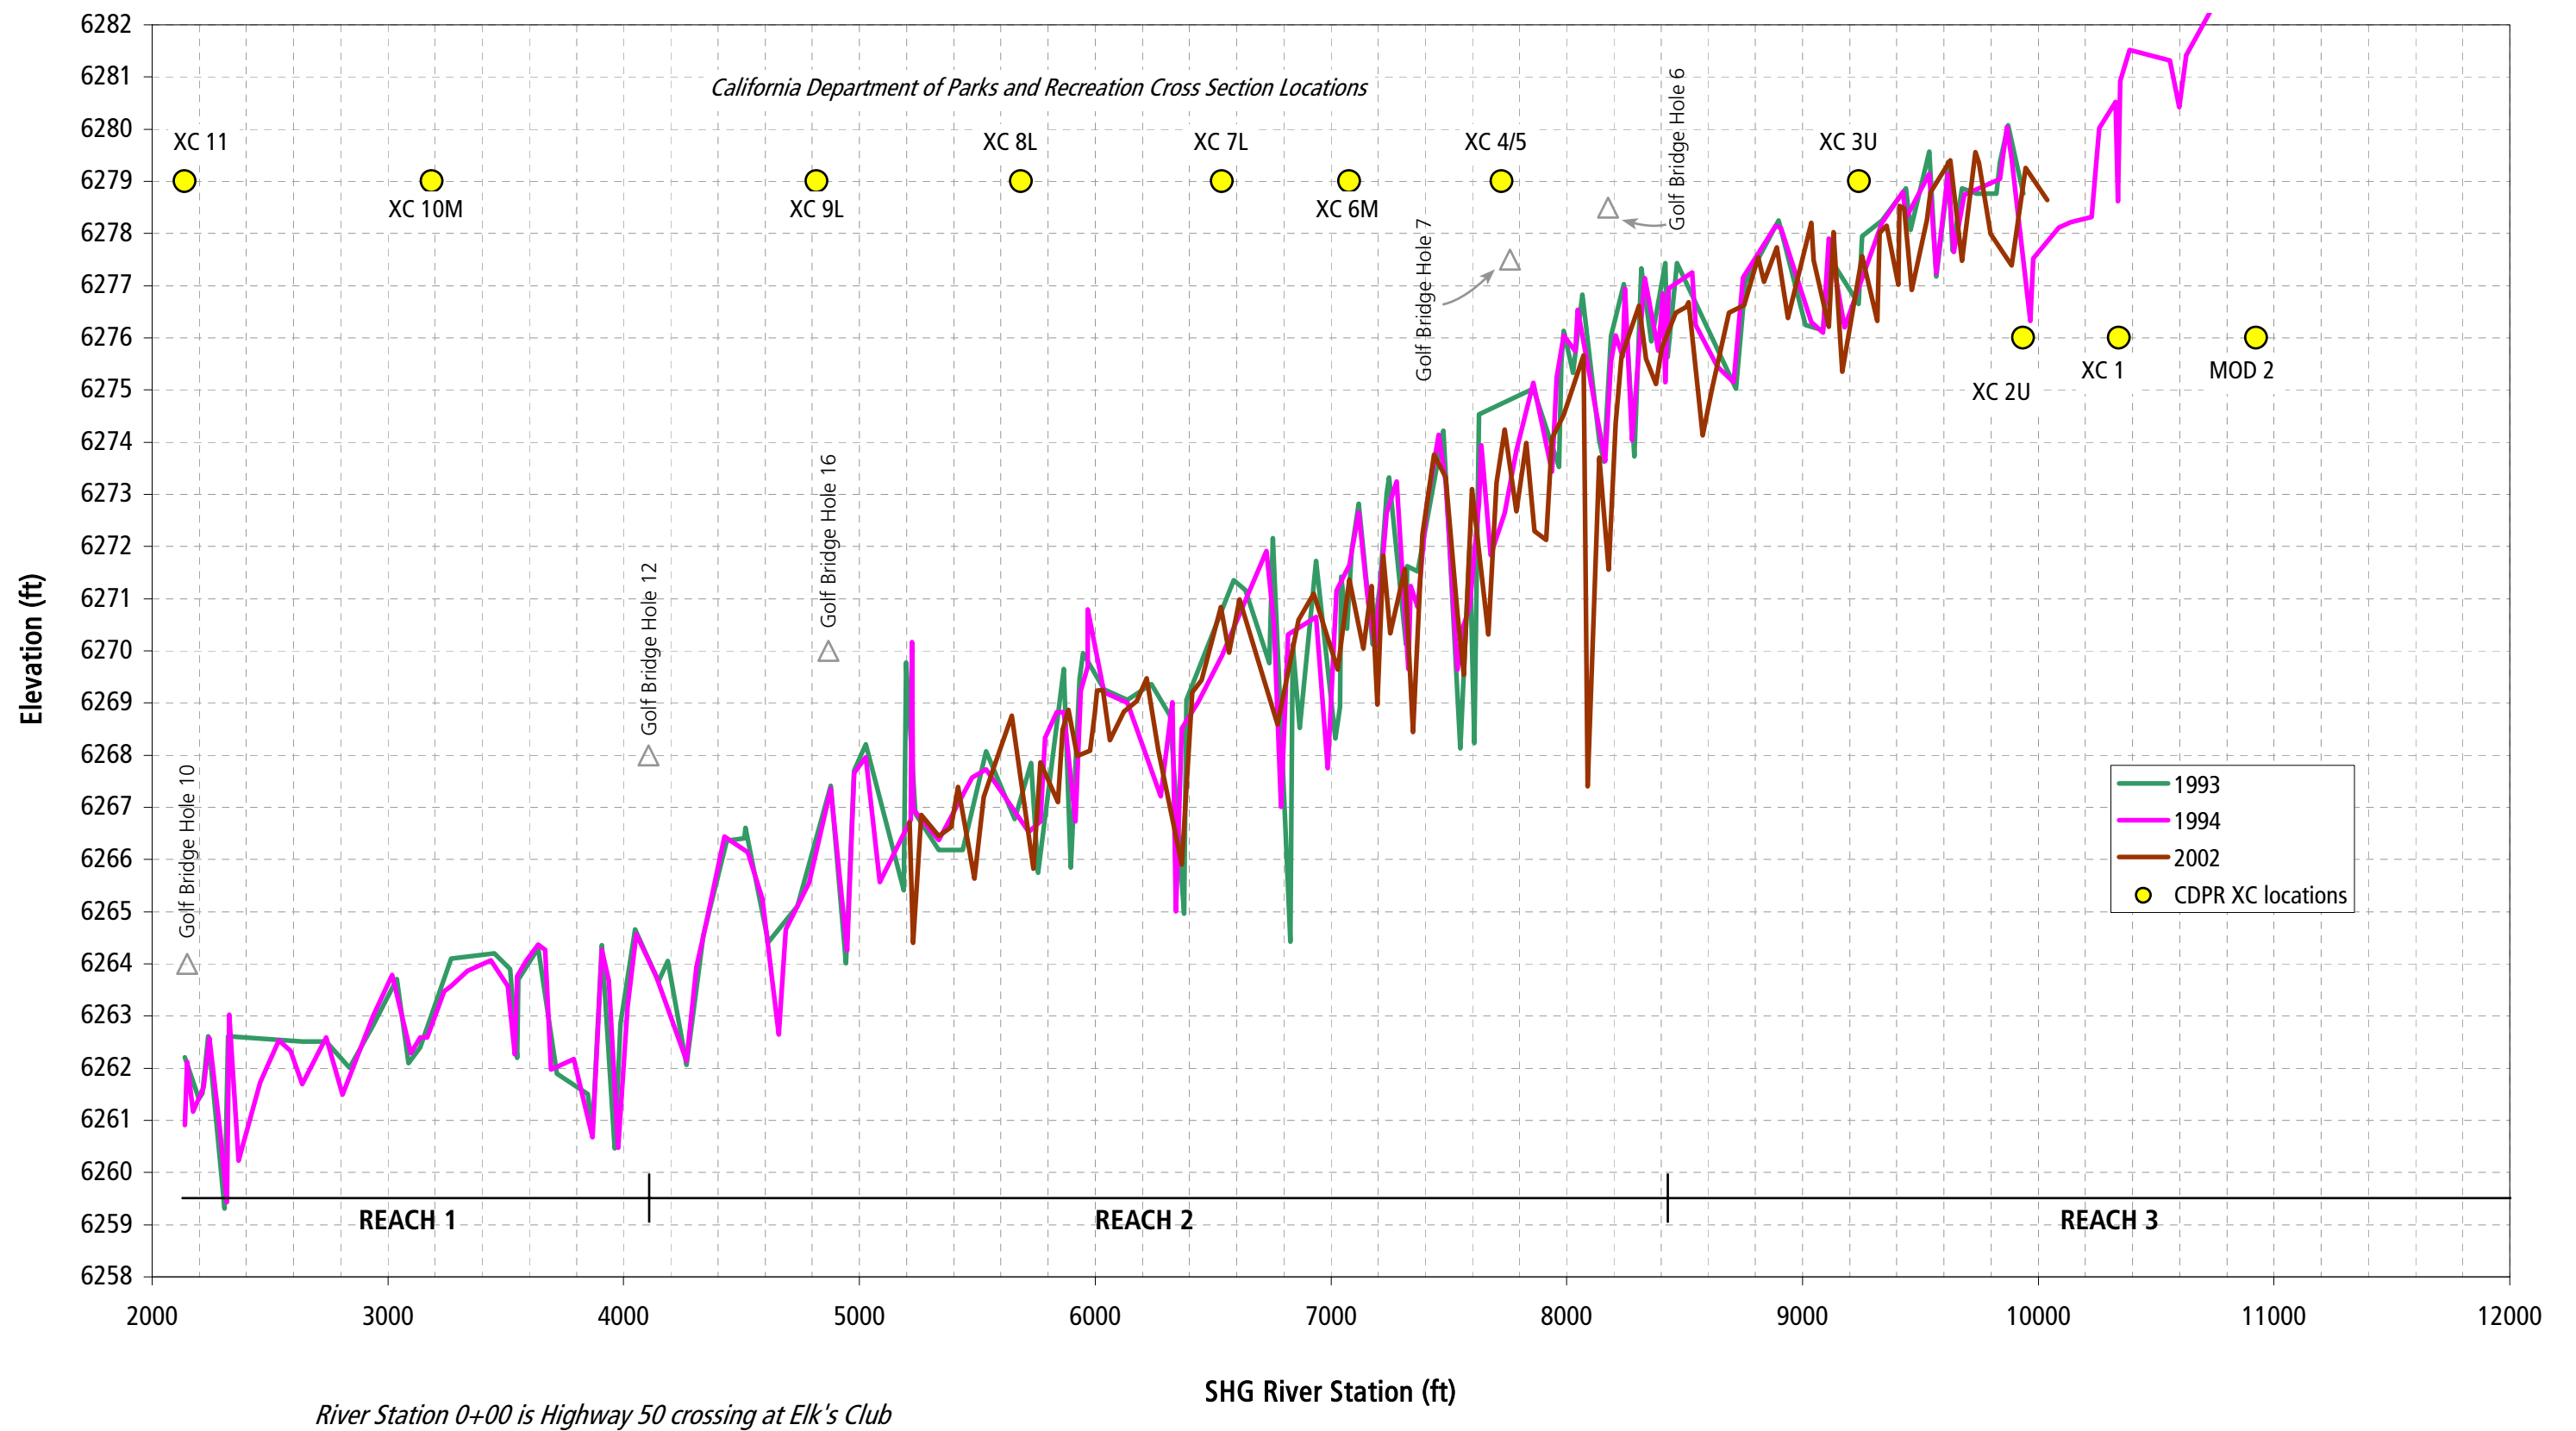
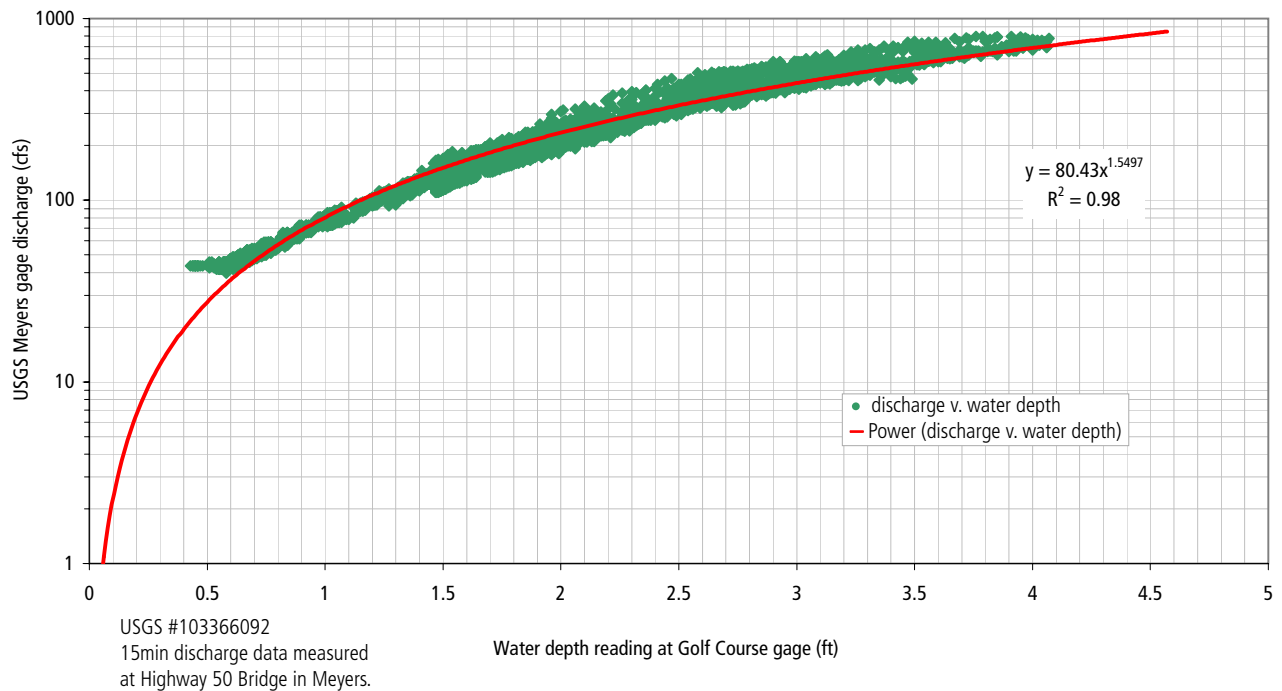
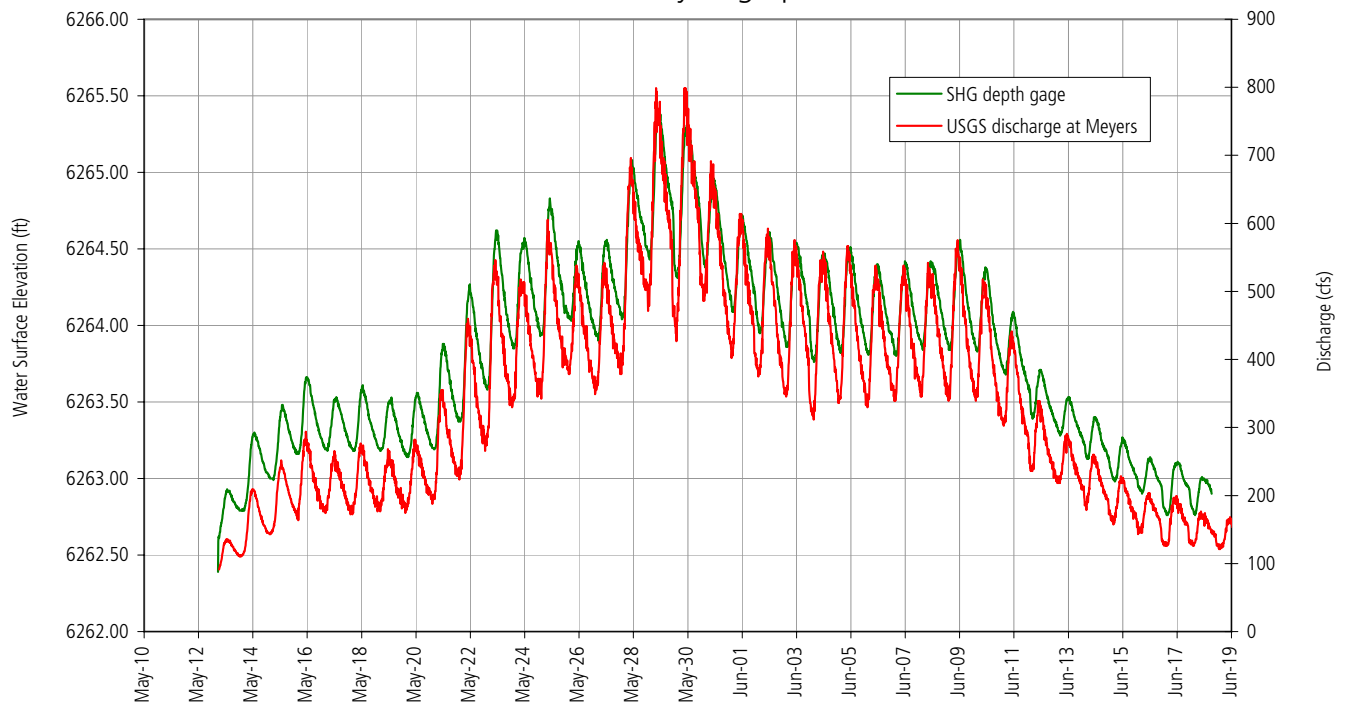
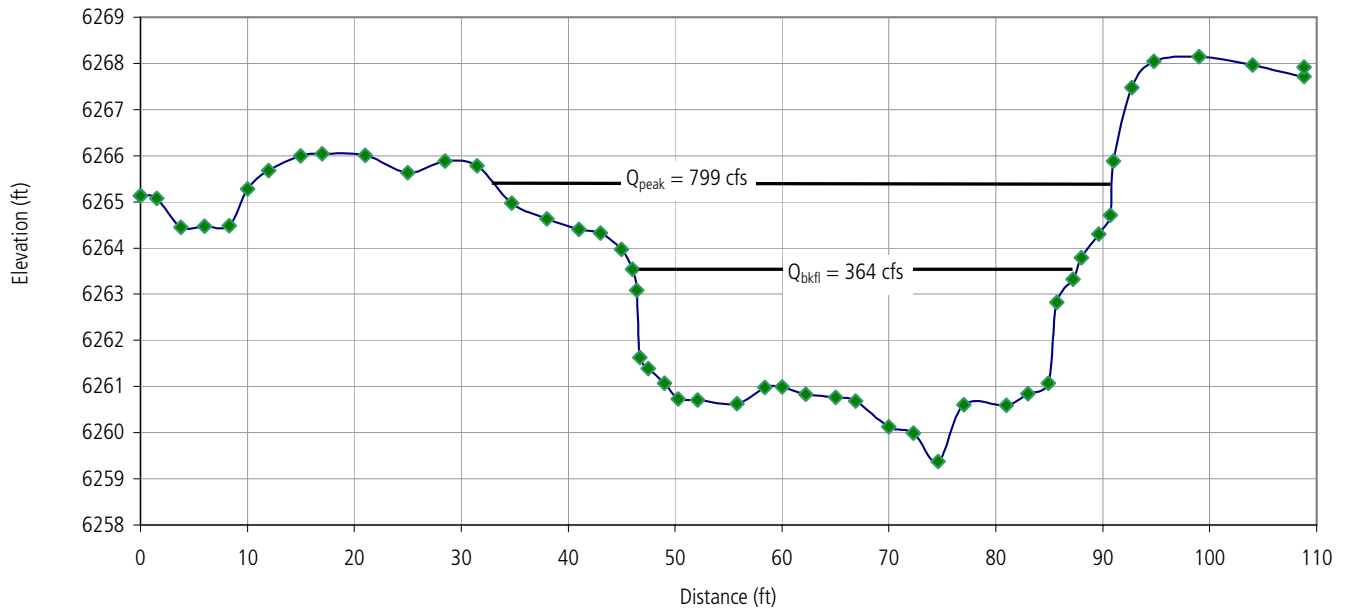
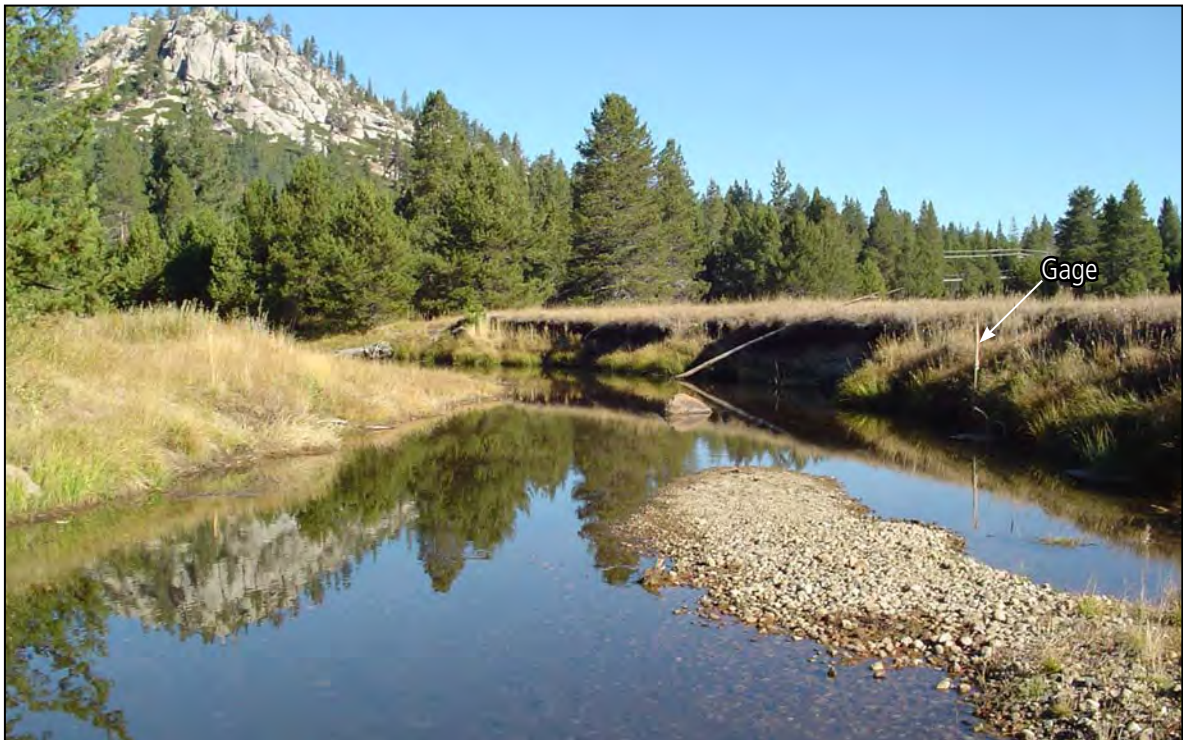
As the cross-sections illustrate, the clearest bankfull indicators of recent geomorphic floodplain formation occur in the narrow zone of the incised channel between 350 and 400 cfs. This bankfull flow agrees with the partial duration flood frequency analysis of 1.5-year flow at the USGS gage in Meyers (Table 3.2), as well as with past measurements and estimates of bankfull flow in the UTR (Table 3.3), which also correspond to the 1.5-year peak flow for snowmelt events (Swanson, 2003; Hanes and Swanson 1997; 1995). Based upon the spring 2003 stage measurements and channel geometry, the estimated channel flood capacity at these three sites is on the order of 600 to 800 cfs.

FIGURE 3.16B: Channel cross-section surveyed at location of SH+G Golf Course gage by California State Parks in September, 2003. Key channel features were identified in the field and associated discharge was calculated using depth gage data.

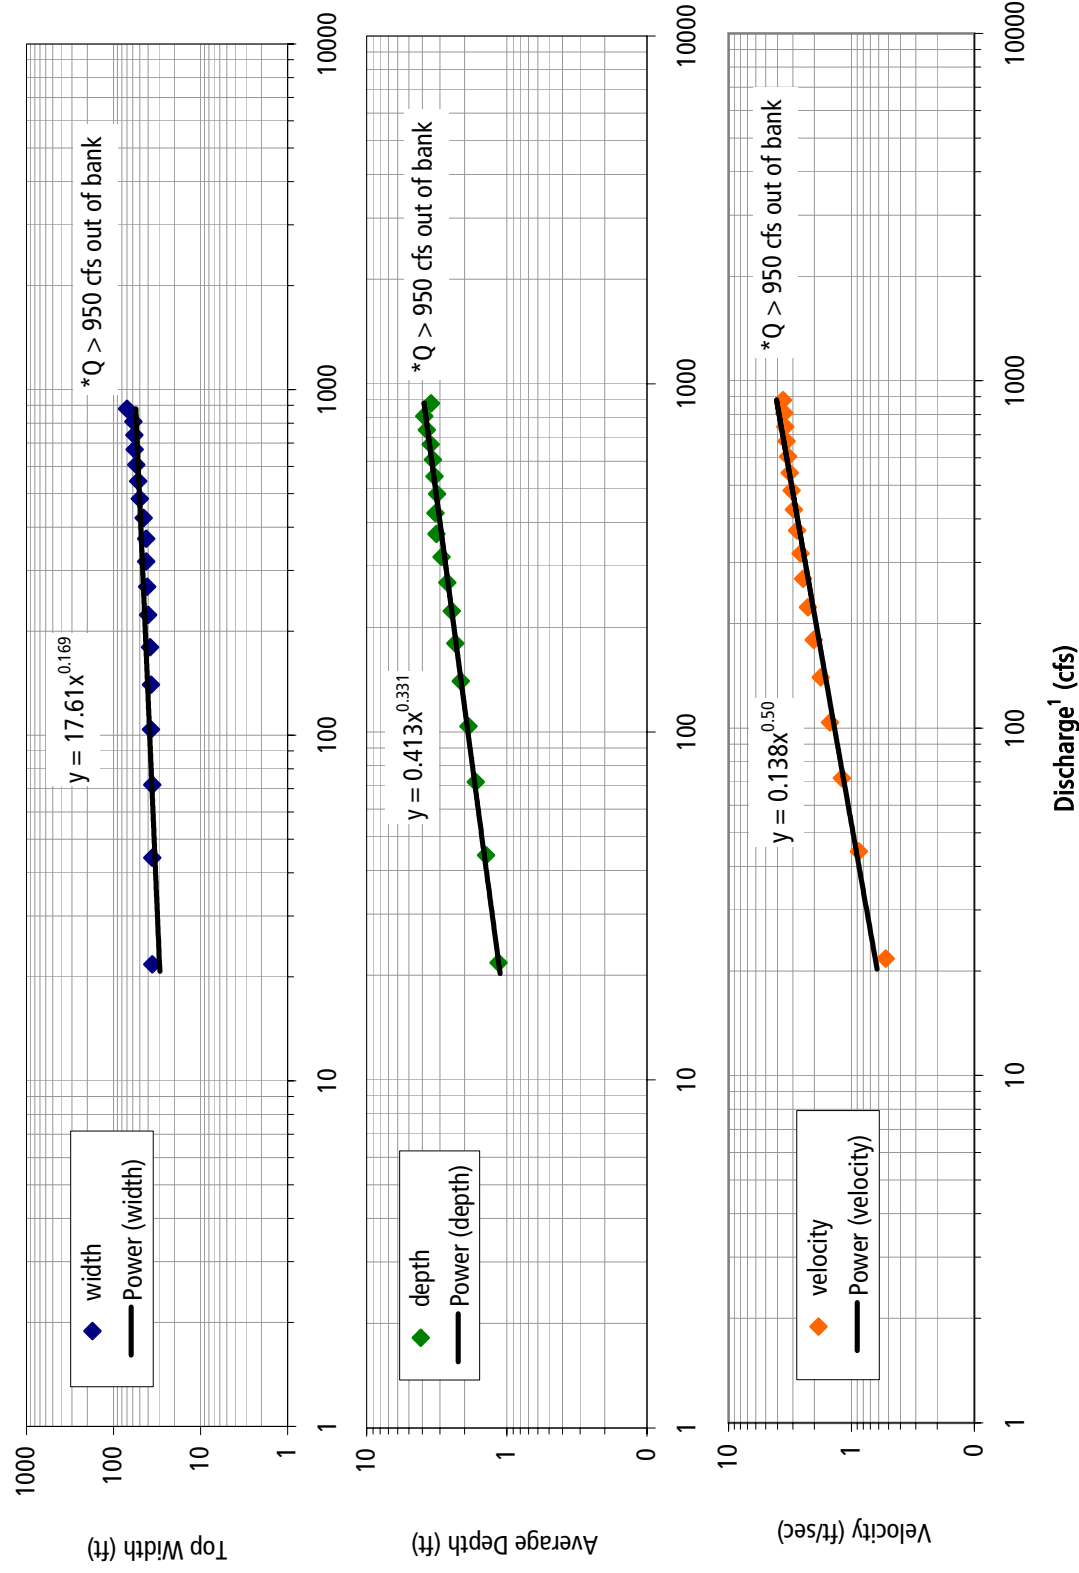
FIGURE 3.16C: Channel geometry calculated for Upper Truckee River at SH+G Golf Course Gage.

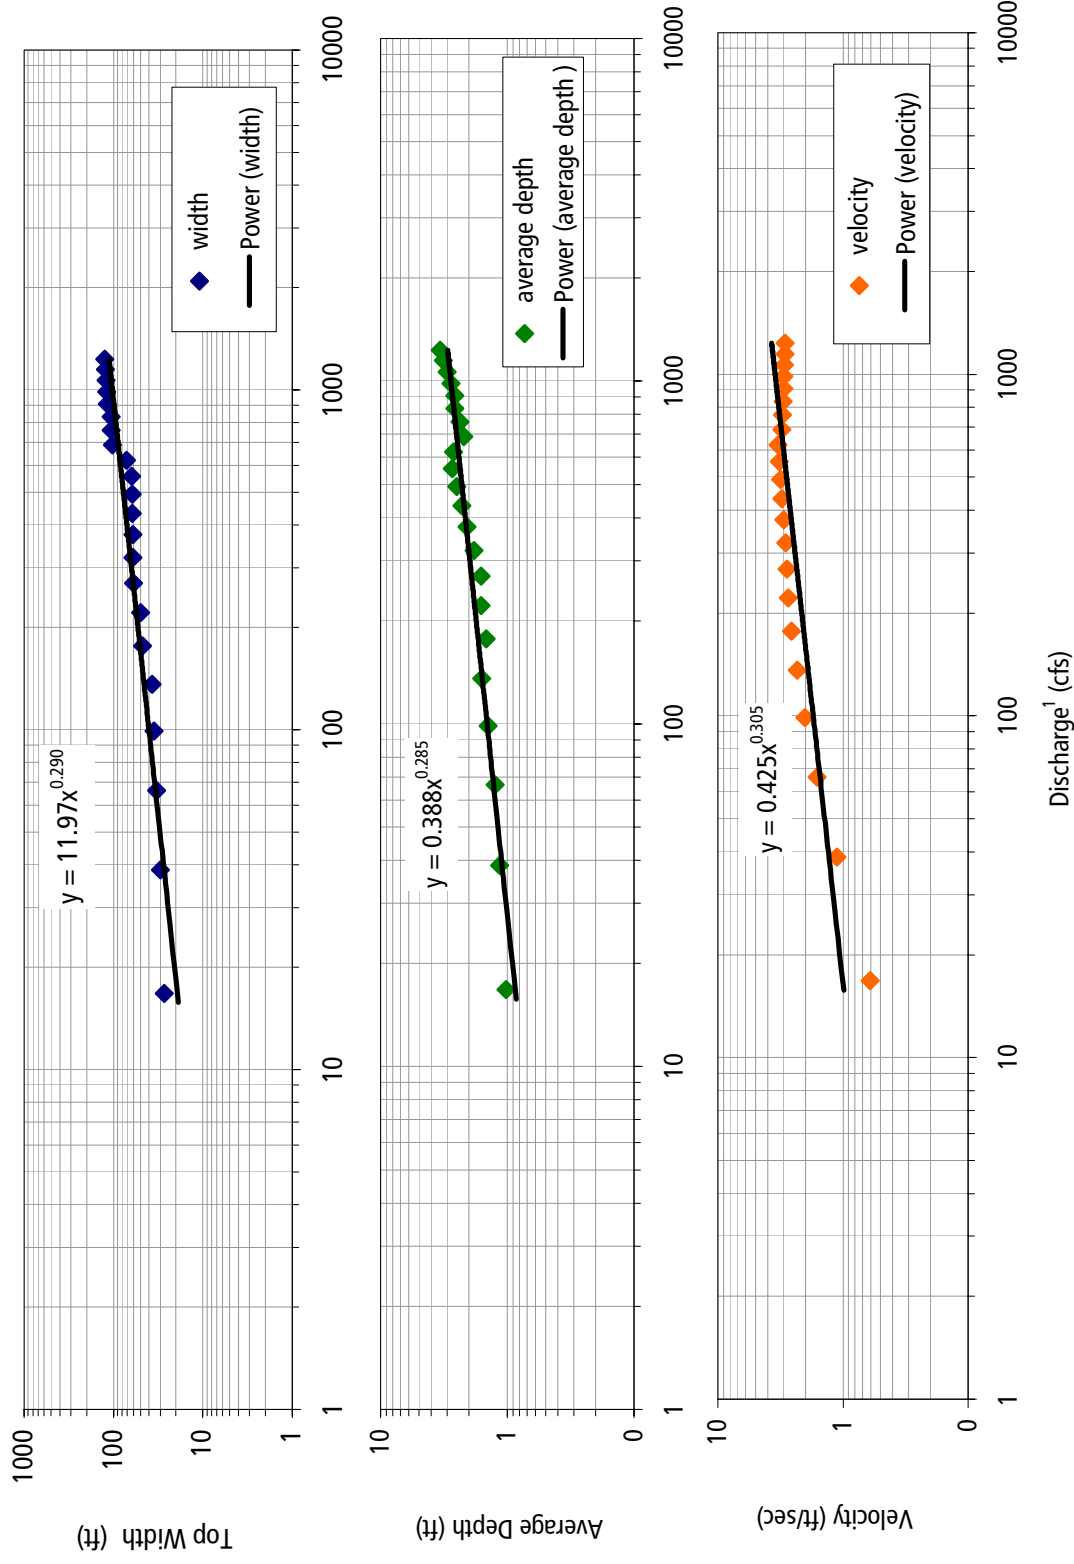
FIGURE 3.17C: Channel geometry calculated for Upper Truckee River at SH+G Hole 6 Gage.

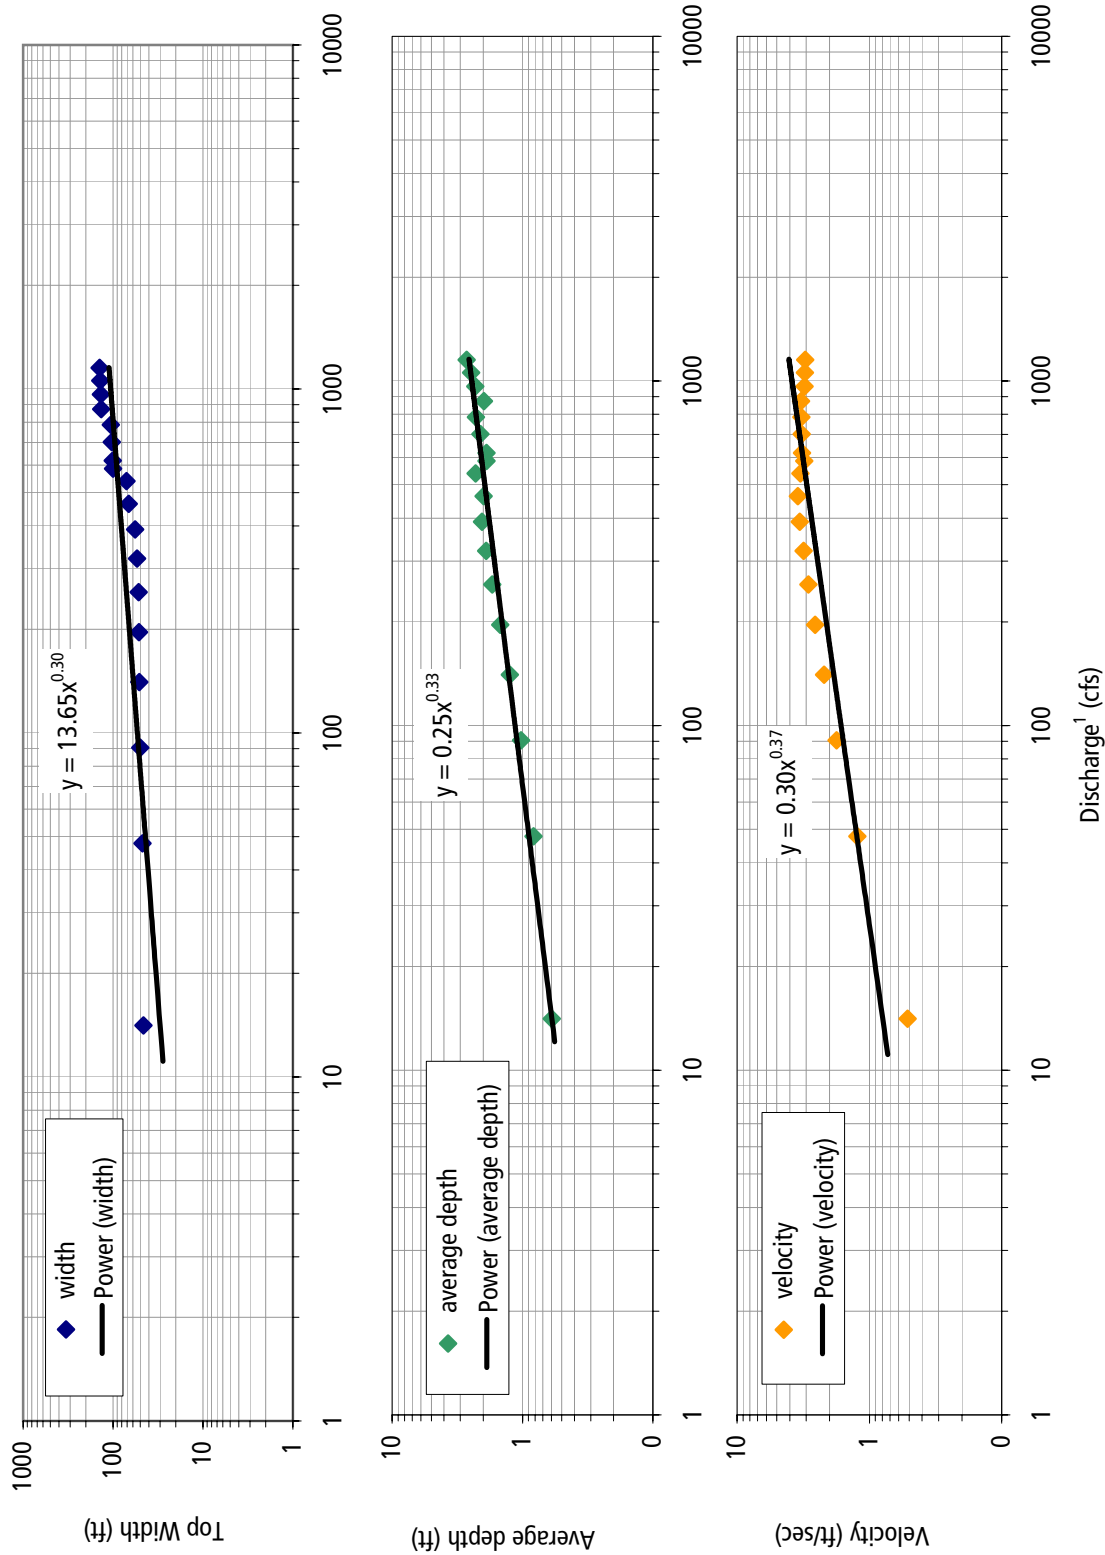
FIGURE 3.18C: Channel geometry calculated for Upper Truckee River at SH+G State Parks Gage.

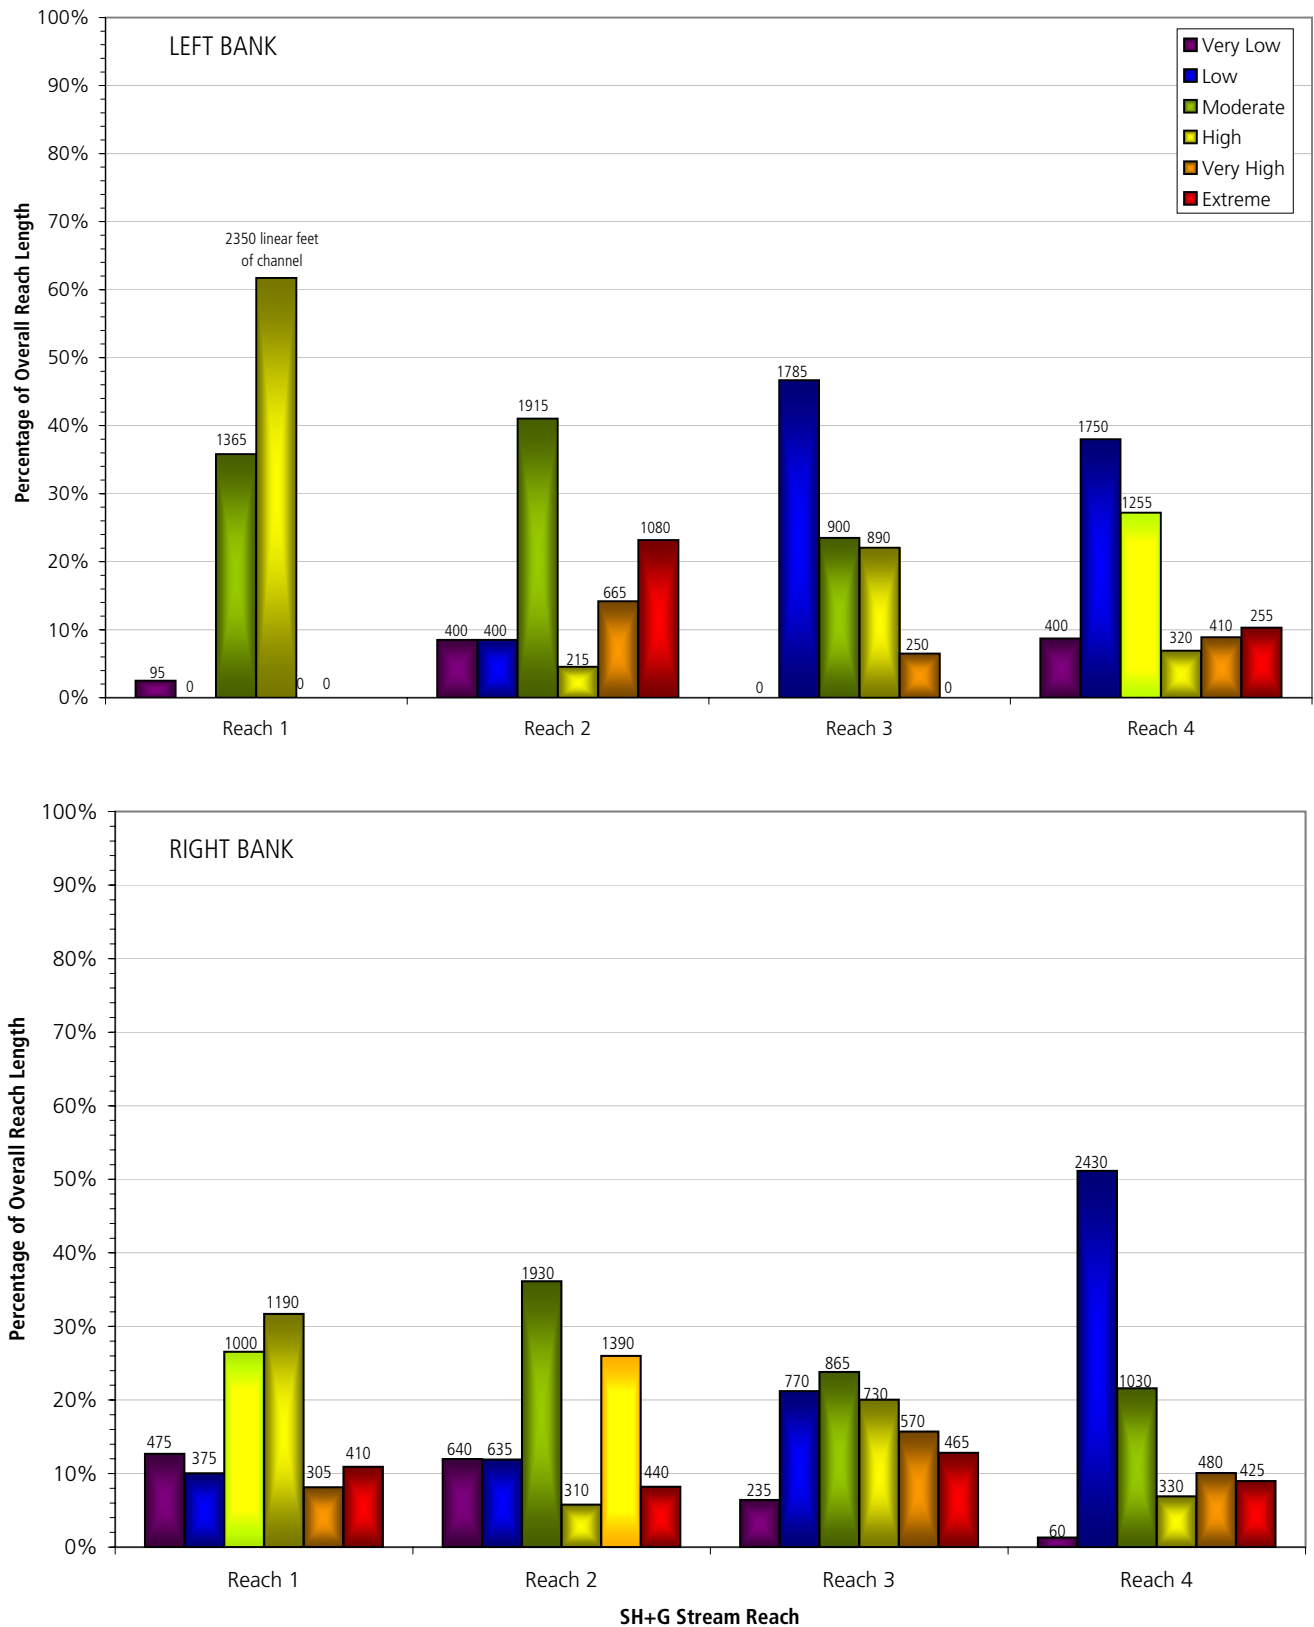
The results of the mainstem UTR bank erosion survey are presented in Figures 3.20A-F and 3.21 and summarized in Table 3.4 (the complete database is presented in Appendix B). The data reflect the recent history of channel incision, with many reaches of unstable banks undercutting bank vegetation, especially in Reaches 1-4. High erosion hazards are also found in the alluvial reaches of Christmas Valley, especially the meadow areas of Reaches 5, 7, 10 and 11. The erosion hazard rating also reflects the fact that many of the banks rating high erosion potential or above are chronic sources of fine sediments. Areas exhibiting low or moderate erosion hazards occur in reaches lined in boulders or bedrock. An interesting exception occurs in the lower end of Reach 3, where it appears that the stream bed is being held nearly at grade with adjacent valley flat similar to the relief that would have been expected prior to disturbance; this appears to be the result of an erosionally resistant layer of older glacial outwash cobble and small boulder underlying the stream bed.

FIGURE 3.21A: Histograms illustrating the bank erosion potential for the left and right banks of Reaches 1-4 by percentage of overall reach length. See Figures 3.20A and B for locations.

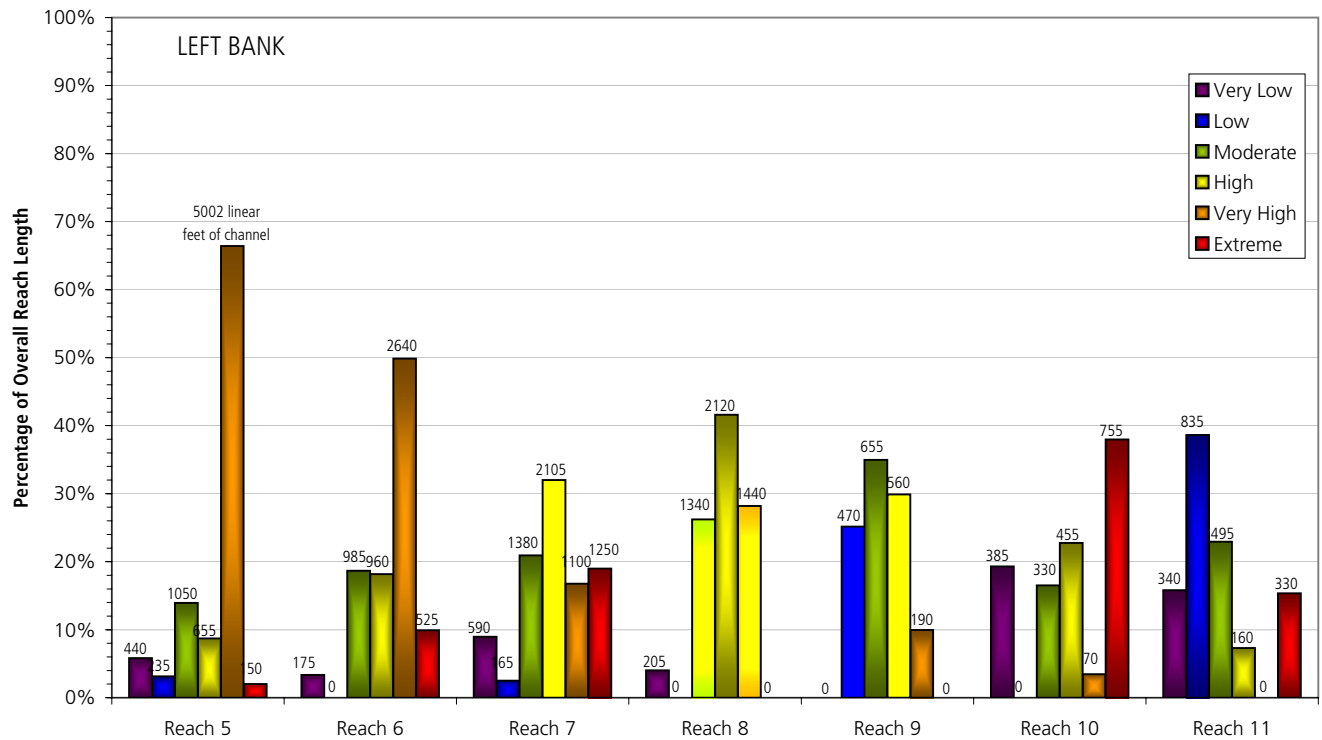
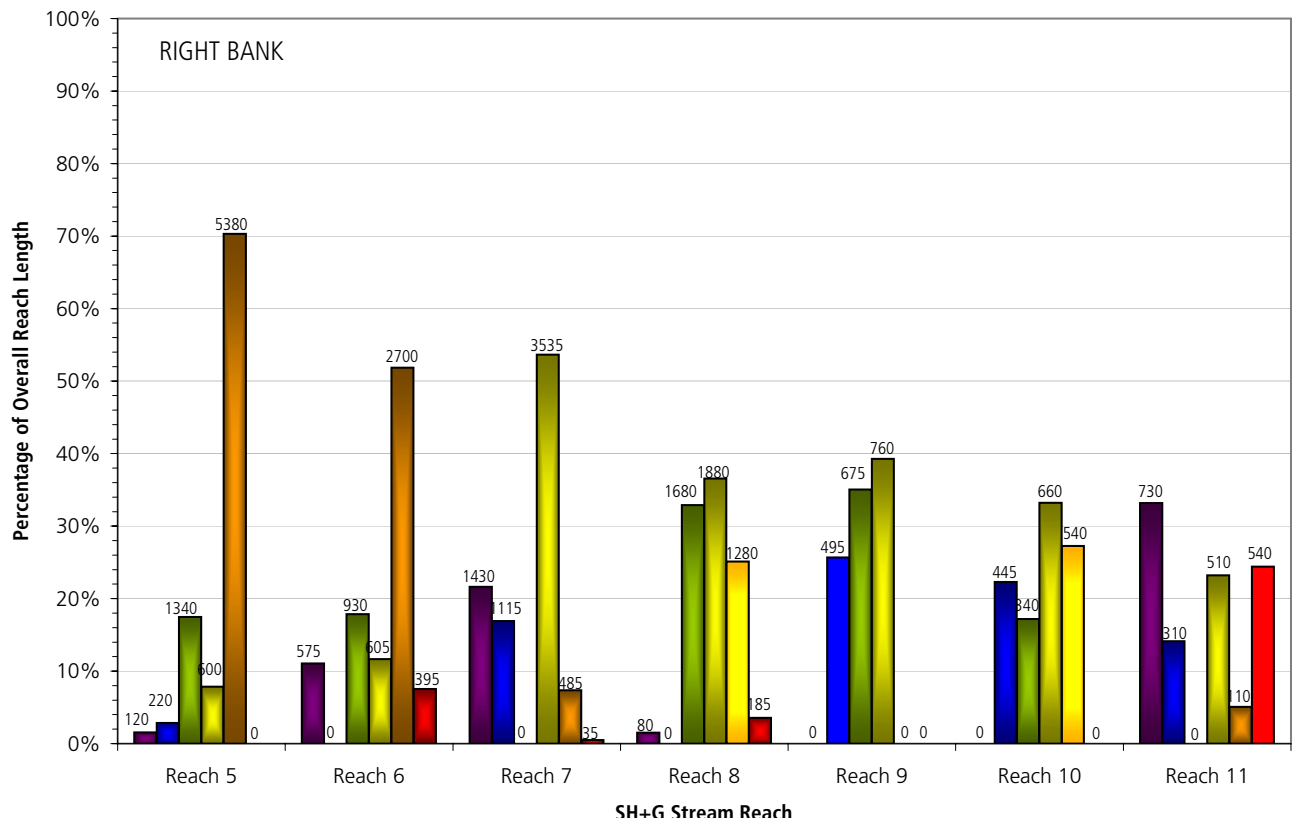
FIGURE 3.21B: Histograms illustrating the bank erosion potential for the left and right banks of Reaches 5-11 by percentage of overall reach length. See Figures 3.20C-E for locations.
