DRAFT ADA SELF-EVALUATION AND TRANSITION PLAN

CALIFORNIA TAHOE CONSERVANCY

DECEMBER 2018

*Accessibility Compliance Evaluation completed by:
California Department of General Services
Real Estate Services Division
Professional Services Branch, Arch Unit B
Eric Driever, Senior Architect, CASp*

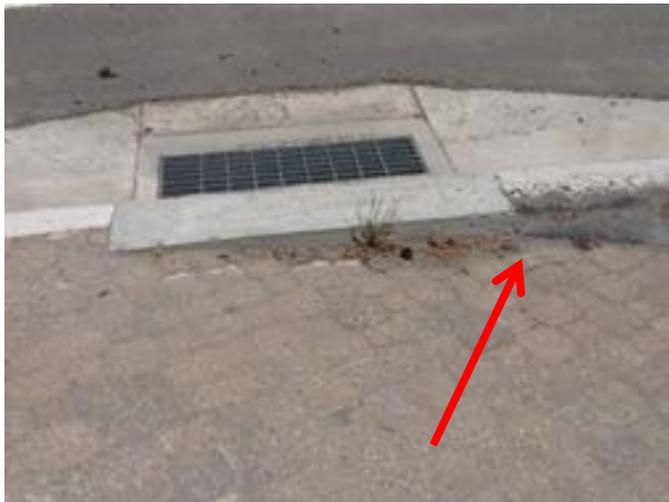
Change in level exceeds ¼".

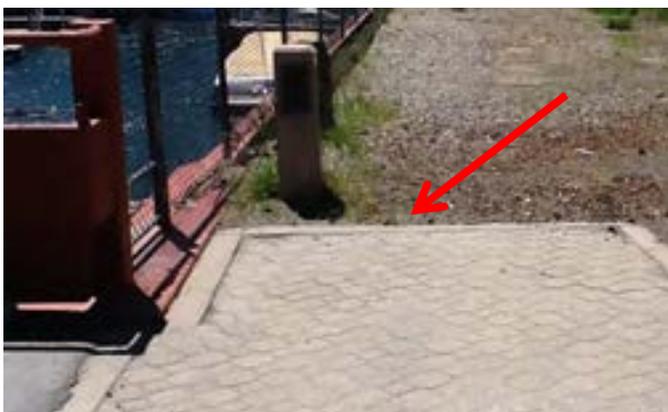
Excessive vertical change exists at the transition to the unimproved trail to beach access.

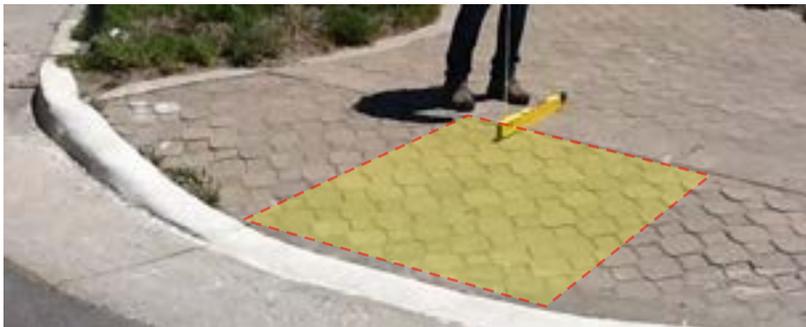
The curb ramp lacks truncated domes and lacks a 24" straight section of curb at flared edges. The ramp exceeds 8.3%.

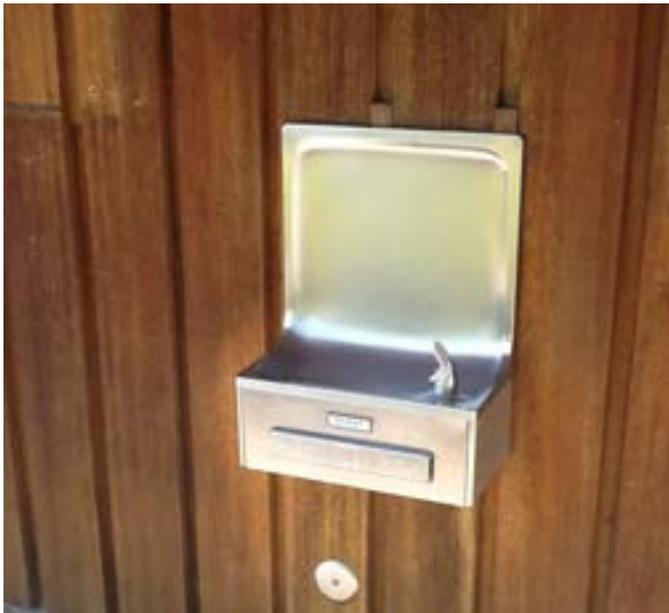
ITEM	EXISTING BARRIER	POTENTIAL OPTIONS	CORRECTIVE TIMELINE
CARNELIAN WEST			
5: Drinking Fountains			
5.A: Drinking Fountains	Only one "low" drinking fountain exists.	Provide a "high" drinking fountain that is accessible to persons who have difficulty bending or stooping.	Mid-term
5.B: Protruding Objects	The wall-mounted drinking fountain is not mounted in an alcove or installed with side rails and therefore projects more than 4" into the circulation path between 27" and 80" above the floor.	Install side rails to meet accessibility requirements for protruding objects.	Mid-term

No "high" drinking fountain provided. Only a "low" fountain provided. Drinking fountain is considered a protruding object because it is not installed in an alcove and does not include rails at both sides for cane detection.

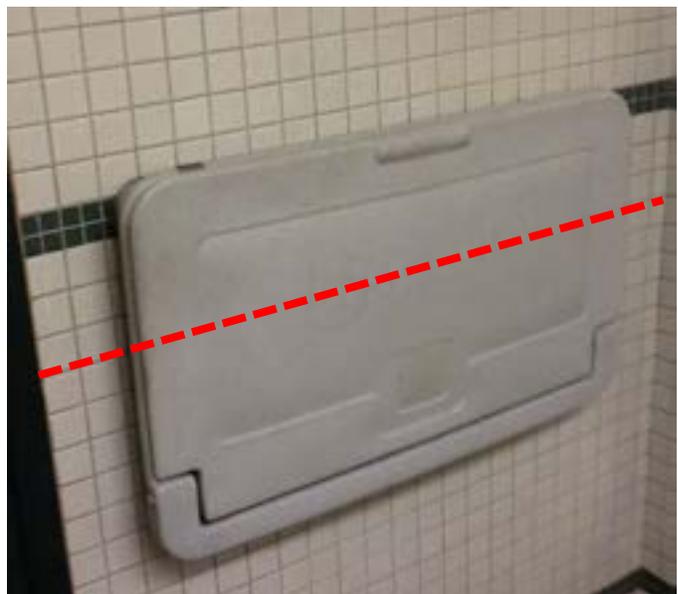
Although the changing table can be opened from 40" above finish floor the actual pull location is above 40" above finish floor.

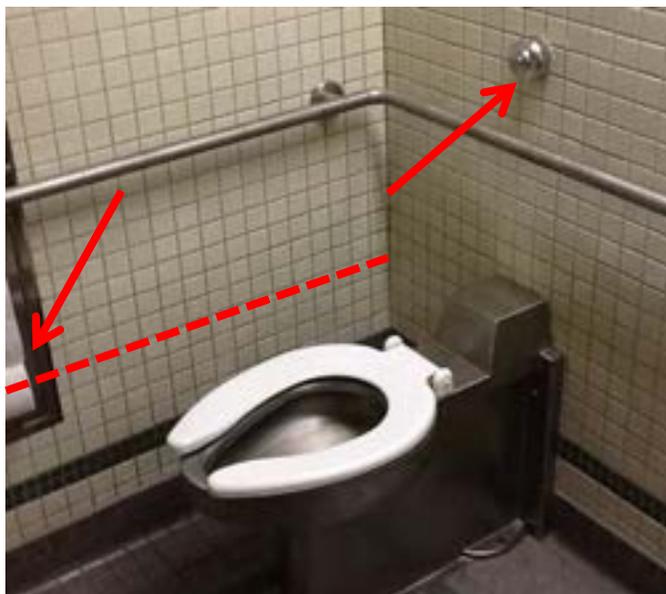
6.E: Water Closet Flush Controls	The push button is centered behind the toilet and controls exceed 5 lbs. operating pressure.	Replace and relocate push button to meet accessibility requirements and be located on the wide side of the water closet where clear floor space is provided.	Done

6.F: Toilet Paper Dispenser	The toilet dispenser is 38" from the rear wall instead of the 36" maximum. The top roll is located above 19" above finish floor instead of having the dispenser centered at least 19" above finish floor. (Note this requirement has changed in the 2013 CBC).	Reinstall/replace toilet dispenser to meet accessibility requirements: distance from the front edge of the toilet to the centerline of the toilet paper dispenser is to be 7" minimum and 9" maximum. The outlet of the dispenser shall be below the grab bar, 19" minimum above the finish floor.	Short-term

6.G: Grab Bar Wall Clearance	The space between the grab bar and the wall is less than 1-1/2" where the toilet paper dispenser passes behind the grab bar.	Recess the toilet paper dispenser or replace with a unit that allows for 1-1/2" between the grab bar and the wall.	Short-term

Flush control is centered instead of being mounted on the wide side of the water closet where clear space is provided. The outlet of the toilet paper dispenser should be 19" minimum above the finish floor. The dispenser unit reduces the clear space behind the grab bar to less than the required 1-1/2".

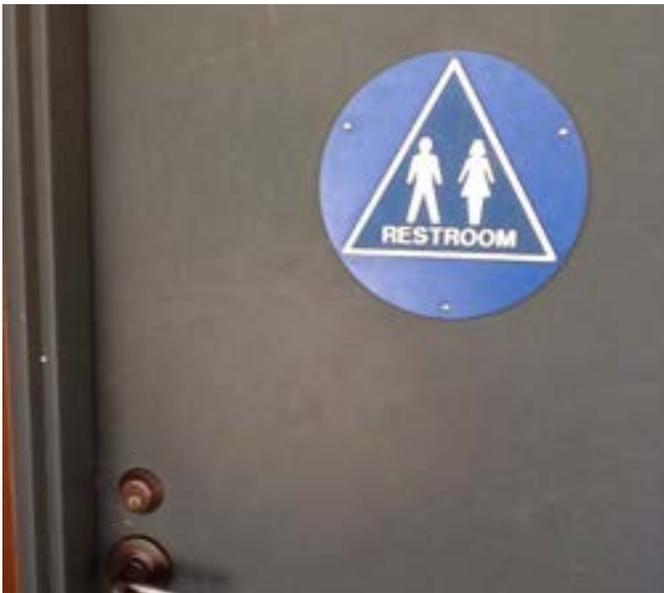
7.B: Identification Symbols	The unisex symbol does not provide appropriate alternating contrast. The circle does not substantially contrast with the door and the triangle is the same color as the circle. The white border around the triangle does not meet the contrasting requirements.	Replace symbol with appropriate contrasting symbol.	Short-term

Triangle does not contrast with the circle and the circle does not substantially contrast with the door.

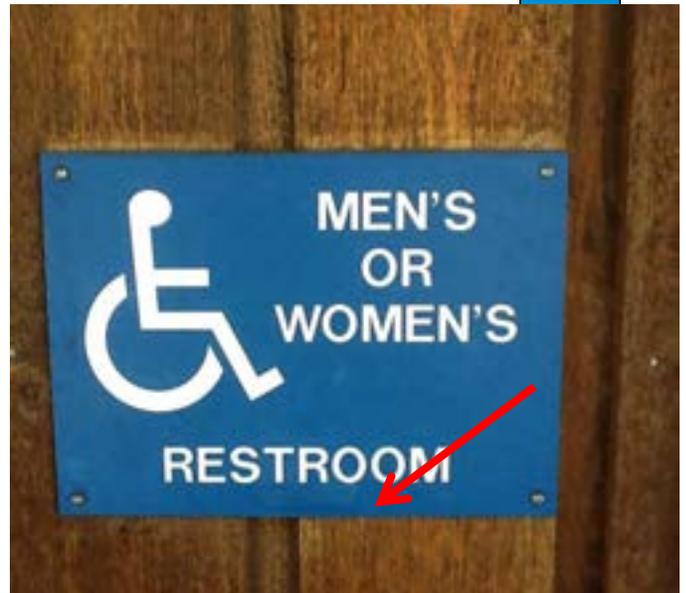
Braille does not indicate "Men's or Women's" or "Unisex". The sign is not located on the latch side of the door.

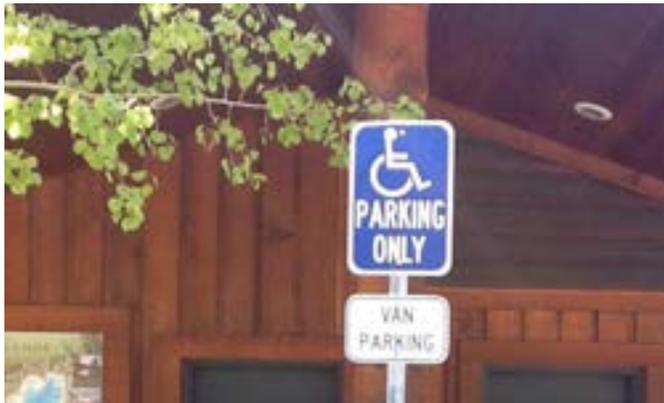
Sign lacks "Minimum Fine \$250".

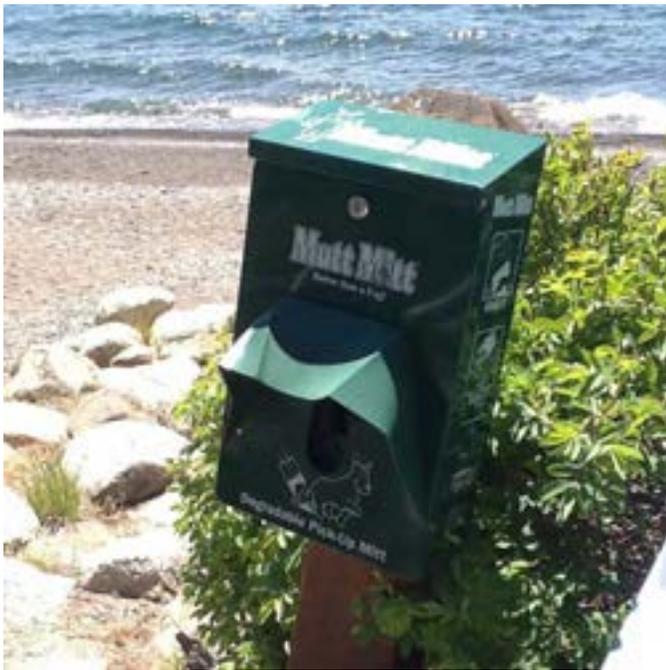
Pet waste receptacle dispenser should be provided along an accessible route.

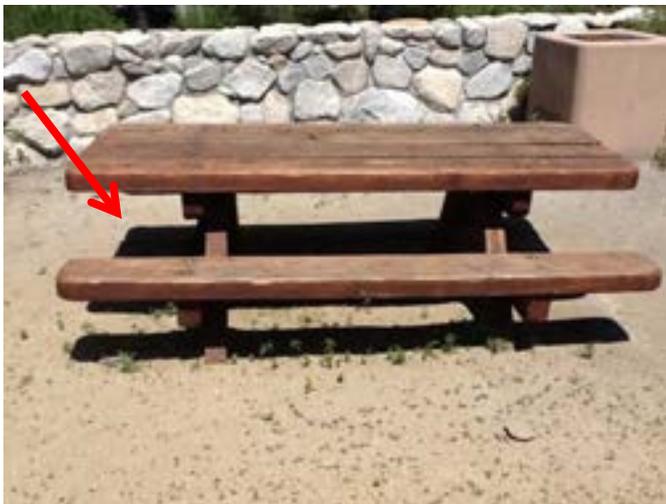
ITEM	EXISTING BARRIER	POTENTIAL OPTIONS	CORRECTIVE TIMELINE
CARNELIAN WEST			
8: Site Furnishings and Amenities			
8.A: Picnic Tables	Picnic table is not on an accessible path and does not provide 27" required knee space.	<p>Replace picnic table with a table that meets accessibility requirements and locate appropriate number of tables on an accessible path.</p> <p>Provide at least one accessible picnic table and one additional table for each 20 tables or fraction thereof. The number of overall tables should be separated by individual picnic areas and by the type of experience. The accessible table and accompanying amenities should be on an accessible route with appropriate clear space.</p>	Mid-term

Picnic table should be provided along an accessible route and provide for 27" knee clearance.

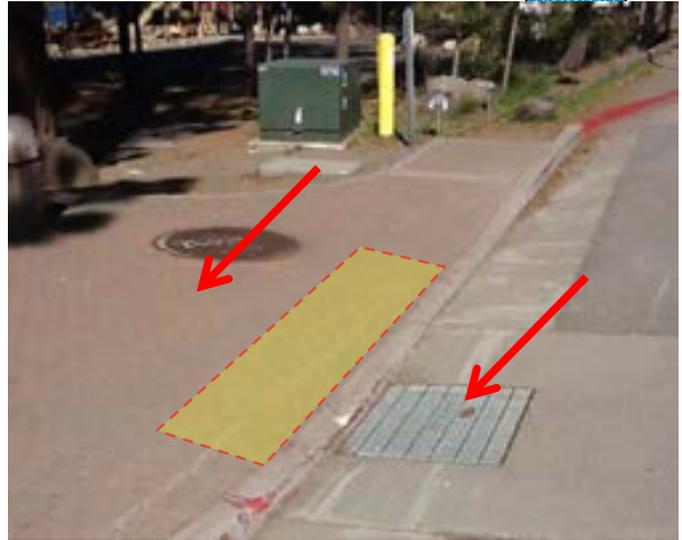
Grate openings in the direction of travel exceed width standards. Curb ramp lacks truncated domes and excessive cross slopes exist across the entire width of the ramp.

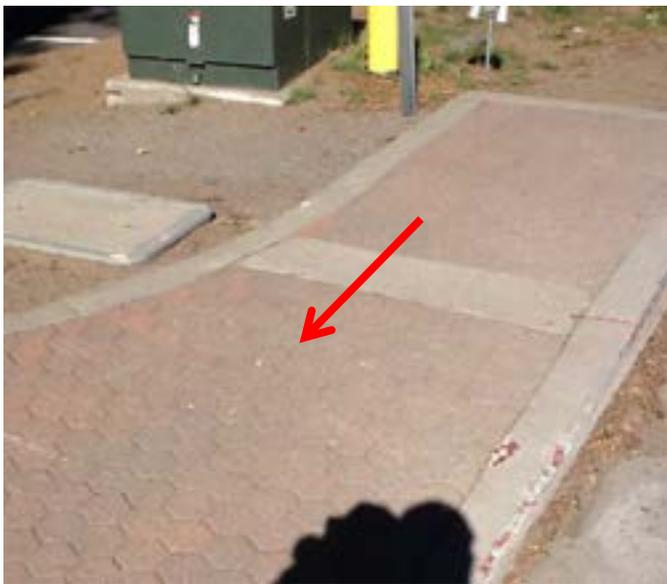
Walkway is less than 48" in width and has excessive cross slopes.

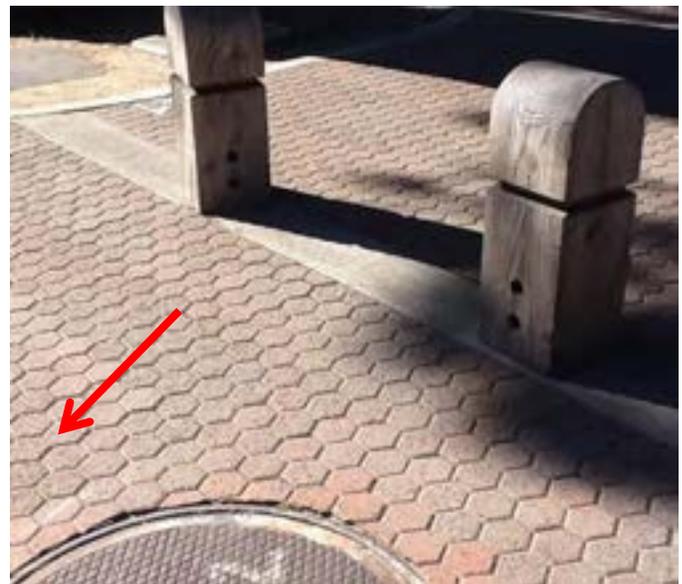
Ramp lacks truncated domes.

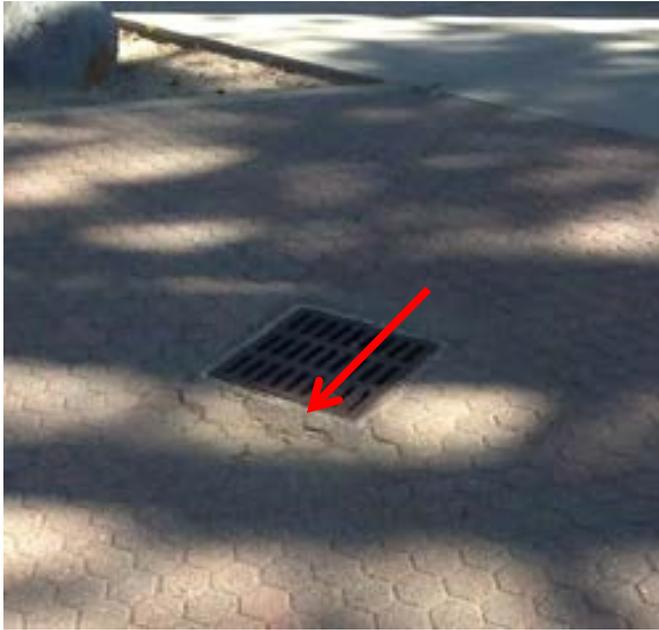
Grate openings in the direction of travel exceed 1/2". Due to the location there is no specific direction of travel. Excessive cross slopes exist at drains. Slopes must not

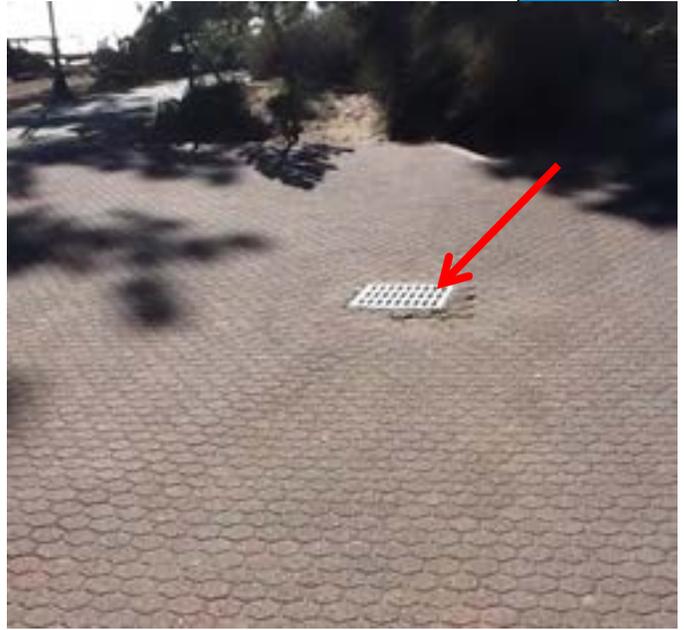
Excessive cross slopes exist at drains. Slopes must not exceed 1:48 (2%).

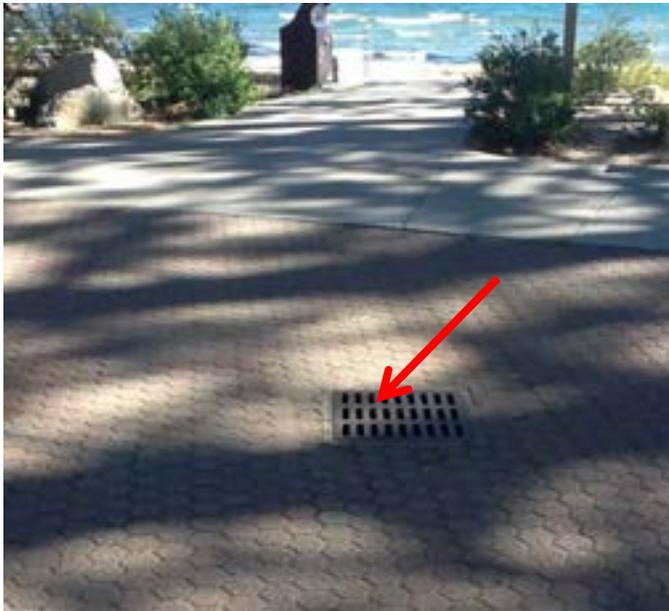
Grate and cross slopes are non-compliant.

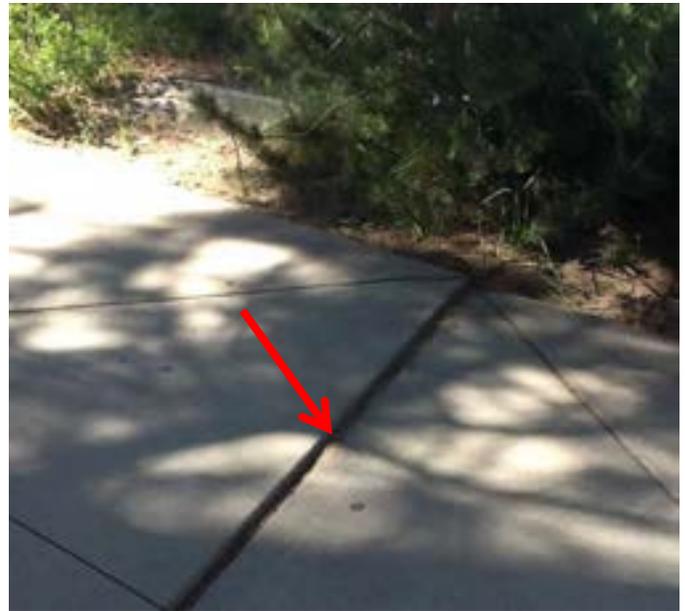
Excessive vertical change exists in walkway.

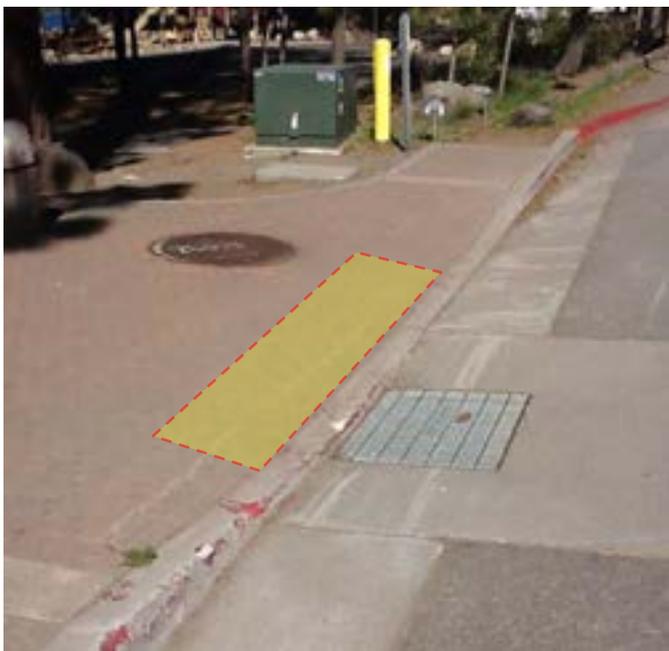
Curb ramp lacks truncated domes and excessive cross slopes exist across the entire width of the ramp.

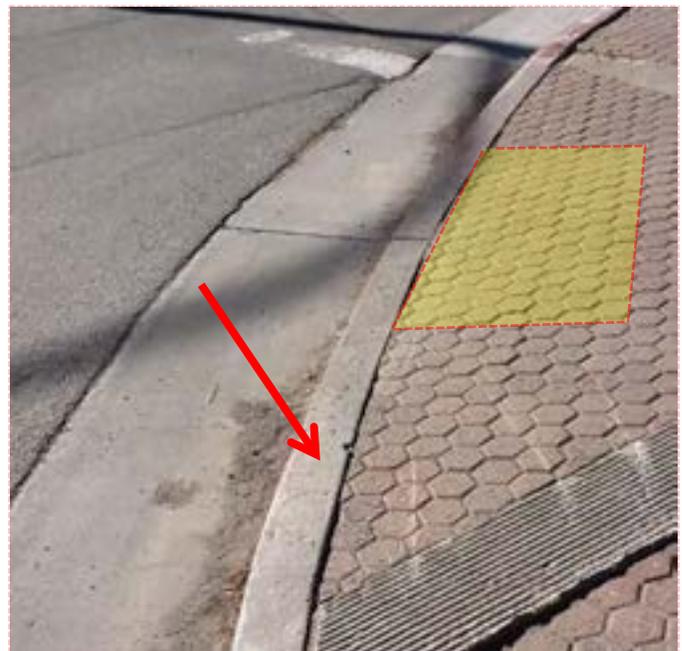
3.D: Detectable Warning	The curb ramps do not have detectable warnings.	Install appropriate detectable warnings on the curb ramps. *Note: Evaluate if issue was corrected with new streetscape improvements in 2014-2015.	Done

3.E: Straight Curb	No 24" segment of straight curb is located on each side of the diagonal curb ramp.	Reconstruct curb ramp to meet accessibility requirements. *Note: Evaluate if issue was corrected with new streetscape improvements in 2014-2015.	Done

The curb ramp lacks truncated domes and lacks a 24" straight section at the flared edges (typical for all curb ramps).

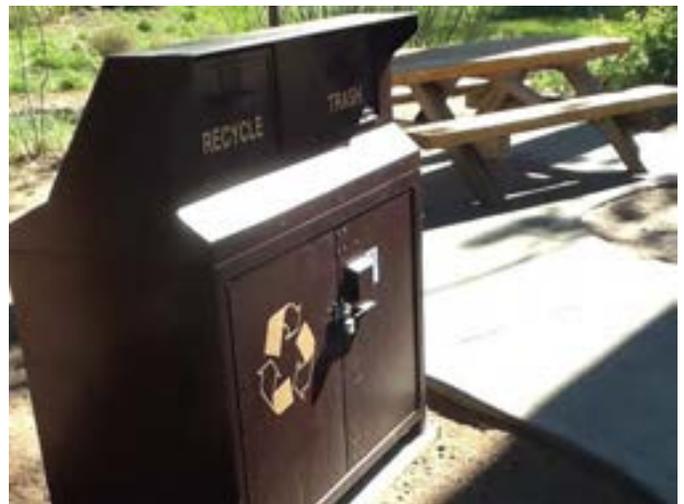
ITEM	EXISTING BARRIER	BARRIER REMOVAL METHOD	CORRECTIVE TIMELINE
KINGS BEACH PLAZA			
7: Site Furnishings & Amenities			
6.A: Amenities on Accessible Routes	<p>Trash receptacle is not on an accessible path at the picnic area intended to be the accessible picnic area.</p> <p>Trash receptacles are generally not on an accessible path or the path does not extend to the trash receptacle.</p>	Provide amenities along an accessible route of travel where possible or provide an accessible route of travel to the amenities.	Mid-term

Trash receptacle is not on an accessible path at the picnic area intended to be the accessible picnic site.

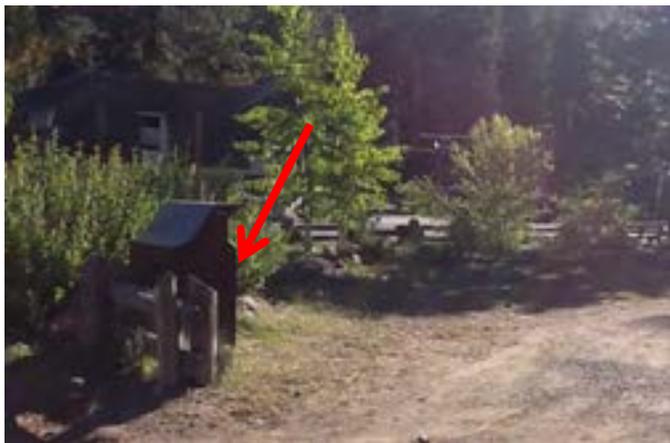
Trash receptacle is not on an accessible path of travel (typical for most trash receptacles).

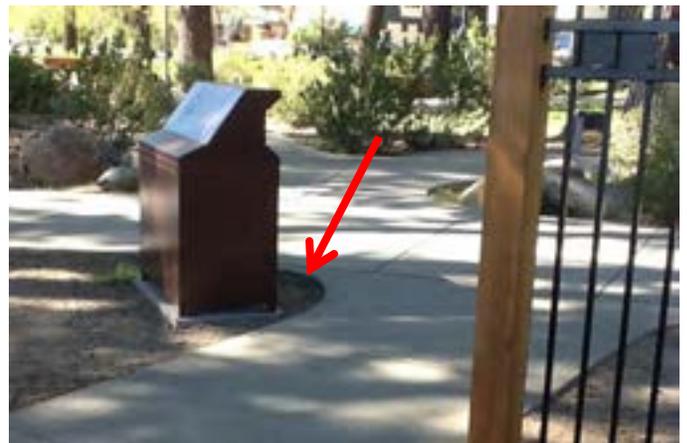
Accessible path does not extend to the trash receptacle.

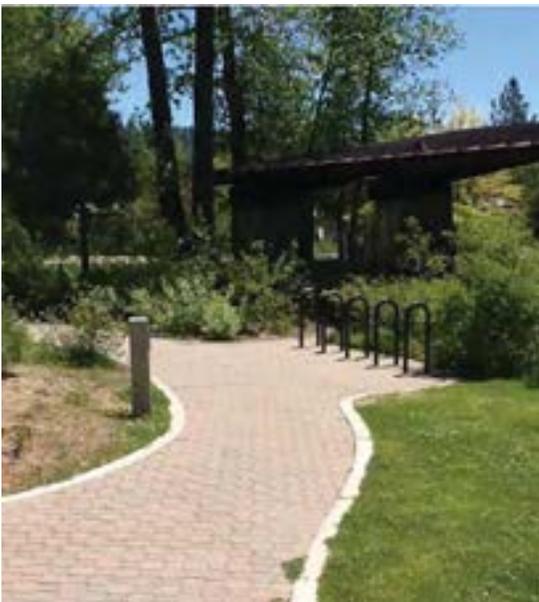
Typical path.

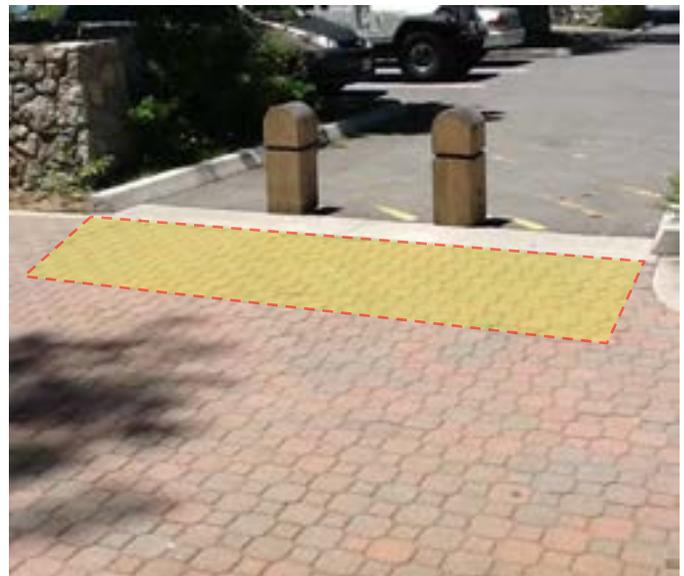
Walkway lacks truncated domes at flush transition to vehicular way.

3.H: Hazardous Vehicular Areas – Detectable Warnings	The curb ramp servicing the accessible parking, the turn-around space adjacent to the restroom facility and the walkway connection to the drive aisle at the terminus of the drive aisle/entry do not have adequate separation or detectable warnings.	Where pedestrian areas cross or adjoin a vehicular way, either separate the walkway from the vehicular way with a curb, a railing or other element or provide a continuous detectable warning at least 36" wide.	Long-term

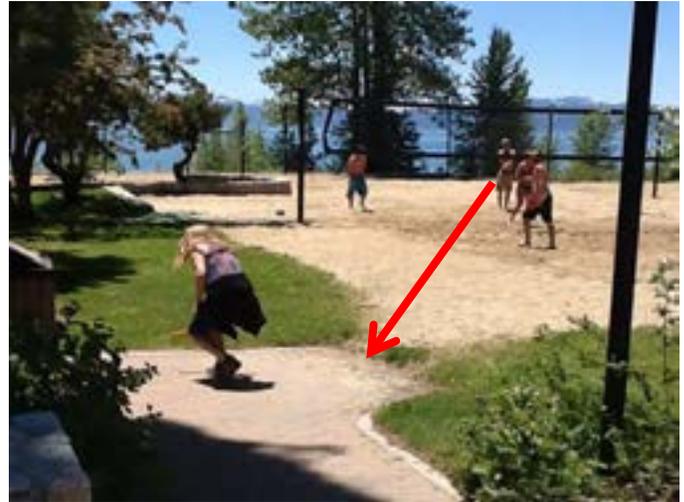
Path terminus has excessive slopes and vertical transition.

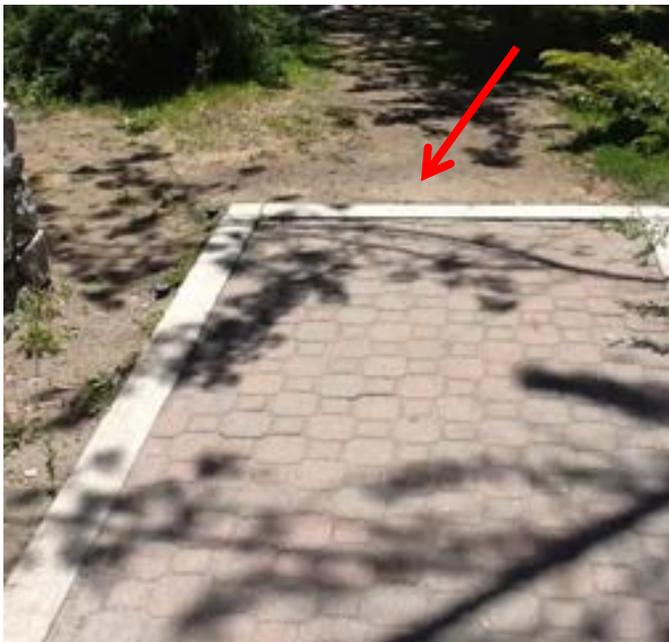
Terminus of improve path of travel has excessive vertical drop. If not considered part of the accessible route, a sign with the ISA symbol is required to direct individuals to an accessible route.

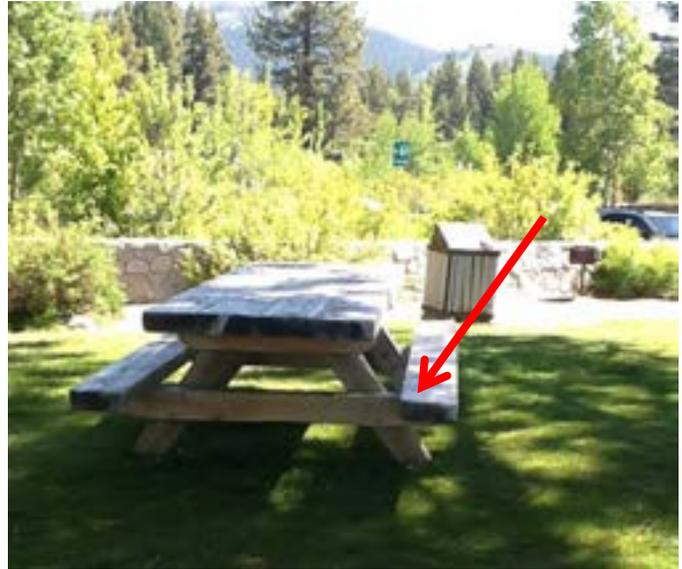
Picnic tables in the lawn area are not on an accessible route or an accessible surface.

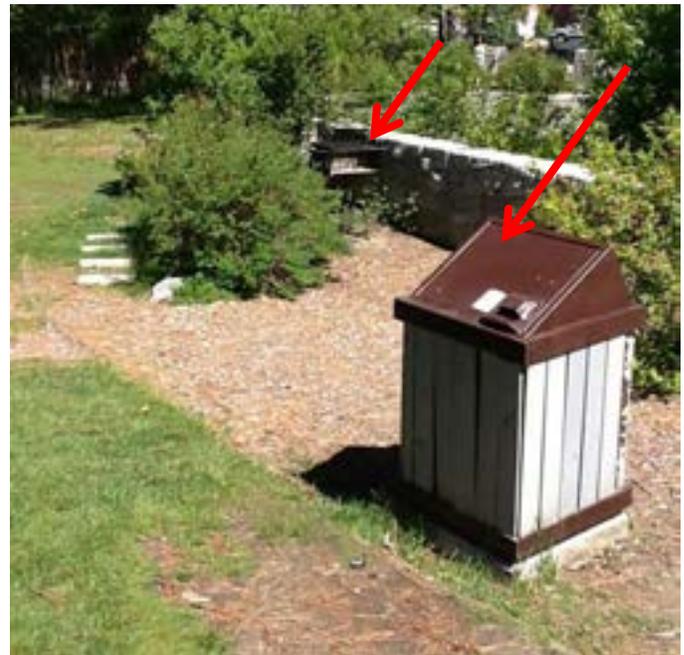
Barbecue and trash receptacle are not on an accessible path.

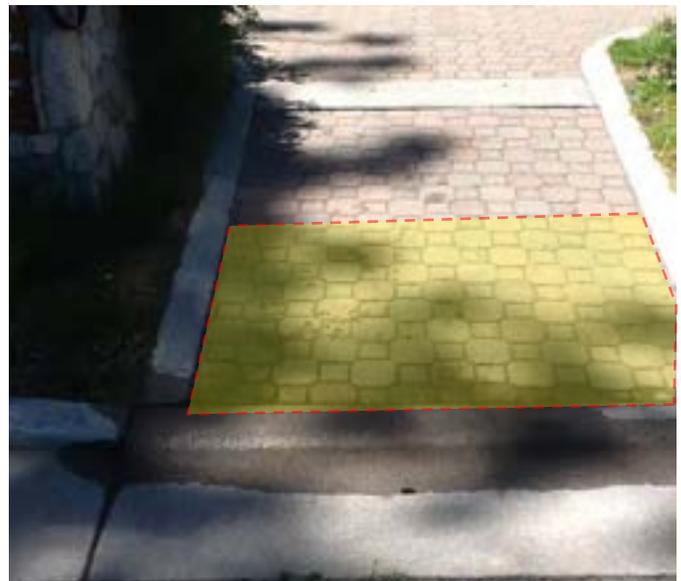
Walkway lacks truncated domes at flush transition to vehicular way. Excessive slopes exist at rolled portion of curb.

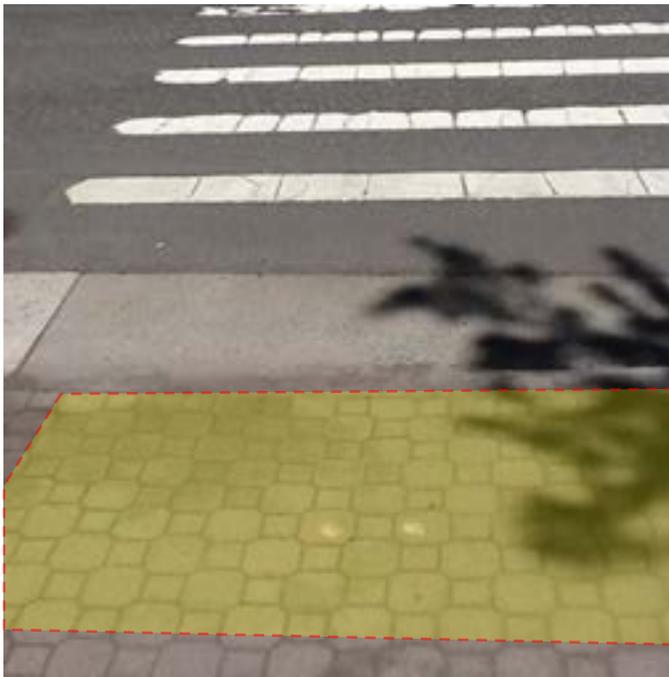
Walkway lacks truncated domes at flush transition to vehicular way.

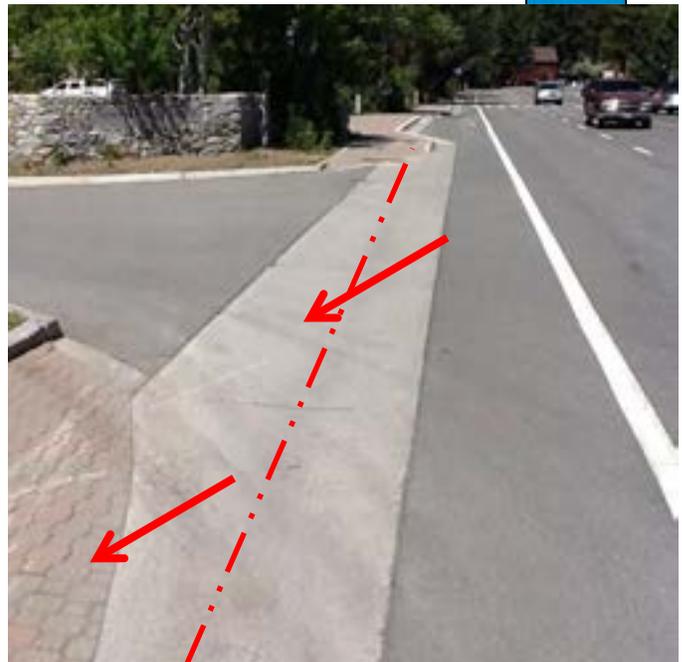
V-gutter cross slopes exceed 2%. Curb ramp lacks truncated domes on both sides of the vehicular way. The property line appears to be at the back of the curb placing the walkway on Conservancy property.

4.F: Cross Slope	The path of travel crossing the drive entrance includes a V-gutter. The cross slopes created by the V-gutter exceed 2%.	Regrade and replace v-gutter if possible to create a path of travel with a cross slope that does not exceed 2%. Coordination with Placer County public works may be required. Consider creating a new curb cut and pedestrian crossing that does not coincide with the v-gutter.	Mid-term

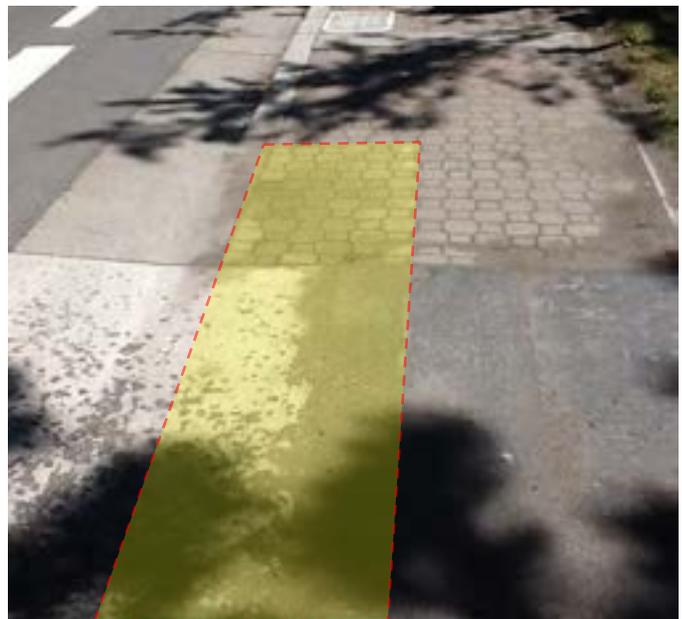
Cross slope exceeds 2% at flared edges. Walkway lacks truncated domes at flush transition to vehicular way. The property line appears to be at the back of curb placing the walkway on Conservancy property.

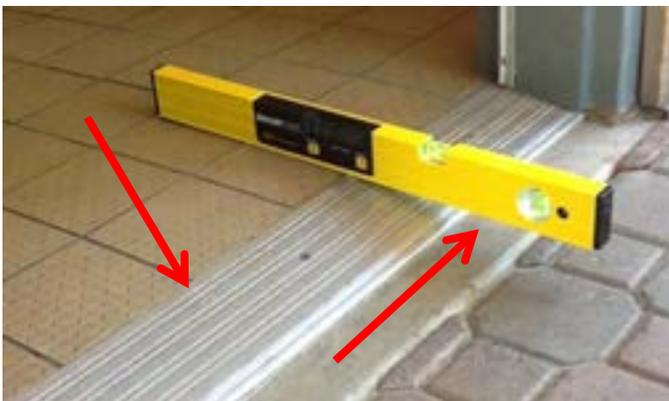
Threshold vertical rise exceeds 1/2" overall maximum. An extended sloped transition is not possible as landings at doors must be a maximum of 2%. Potential solutions include raising the entire landing at the exterior walk or lowering the level of the interior floor as well as the associated fixtures and accessories adversely affected.

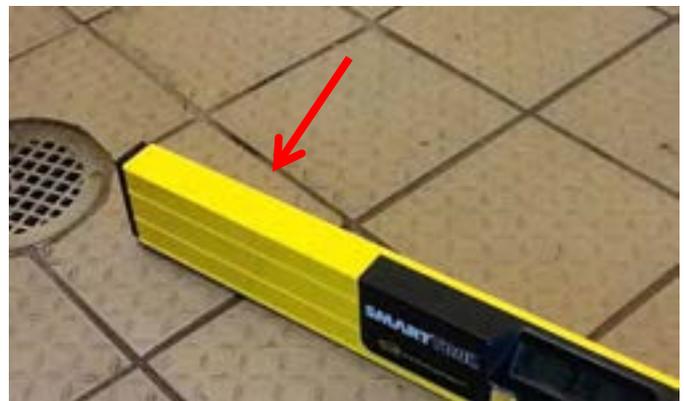
Slope at drain exceeds slope requirements.

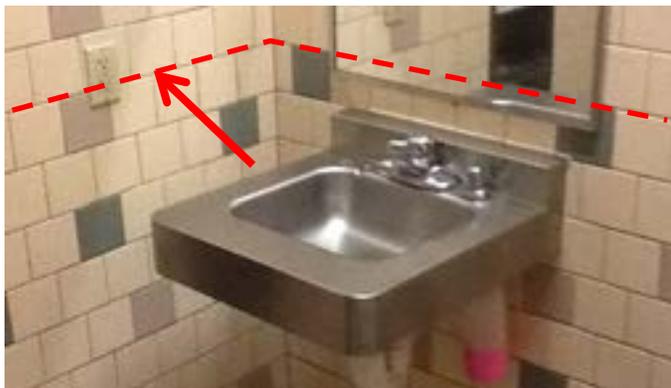
Electrical outlet exceeds maximum height above finish floor (41 1/2" instead of 40" allowable maximum).

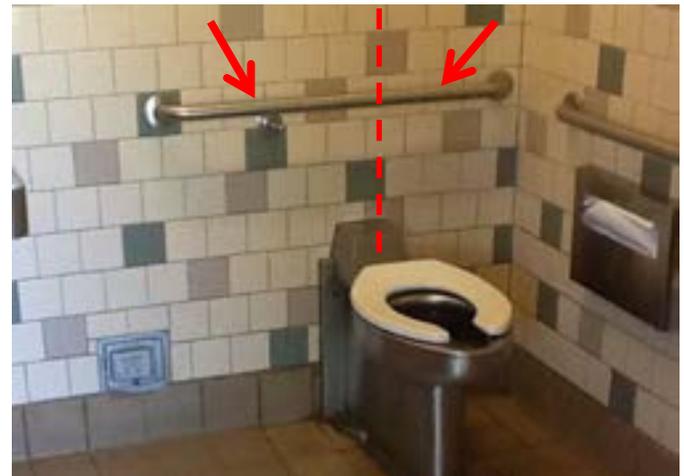
Grab bar is incorrectly offset. A 12" and 24" offset is required. The toilet seat exceeds maximum height above finish floor (19 1/2" instead of 19" maximum).

5.C: Water Closet Seat	There is 19 ½" between the top of the water closet seat and the finish floor.	Replace water closet seat or water closet so that the distance between the top of the water closet seat and the finish floor is between 17" and 19".	Mid-term

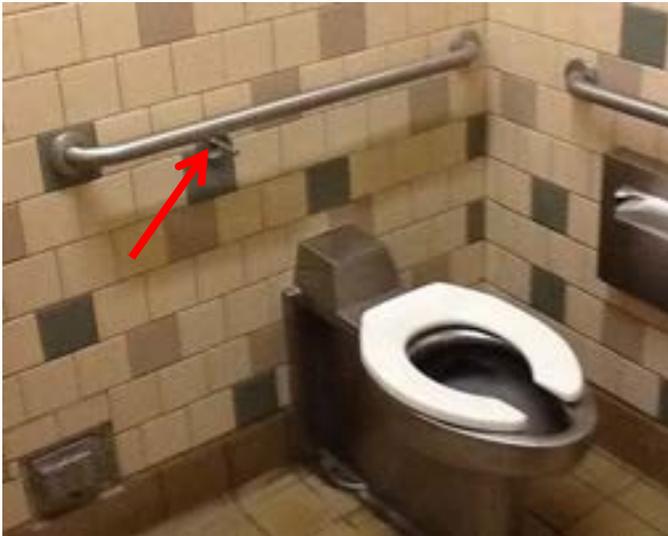
Control is set approximately 1 ½" below the grab bar as required, but it may be difficult to operate.

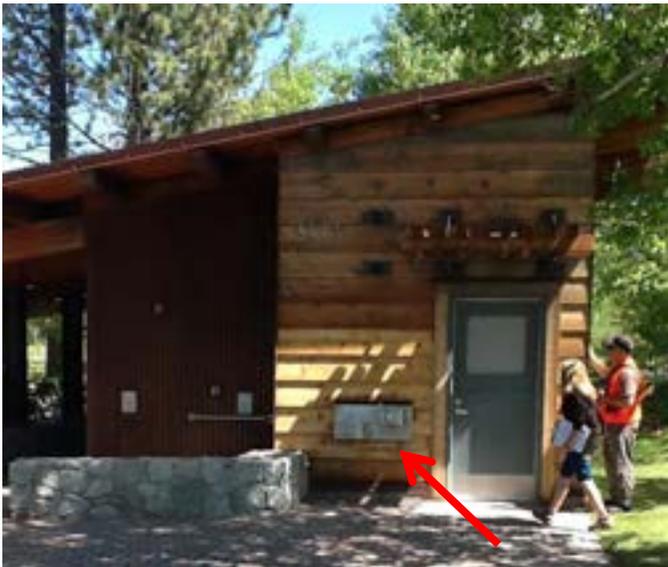
Outdoor showers have a number of non-conforming items, including slope, lack of folding benches and lack of a shower spray unit that can be used either fixed or hand-held. The hi-low drinking fountain is not in an alcove nor does it have rails for cane detection on either side. Should rails be installed, ensure the rails do not encroach into door clearance.

ITEM	EXISTING BARRIER	BARRIER REMOVAL METHOD	CORRECTIVE TIMELINE
NORTH TAHOE BEACH			
5: Restrooms			
5.J: Exterior Rinse Shower	Exterior shower does not have folding seats, appropriate grab bar configurations or a flexible 59" long shower spray unit that can be used in a fixed position and as a hand-held unit.	Identify the intended purpose of the lower shower head. If this is a foot rinse shower, CTC should adopt standards for such elements in its program and ensure the standards comply with the related similar elements in the CBC and/or ADA.	Long-term

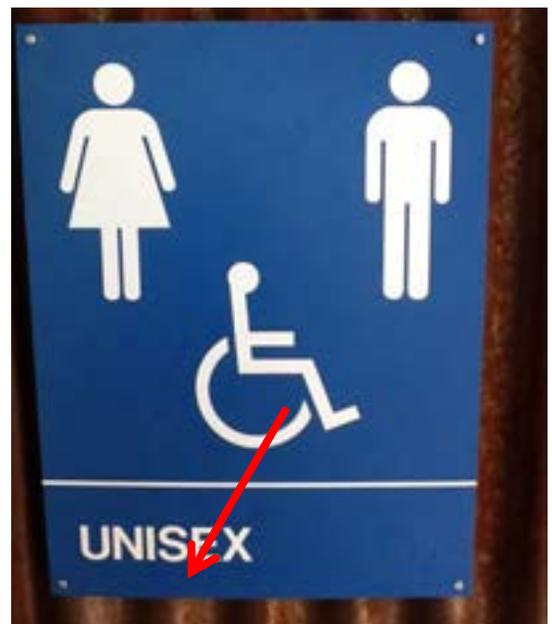
Braille is required to be below the text between 3/8" - 1/2" either center or left justified, not set to the side.

6.E: Identification Symbols	Restroom signage is not compliant. The geometric symbol's circle does not contrast with the triangle and the identification sign's braille is placed to the side of the sign instead of below the tactile characters.	Replace the geometric symbol so that its contrast is distinctly different than the contrast with the door. Replace the identification sign with one in which the braille is below the text between 3/8" - 1/2" either centered or left justified.	Short-term

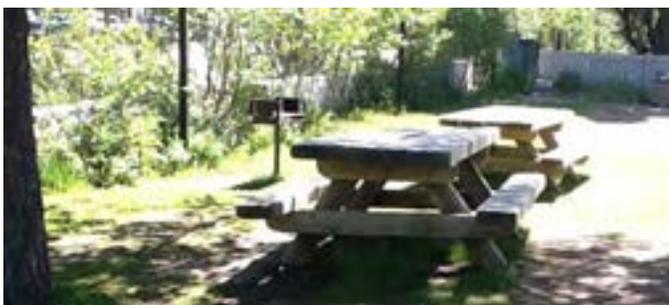
These inaccessible picnic tables and barbecue are provided in an alternative area from the accessible picnic tables and may offer a different experience.

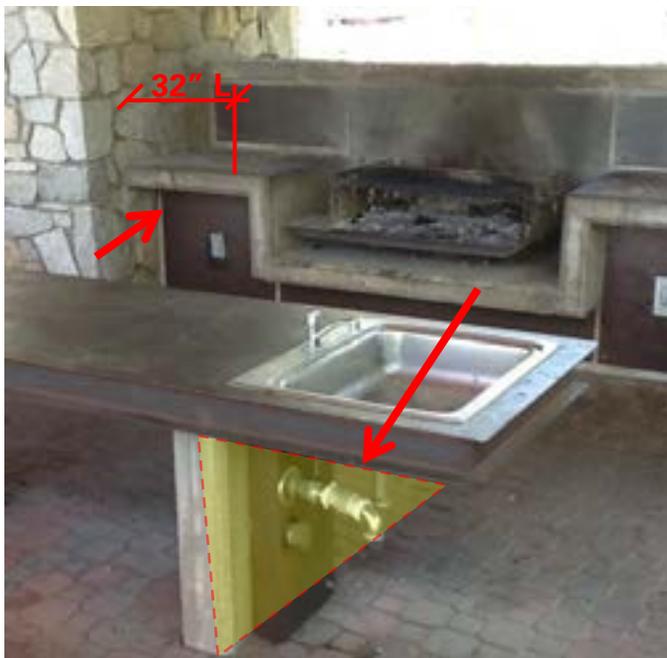
Knee clearance to the bottom of the sink counter is only 26 ½", not the required 27" minimum. The sink is also considered a protruding object as it lacks sides or posts to allow for cane detection.

8.B: Pavilion Sink – Knee Clearance	Bottom of sink is 26 ½" above finish floor; less than the 27" minimum required clear for knee space.	Replace sink design with a sink that has a minimum 27" clear space under the sink; maximum 34" height for the top of the counter.	Long-term

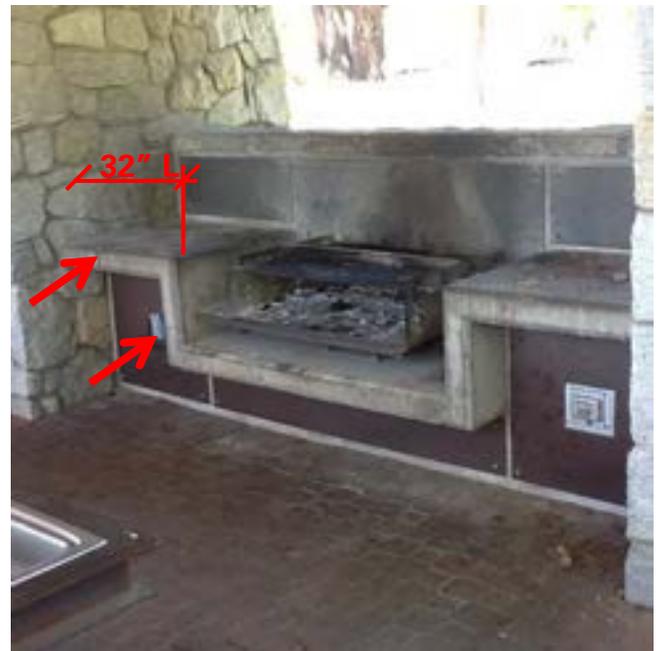
The counters do not provide adequate knee space and the far right counter does not allow for a 36" parallel approach. The electric outlets are set at appropriate height; however, it is ergonomically difficult for wheelchair users to reach under obstructions as designed.

8.C: Pavilion Counter – Approach/Knee Space	Counter at the built-in barbecue does not have adequate knee space or, as an alternative, a 36" long parallel approach (only 32" long).	Revise counter to either provide appropriate knee space with clear approach space or extend the counter 4".	Long-term

8.D: Pavilion Counter – Electrical Outlets Obstructed	Electrical outlets placed under counters of built-in barbecue are difficult to reach as they are recessed under the counter (not specifically addressed in CBC or ADA, but it is generally accepted that for wheelchair users it is ergonomically difficult to reach under obstructions).	Consider relocating electrical outlets to a location not under a counter and within appropriate height requirements (minimum 15" above finish floor).	Long-term

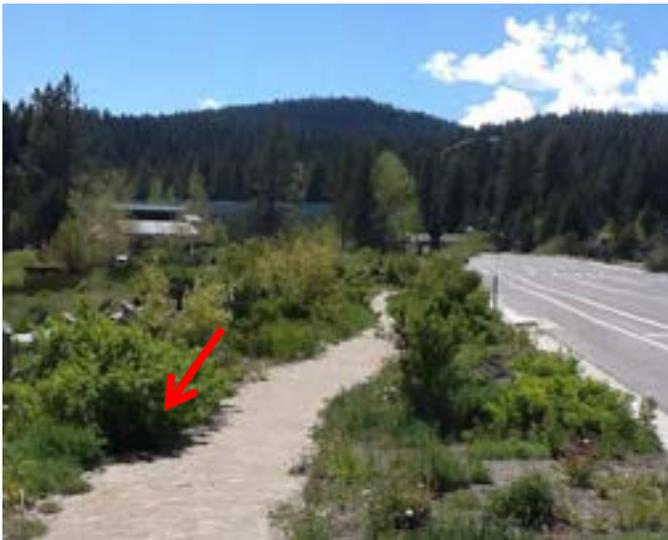
Plants reduce the width of the accessible route to less than 48".

2.D: Width	Plants reduce the clear path of travel to less than 48".	Trim plants to maintain minimum clear path of travel along walkways.	Short-term
2.E: Detectable Warning	Walkway terminates into a decomposed granite path that is not stable or slip resistant and does not have a detectable warning system at its flush transition to the roadway.	Replace decomposed granite with a firm and stable material and install truncated domes.	Mid-term

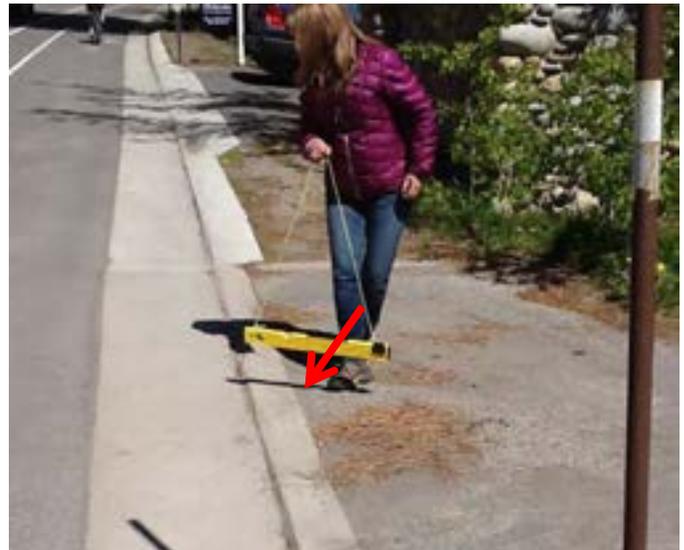
A detectable warning system or truncated domes are required at flush transitions from walkways to vehicular ways.

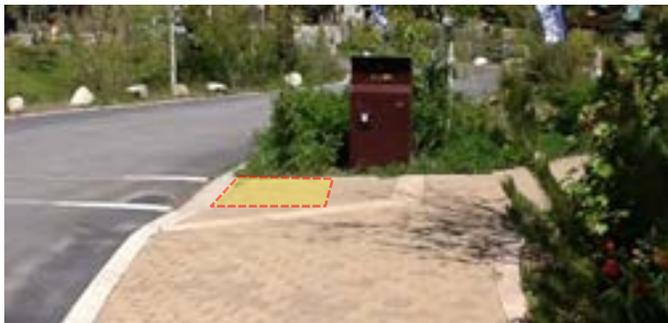
The curb ramp lacks truncated domes and does not meet other accessibility requirements.

4.D: Detectable Warning	The curb ramps do not have detectable warnings.	Install appropriate detectable warnings on the curb ramps.	Mid-term
4.E: Straight Curb	No 24" segment of straight curb is located on each side of the diagonal curb ramp.	Reconstruct curb ramp to meet accessibility requirements.	Mid-term

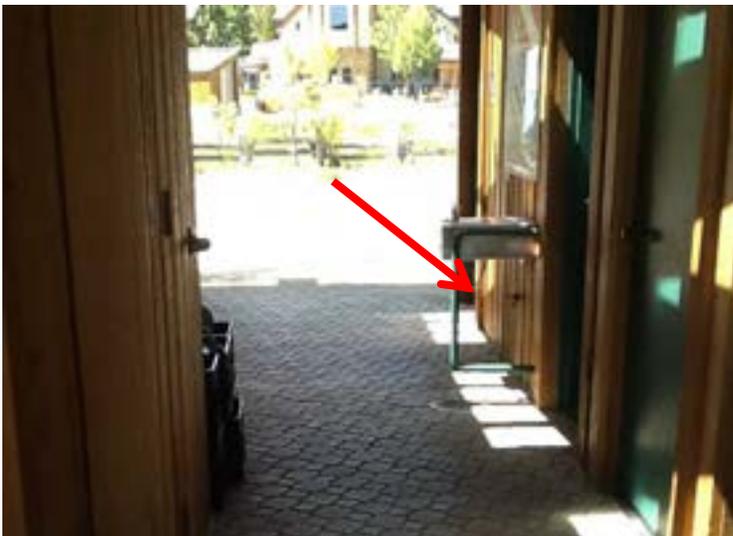
No "high" drinking fountain provided. Only a "low" fountain provided. Drinking fountain is considered a protruding object because it is not installed in an alcove or rails are not provided on both sides for cane detection.

ITEM	EXISTING BARRIER	BARRIER REMOVAL METHOD	CORRECTIVE TIMELINE
PATTON LANDING			
5: Drinking Fountains			
5.A: Drinking Fountains	Only one "low" drinking fountain exists.	Provide a "high" drinking fountain that is accessible to persons who have difficulty bending or stooping.	Mid-term
5.B: Protruding Objects	The wall-mounted drinking fountain is only protected by a rail on one side and is considered a protruding object.	Install an additional side rail to meet accessibility requirements for protruding objects.	Mid-term

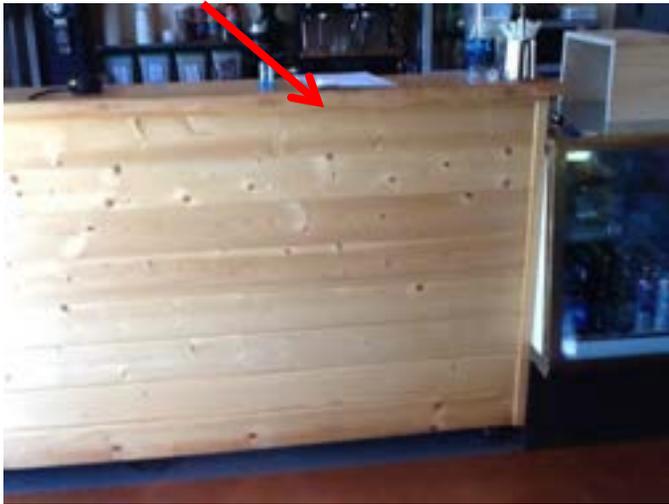
Counter height is greater than 34" with no lower accessible portion.

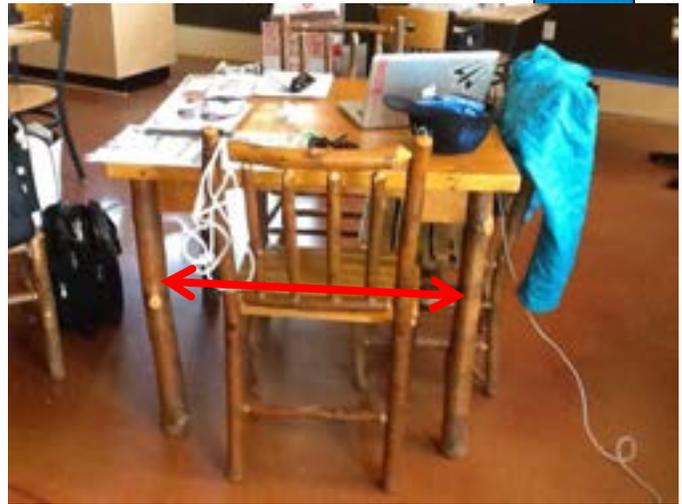
Table height of 31" meets requirements but the clear space between legs is only 29", less than the required minimum 30".

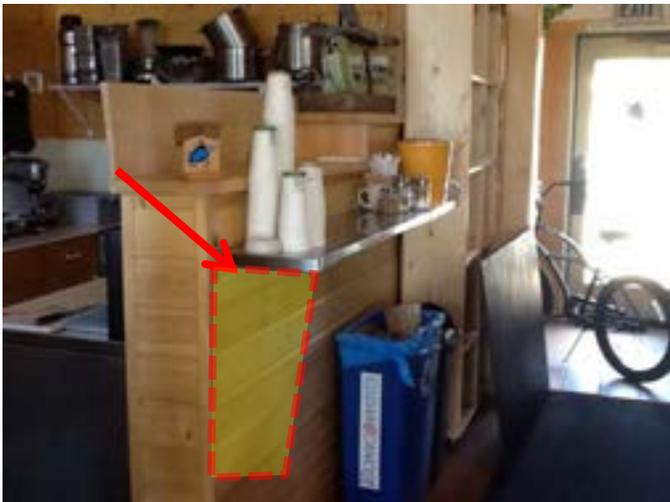
The counter is taller than 34" with no lower accessible portion. An end panel is required down to 27" above finish floor for cane detection. Shelving provides the cane detection on the far end.

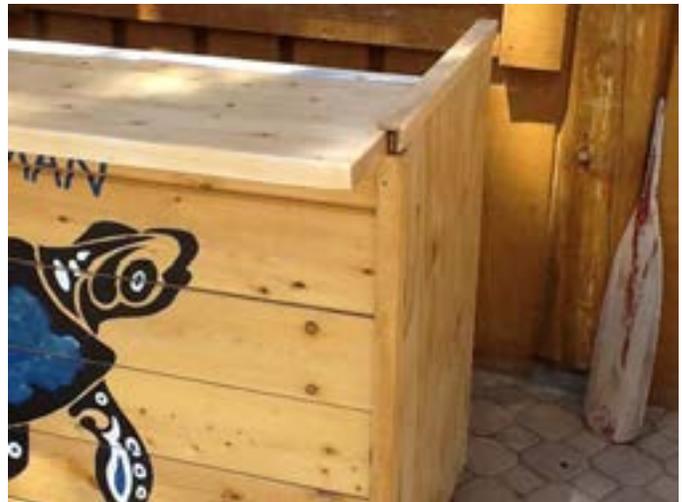
Outdoor counter height is greater than 34" with no lower accessible portion.
