DRAFT ADA SELF-EVALUATION AND TRANSITION PLAN

CALIFORNIA TAHOE CONSERVANCY

DECEMBER 2018

*Accessibility Compliance Evaluation completed by:
California Department of General Services
Real Estate Services Division
Professional Services Branch, Arch Unit B
Eric Driever, Senior Architect, CASp*

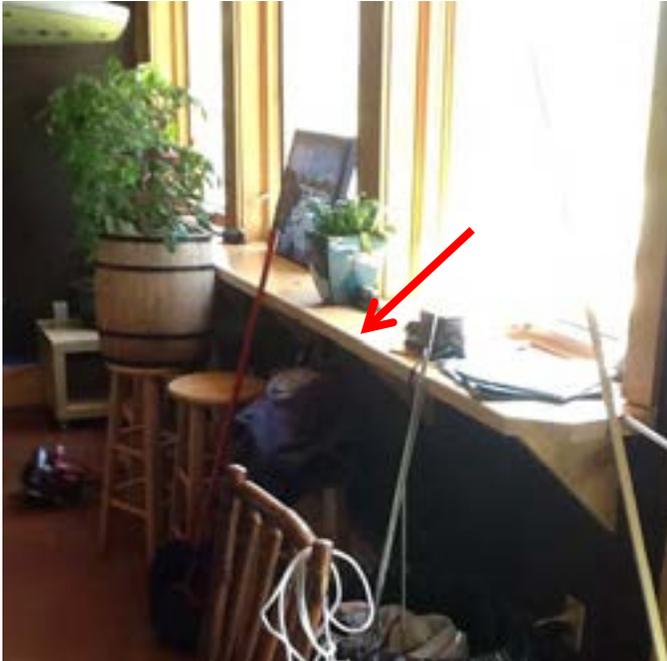
The standing eating area does not provide a lower section (34" maximum height) for wheelchair users.

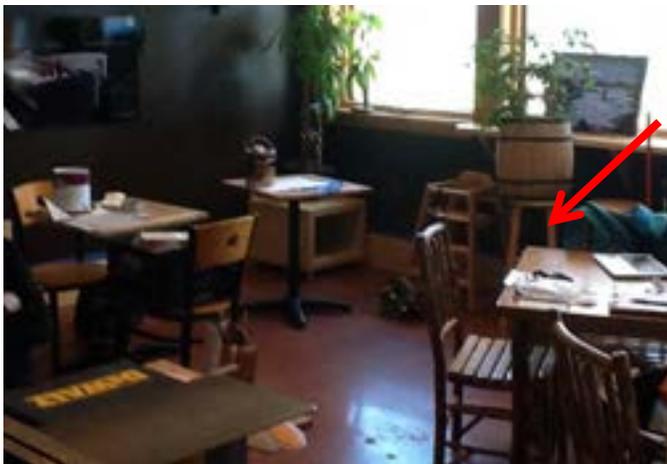
An aisle with 36" minimum clear width must be provided between tables.

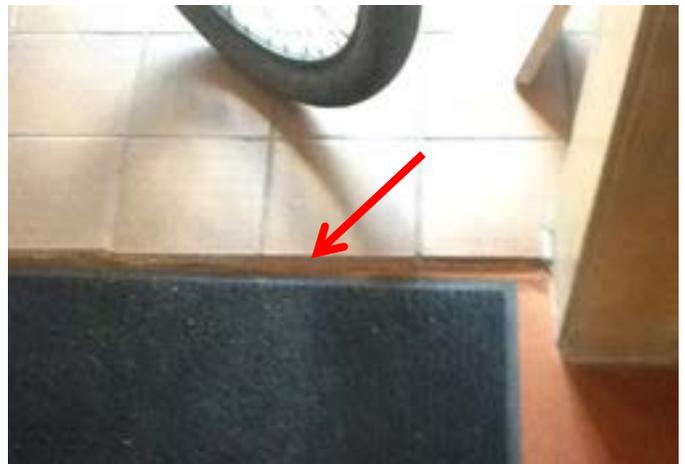
The threshold's vertical change exceeds more than 1/2" overall. Provide a rubber or aluminum transition strip.

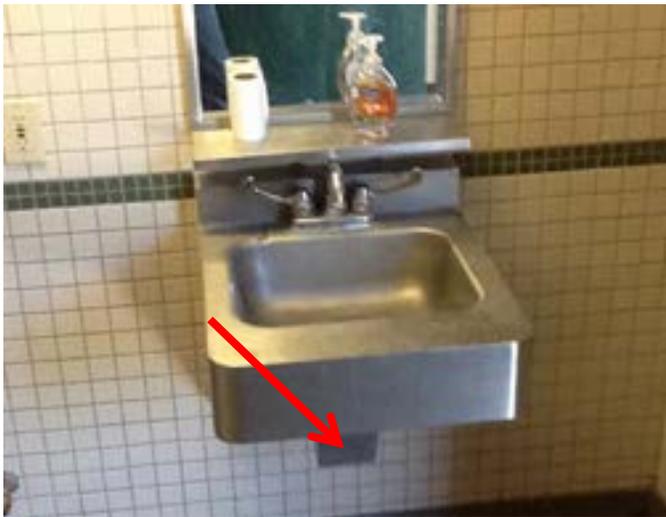
The metal shroud invades the knee space so that the knee clearance does not extend 8" from the front edge of the lavatory.

9.G: Lavatory Knee Clearance	Knee clearance does not extend 8" from the front edge of the lavatory.	Replace lavatory or adjust stainless steel shroud over piping so that it allows for the required knee clearance.	Mid-term

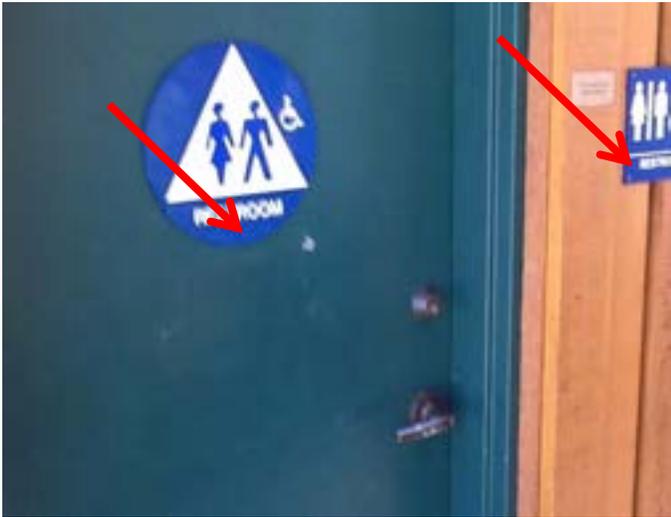
Braille should not be on door signs and the sign mounted on the side of the building should indicate "UNISEX" in raised characters and braille.

10.D: Door Sign	Braille is located on the restroom door sign and should not be.	Remove or cover braille located on the door sign or replace door sign.	Short-term

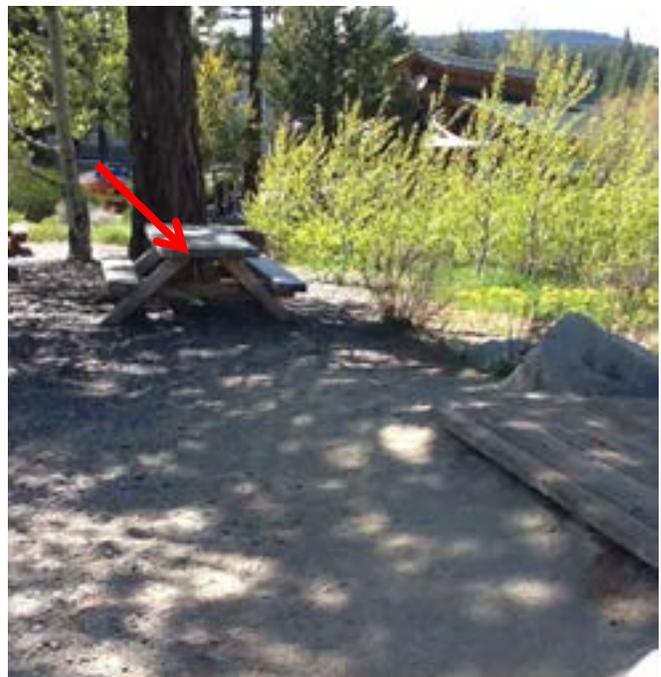
Picnic tables are provided but none are located on an accessible route.

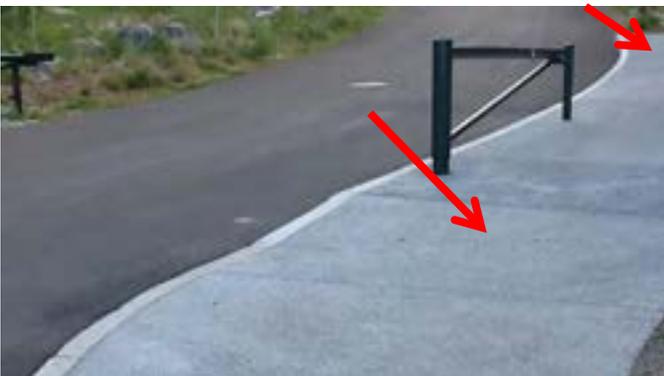
Running slopes exceed 5% and cross slope exceeds 1:48 (2%) in sections.

ITEM	EXISTING BARRIER	BARRIER REMOVAL METHOD	CORRECTIVE TIMELINE
VAN SICKLE BI-STATE PARK			
2: Accessible Route of Travel – Public Rights of Way			
2.A: Cross Slope	In one area of the concrete walk the cross slope is 2.9%.	Reconstruct walkway to not exceed 2% cross slope.	Long-term
2.B: Running Slope	The majority of the concrete walk exceeds 5%. Excessive slopes range from 5.1% to 10%.		Long-term
2.C: Changes in Level	A change in level greater than ¼" exists where the path transitions to decomposed granite.	Replace or reinstall the sections of walkway to provide transitions less than ¼".	Short-term
2.D: Detectable Warnings	Detectable warnings are not provided where walkway transitions to vehicular way.	Install appropriate detectable warnings on walkways that transition vehicular ways.	Mid-term

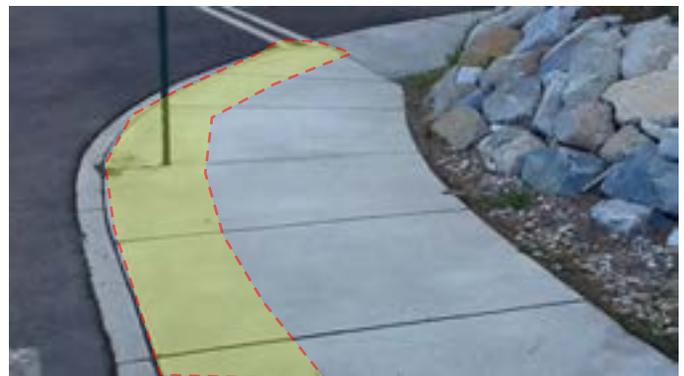
Truncated domes are not provided at flush transitions to vehicular ways.

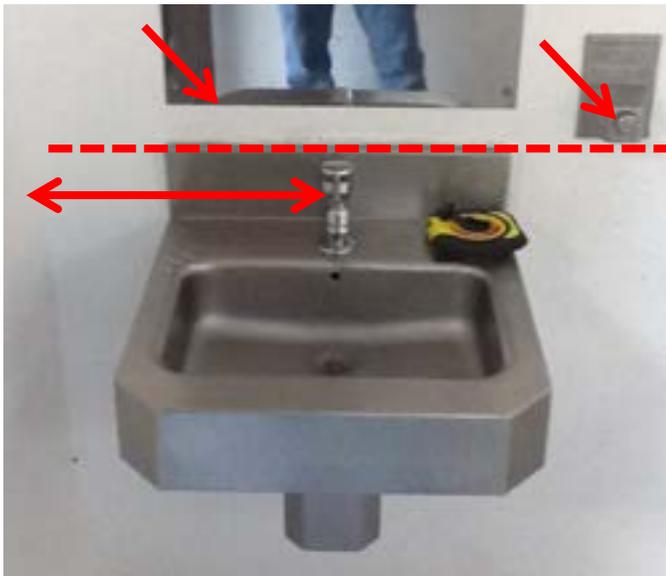
The air dryer operating mechanism and the bottom edge of the mirror exceed the maximum 40" allowed height above finish floor. The center of the lavatory is located less than the 18" minimum distance from the edge of wall.

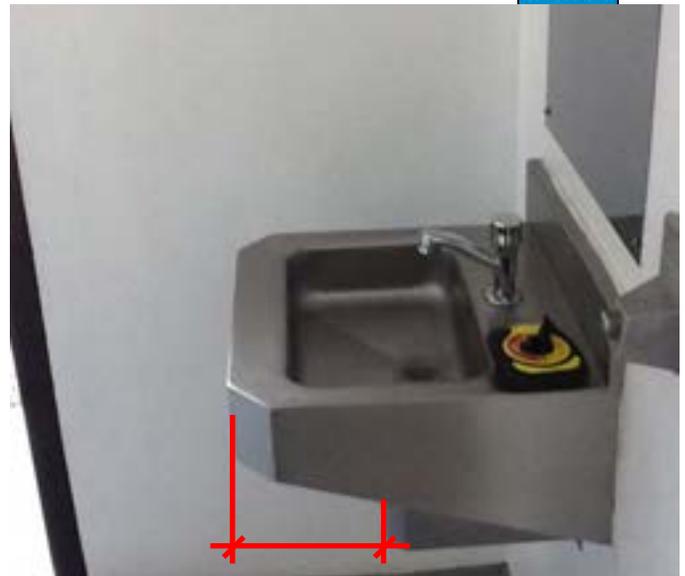
4.D: Lavatory Knee Clearance	Knee clearance does not extend 8" from the front edge of the lavatory. It extends 7½".	Replace lavatory or adjust stainless steel shroud over piping so that it allows for the required knee clearance.	Long-term

The metal shroud is 7 1/2" from the leading edge of lavatory. An 8" minimum id allowed.

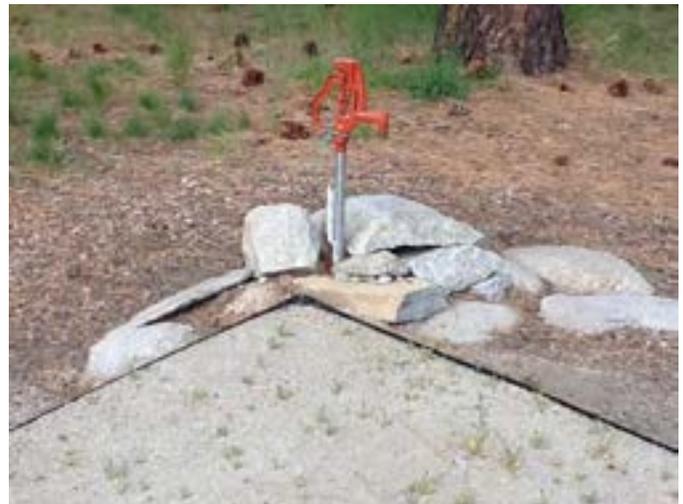
Water spigot location does not provide wheelchair access. Controls exceed 5 lbs. maximum operating pressure and would require tight grasping.

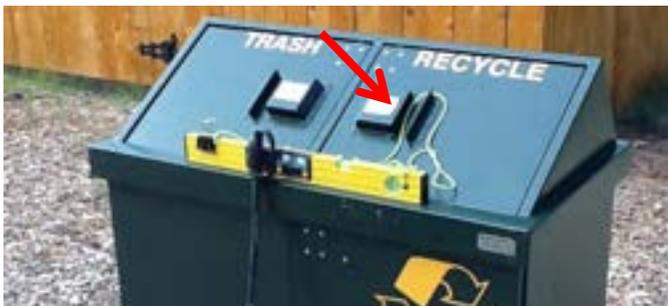
A person without hands may find the opening mechanism difficult or impossible to operate.

ITEM	EXISTING BARRIER	BARRIER REMOVAL METHOD	CORRECTIVE TIMELINE
VAN SICKLE BI-STATE PARK			
6: Site Furnishings & Amenities			
6.A: Picnic Tables	Accessible picnic table does not provide 30"x48" wheelchair space nor the allowed knee space within those limits.	Replace picnic table with a table that meets accessibility requirements.	Short-term
6.B: Water Spigot	Water spigot location does not provide wheelchair access. Controls exceed 5 lbs. maximum operating pressure and would require tight grasping.	Replace water spigot with a unit that requires no more than 5 lbs. of pressure to operate and is within prescribed reach ranges. Provide a clear, stable, firm ground surface area for a forward approach.	Short-term
6.C: Animal Resistant Trash Receptacle	A person without hands may find the opening mechanism difficult or impossible to operate.	Consider in additional guidelines.	Long-term
