NORTH TAHOE BEACH

CALIFORNIA TAHOE CONSERVANCY

ADA SELF-EVALUATION AND TRANSITION PLAN

PATTON LANDING

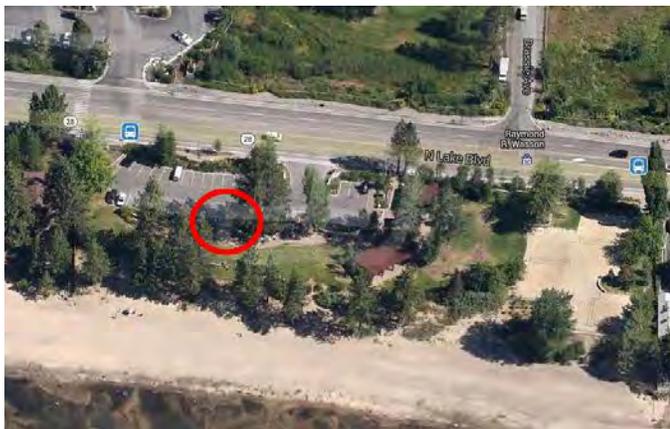
Site Plan – Accessible Parking Location

ITEM	EXISTING BARRIER	BARRIER REMOVAL METHOD	CORRECTIVE TIMELINE
NORTH TAHOE BEACH			
1: Parking			
1.A: Location of Accessible Spaces	Parking spaces are not on the shortest possible route to a majority of built facilities.	Restripe parking spaces to locate accessible spaces near the restroom facilities.	Done

1.B: Cross Slope and Surface	Cross slope in accessible aisle is greater than 2% (2.2%). Uneven surface and inconsistent striping of accessible spaces due, respectively, to parking space location over concrete storm filter vault and the inconsistent replacement of the manhole cover.	With the relocation of parking spaces to the restroom area, re-grade parking area if needed so that cross slope does not exceed 2% and provide appropriate striping.	Long-term

1.C: Lettering	The words "NO PARKING" are not provided in the access aisle.	Revise access aisle striping to include required lettering at appropriate dimensions.	Done

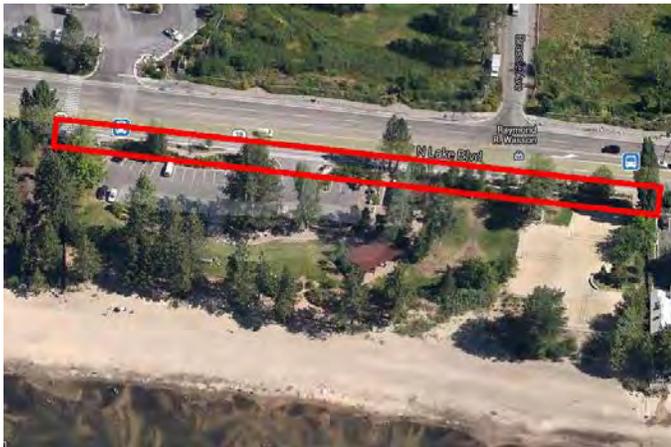
Site Plan – Accessible Route of Travel (Public ROW)

ITEM	EXISTING BARRIER	BARRIER REMOVAL METHOD	CORRECTIVE TIMELINE
NORTH TAHOE BEACH			
2: Accessible Route of Travel – Public Rights of Way			
2.A: Curb Ramp Cross Slope	Cross slope varies at curb ramp on the west side of the drive entrance. (7.4% in some areas)	Regrade curb ramp so that cross slope does not exceed 2%.	Mid-term
2.B: Changes in Level	Changes in walkway levels are greater than ¼" along the concrete paver walkway at certain transition points between the pavers and adjacent concrete walks and utility inlets and utility access boxes.	Replace or reinstall the sections of walkway to provide transitions less than ¼".	Mid-term

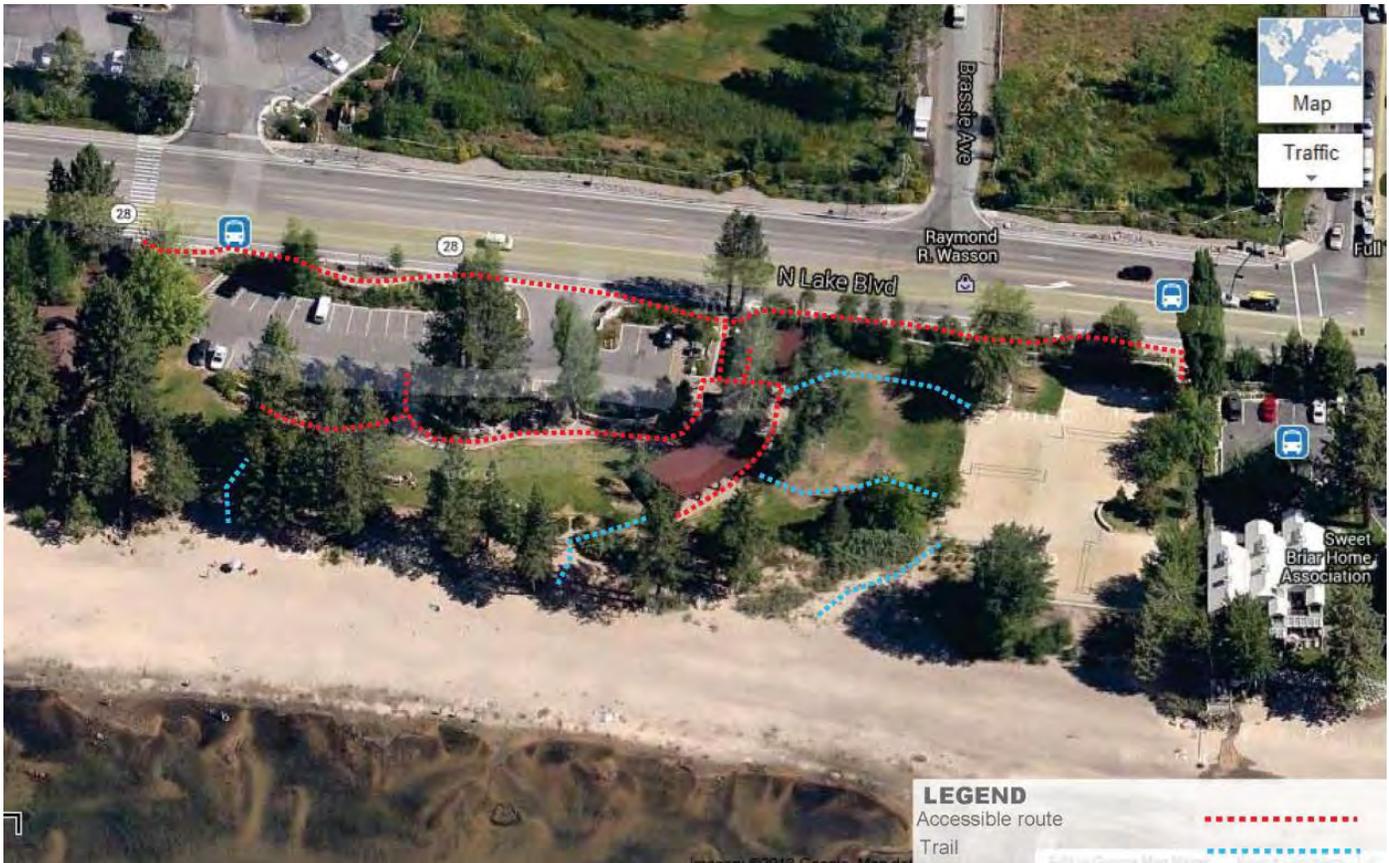
Site Plan – Accessible Route of Travel: On Site

ITEM	EXISTING BARRIER	BARRIER REMOVAL METHOD	CORRECTIVE TIMELINE
NORTH TAHOE BEACH			
3: Accessible Route of Travel – On Site			
3.A: Overlap with route for general public	The path that links to the sand volleyball courts does not coincide with the route for the general public. It requires use of the route within the public rights of way which leads to a viewing area.	Provide a more direct accessible route to the sand volleyball courts.	Long-term

3.B: Connection of Facilities	No accessible route connects a user to the beach, to the sand volleyball courts, or to the horseshoe pits.	Provide an accessible route that connects all accessible facilities on the site to one another and to site amenities such as waste receptacles, picnic tables and barbecues.	Long-term

3.D: Cross Slope	The cross slope of the primary walk and paved area under the pavilion exceeds 2%. Cross slopes vary as follows: <ul style="list-style-type: none"> • South side of the parking area: 2.1%-3.3% • North-south section connecting restrooms to the pavilion: 3.1%-4.0% • Pavilion paved area: 2.1%-3.7% (potentially from settling caused by erosion due to irrigation) 	Regrade walkways and paved area under pavilion to ensure no cross slopes exceed 2%. Stabilize soil and revise irrigation design at southern corner of pavilion to reduce erosion potential.	Long-term

3.F: Walkway Change in Level	Walkway levels change greater than ¼" along the concrete paver walkway at certain transition points between the pavers and adjacent concrete walks and utility inlets and utility access boxes.	Replace or reinstall the sections of walkway to provide transitions less than ¼".	Long-term

3.H: Hazardous Vehicular Areas – Detectable Warnings	The curb ramp servicing the accessible parking, the turn-around space adjacent to the restroom facility and the walkway connection to the drive aisle at the terminus of the drive aisle/entry do not have adequate separation or detectable warnings.	Where pedestrian areas cross or adjoin a vehicular way, either separate the walkway from the vehicular way with a curb, a railing or other element or provide a continuous detectable warning at least 36" wide.	Long-term

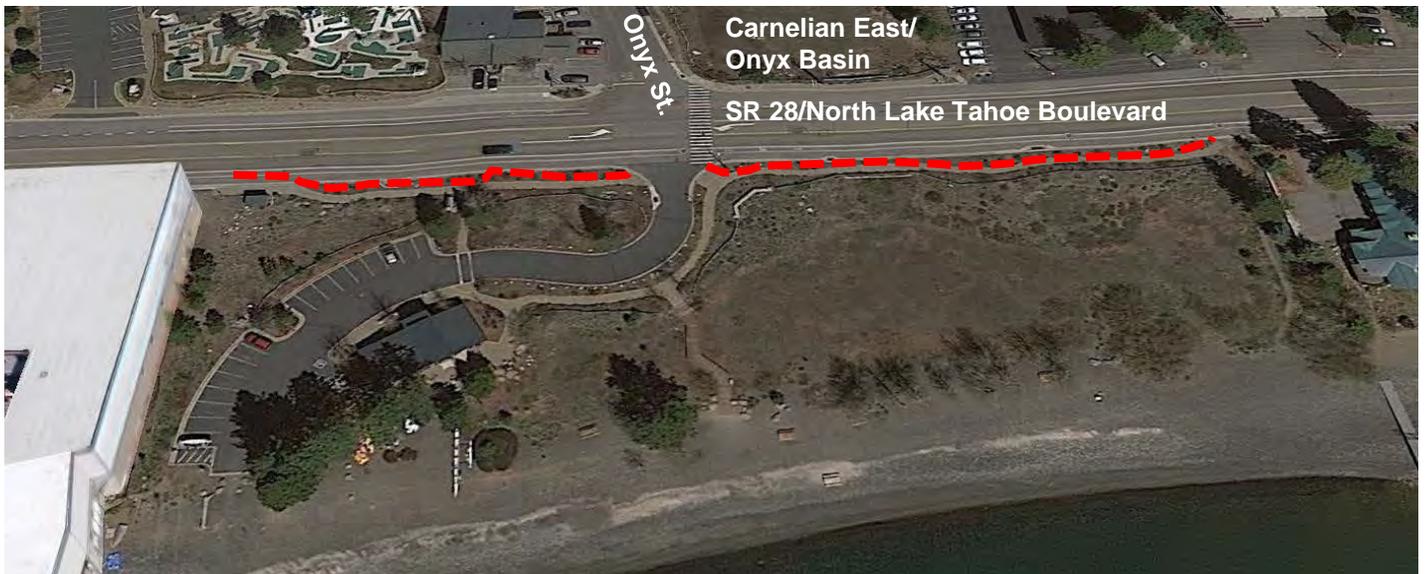
Site Plan: Location of accessible routes of travel in the public rights of way.

2.C: Changes in Level	Changes in walkway levels are greater than ¼" at transitions from paver to concrete or asphalt due to settling. Transitions at concrete utility inlets or concrete utility access boxes are not compliant. The terminus of the paver system at either end of the site exceeds ¼" where the paver system transitions to the adjacent surface. A few areas of general settlement have created sunken areas that are non-compliant.	Replace or reinstall the sections of walkway to provide transitions less than ¼".	Long-term

2.D: Width	Plants reduce the clear path of travel to less than 48".	Trim plants to maintain minimum clear path of travel along walkways.	Short-term
2.E: Detectable Warning	Walkway terminates into a decomposed granite path that is not stable or slip resistant and does not have a detectable warning system at its flush transition to the roadway.	Replace decomposed granite with a firm and stable material and install truncated domes.	Mid-term

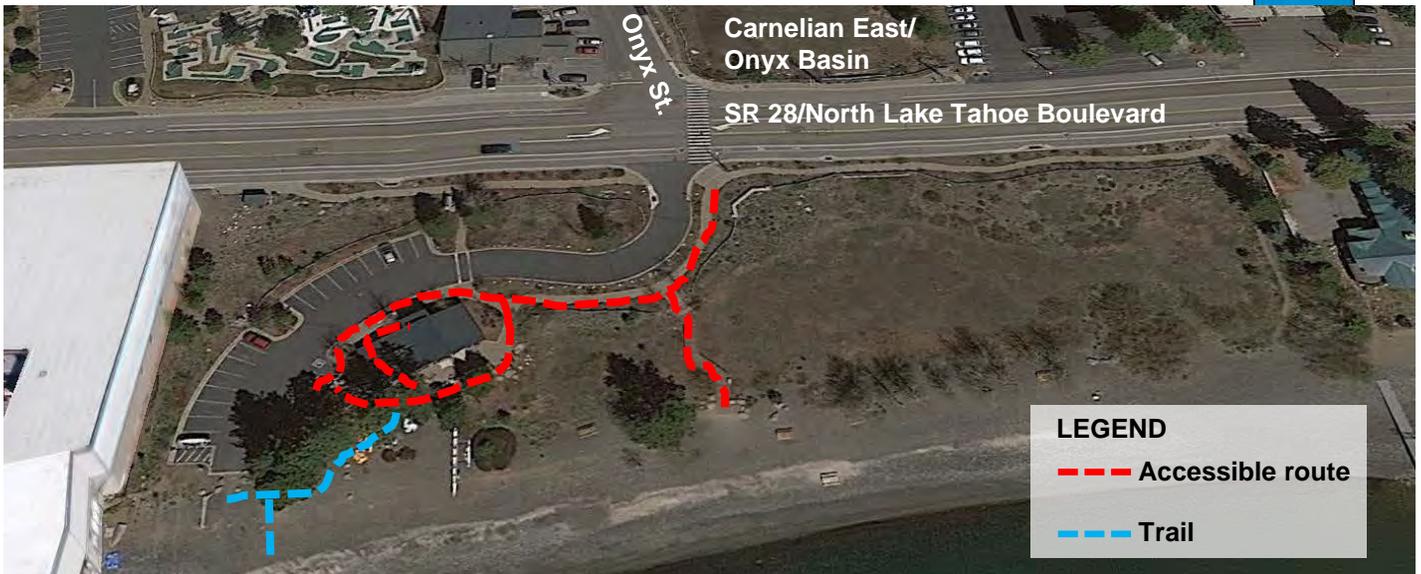
Site Plan: Location of accessible routes of travel on site.

3.C: Running Slope	The curb ramp leading to the accessible parking access aisle is 8.5%.	Reconstruct curb ramp. (See curb ramps.)	Mid-term
3.D: Changes in Level	<p>Changes in walkway levels are greater than ¼" at transitions from paver to concrete or asphalt due to settling.</p> <p>The rough nature and degradation of the timber boardwalk's wood has created vertical changes greater than ¼".</p>	<p>Replace or reinstall the sections of walkway to provide transitions less than ¼".</p> <p>Replace select boardwalk timbers to provide vertical changes no greater than ¼".</p>	Long-term

3.E: Grates	The smaller dimension of a grate is greater than ½", and the long dimensions of rectangular gaps are not placed perpendicular to the usual direction of travel.	Replace non-compliant grates with grates that meet accessibility requirements.	Short-term

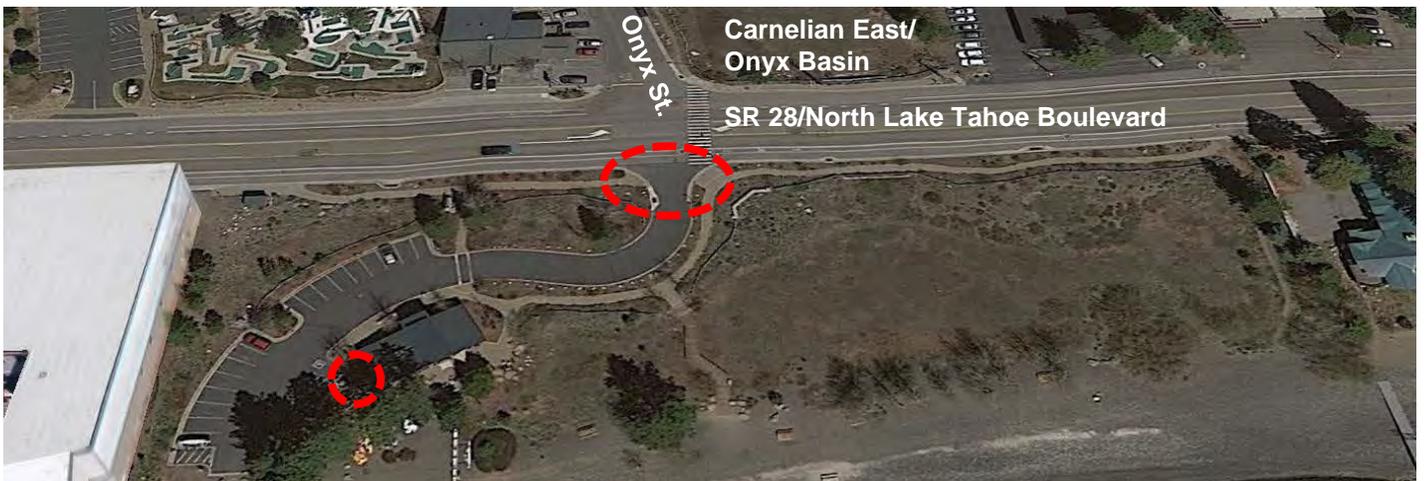
Site Plan – Curb Ramp Locations

4.C: Counter Slope	The terminus where the on-site walkway adjoins the public path of travel is 5.6% (exceeds 5%).	Reconstruct the facility to not exceed 5% slope.	Mid-term

4.D: Detectable Warning	The curb ramps do not have detectable warnings.	Install appropriate detectable warnings on the curb ramps.	Mid-term
4.E: Straight Curb	No 24" segment of straight curb is located on each side of the diagonal curb ramp.	Reconstruct curb ramp to meet accessibility requirements.	Mid-term
