## ADA SELF-EVALUATION AND TRANSITION PLAN

### VAN SICKLE BI-STATE PARK

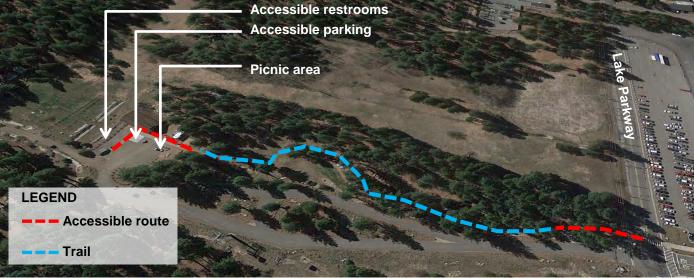
Site Plan – Accessible Routes

ITEM	EXISTING BARRIER	BARRIER REMOVAL METHOD	CORRECTIVE TIMELINE
	VAN SICKLE B	I-STATE PARK	
2: Accessible Ro	ute of Travel – Public Rights of Way		
2.A: Cross Slope	In one area of the concrete walk the cross slope is 2.9%.	Reconstruct walkway to not exceed 2% cross slope.	Long-term
2.B: Running Slope	The majority of the concrete walk exceeds 5%. Excessive slopes range from 5.1% to 10%.		Long-term
2.C: Changes in Level	A change in level greater than ¼" exists where the path transitions to decomposed granite.	Replace or reinstall the sections of walkway to provide transitions less than ¼".	Short-term
2.D: Detectable Warnings	Detectable warnings are not provided where walkway transitions to vehicular way.	Install appropriate detectable warnings on walkways that transition vehicular ways.	Mid-term
